Prettyboy Reservoir Watershed Stream Corridor Assessment

Winter 2011

Prepared By
Carroll County Bureau of Resource Management

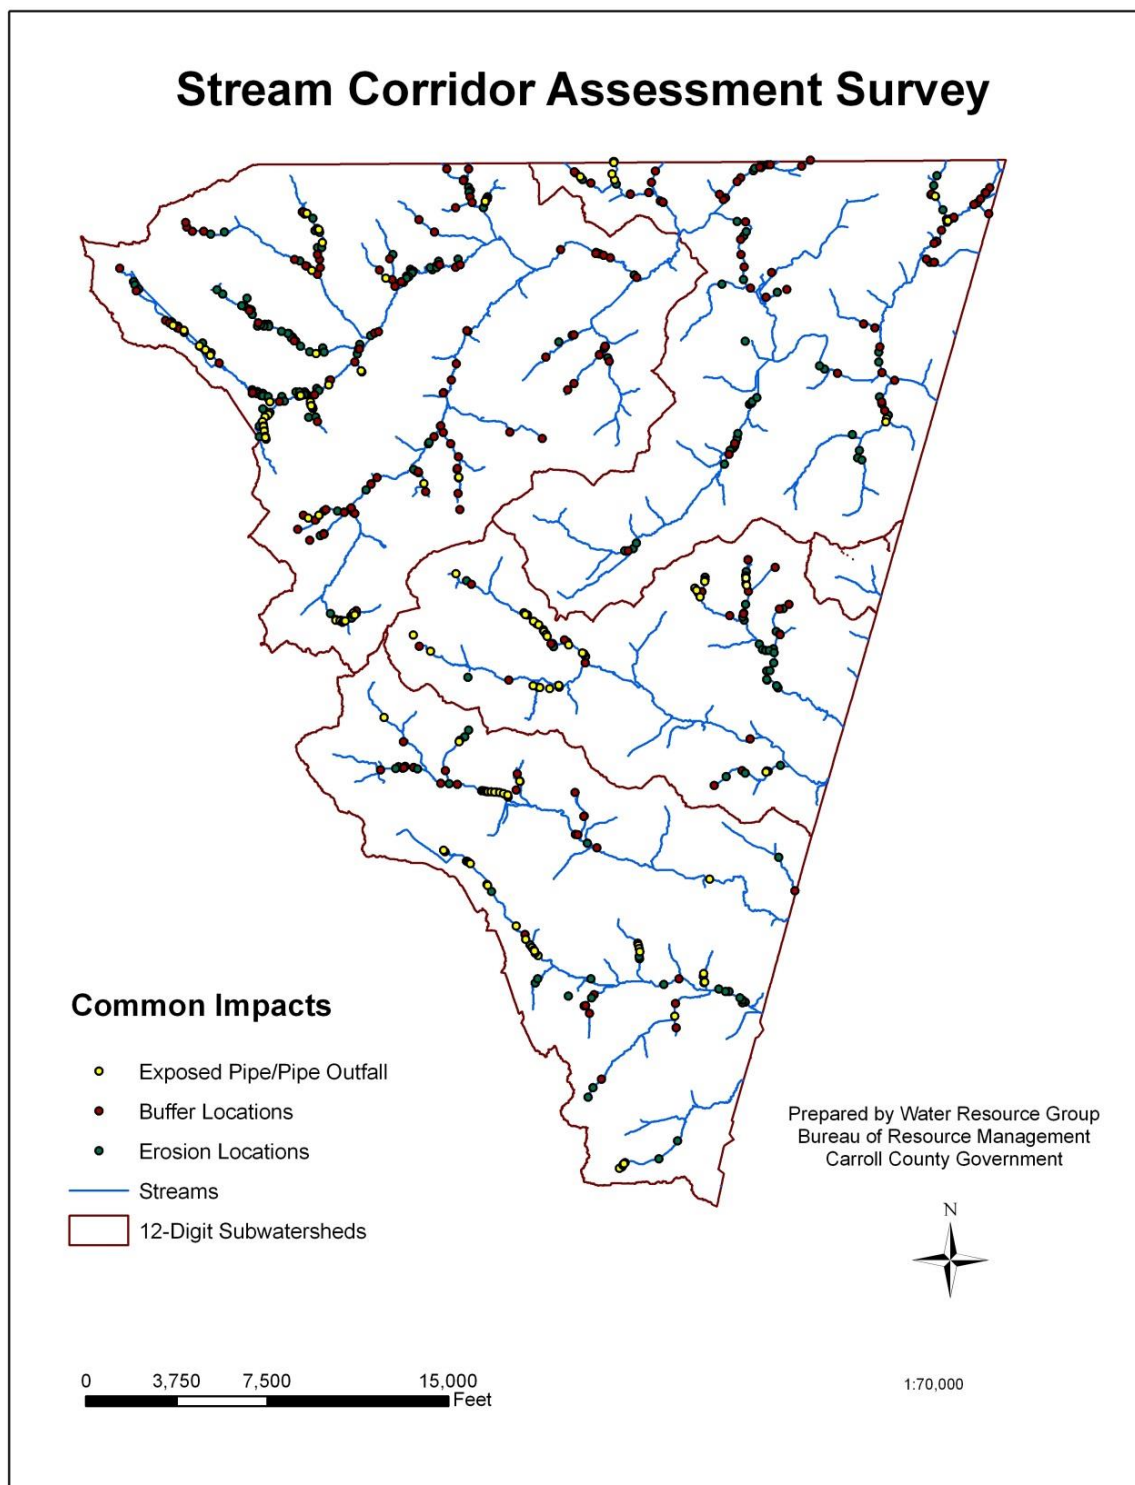
Figure 1-3: Most Commonly Identified Impacts

A total of 568 data points were collected across the watershed. Inadequate buffers and stream bank erosion were the most frequently identified problems. Drainage pipe outfalls were also regularly present throughout the watershed. Table 1-2 lists the data points by severity across the entire watershed. The most commonly identified impacts are shown in Figure 1-3 and Table 1-3 presents a summary of the number of impacts identified in each subwatershed. Criteria for ranking each impairments severity can be found in Appendix B.

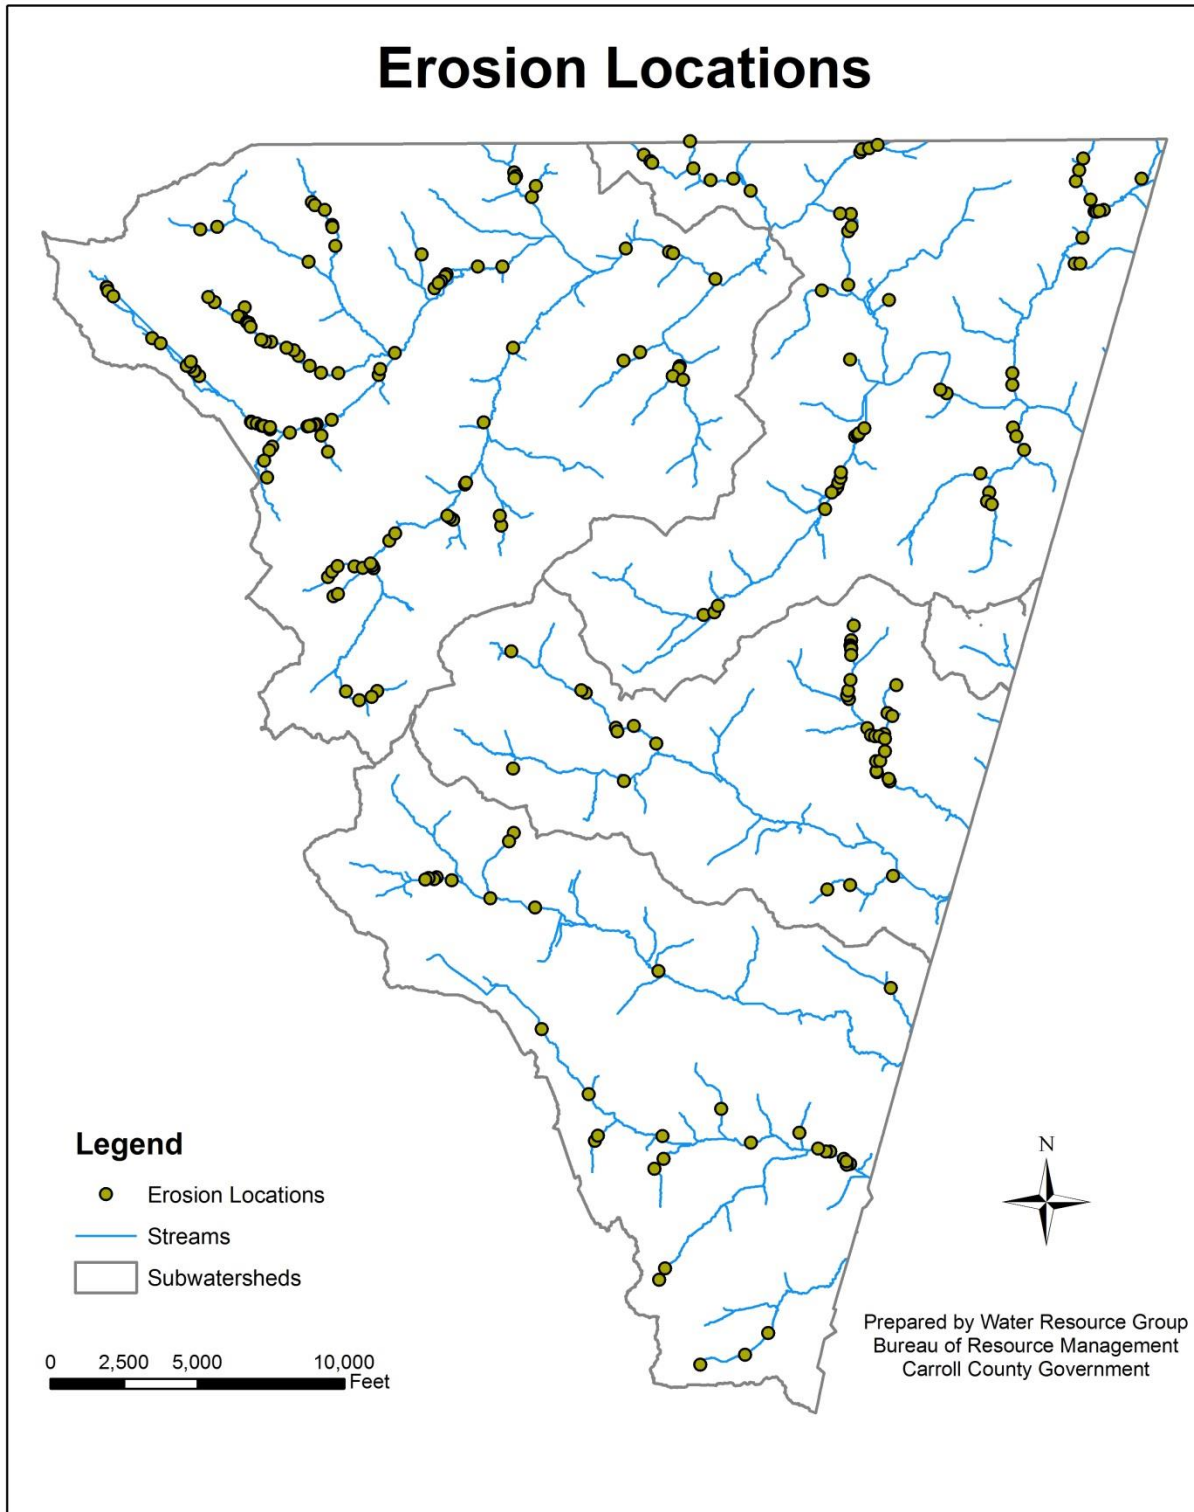
Figure 1-4: Erosion Locations

The most common problem identified through the Stream Corridor Assessment was erosion. A total of 11.67 miles (14.5%) of the 80 miles assessed were found to have an erosion problem, with approximately 2.5 percent of the watershed categorized as having a severe erosion problem. Figure 1-4 shows the location of active erosion sites identified during the Stream Corridor Assessment.

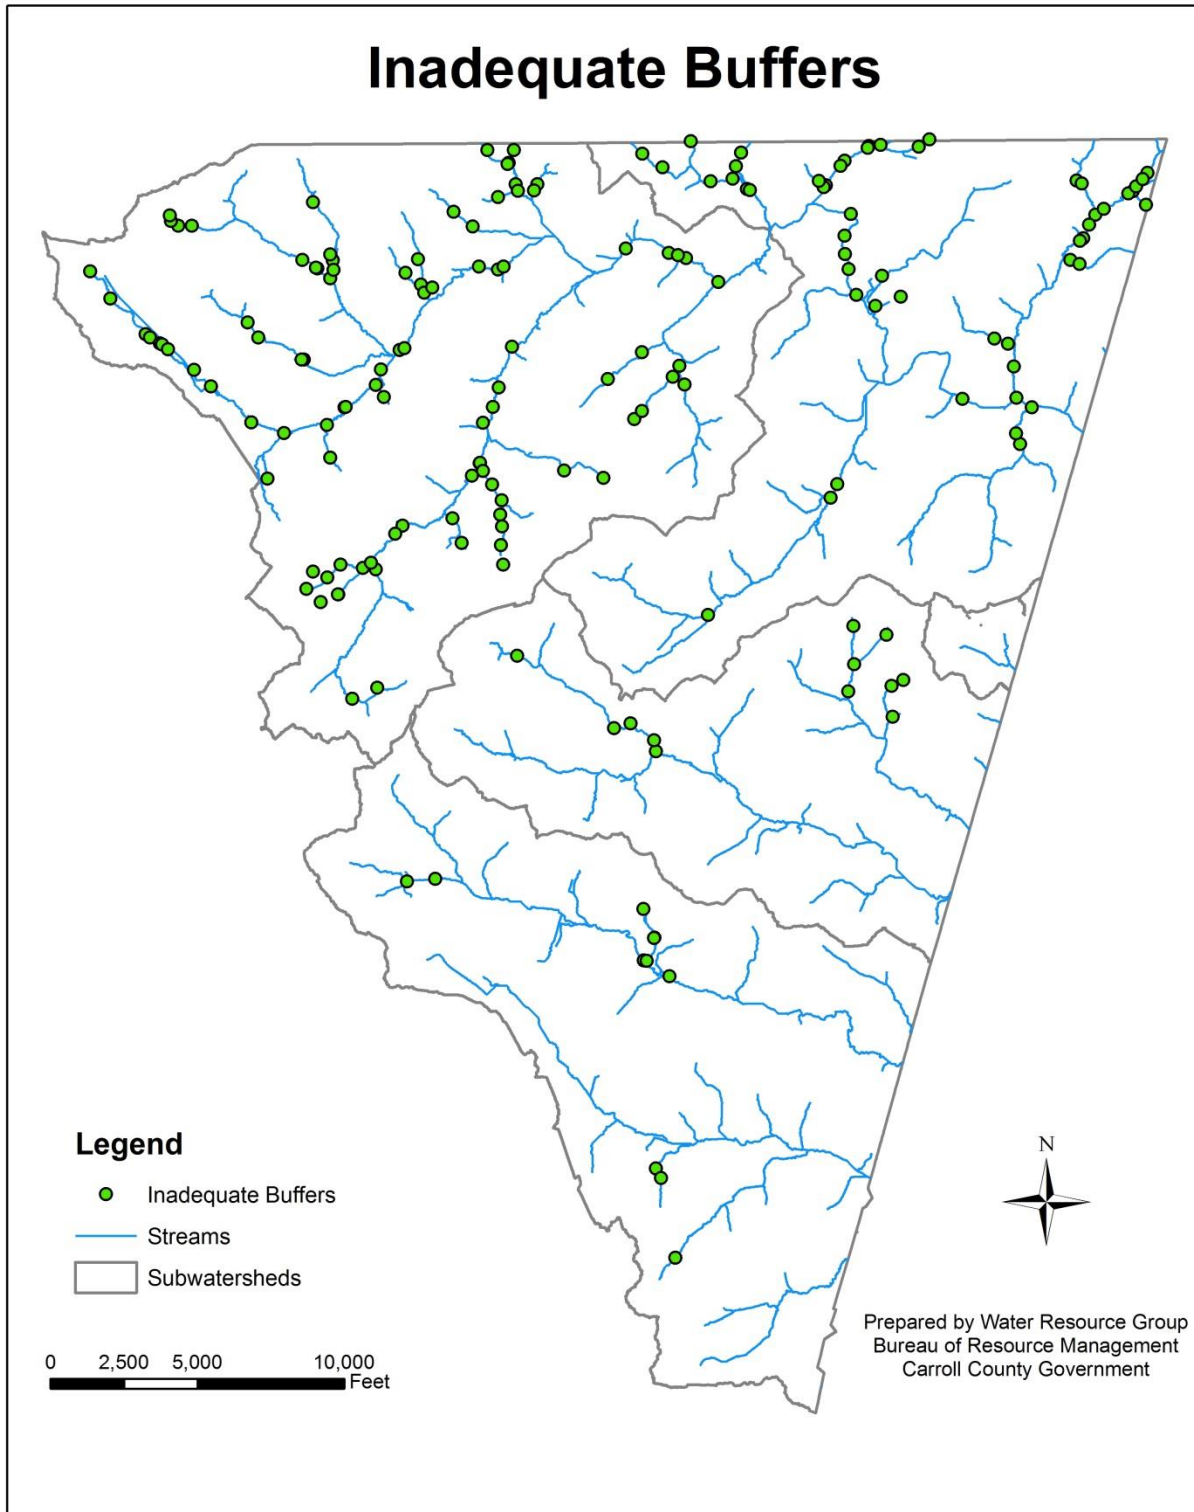
Figure 1-5: Inadequate Buffers

Buffer areas were identified as inadequate for 24 miles (30%) of the streams assessed, with 11.7 percent of the entire watershed classified as severely un-buffered. Forty-nine of the sites identified left both sides of the stream completely unshaded, and livestock was noted to be present at 17 different sites. Of the 128 sites identified, 5 had been recently planted but were not yet established. Figure 1-5 shows the location of identified inadequate buffers.

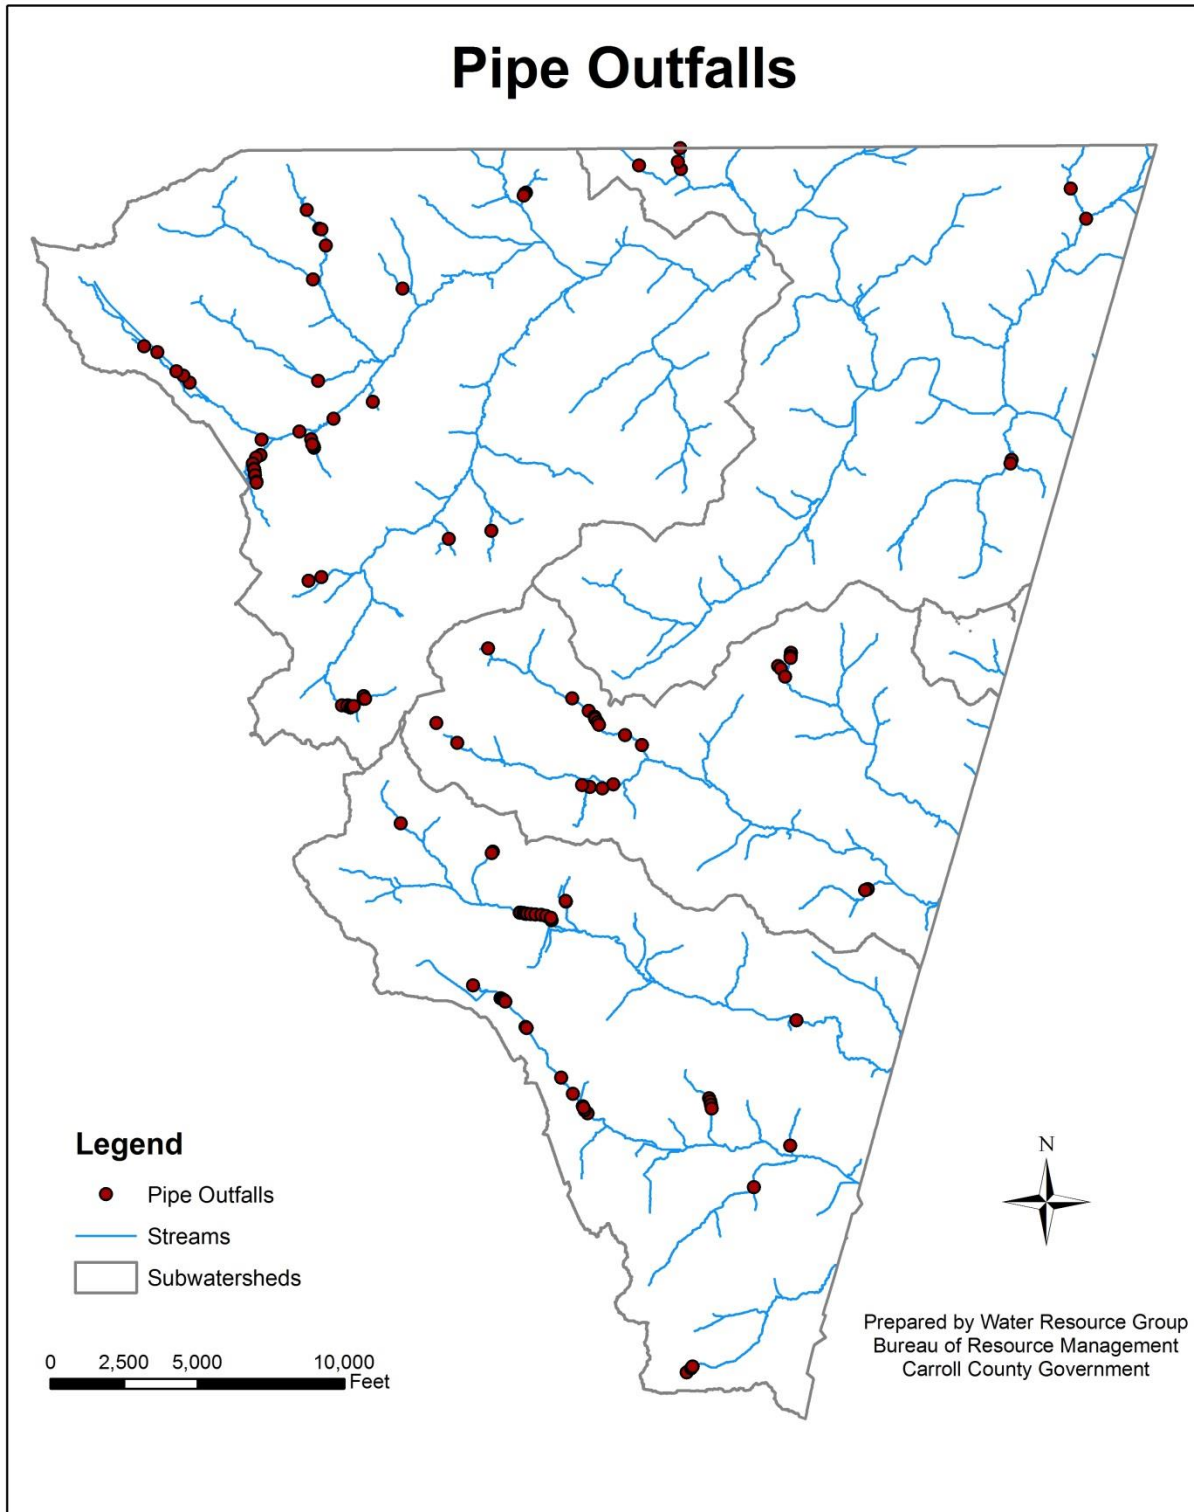
Figure 1-6: Pipe Outfalls

Outfalls were found throughout the entire watershed, but the highest concentrations were located in South Branch, Georges and Murphy Run. This higher concentration can be attributed to the towns of Hampstead and Manchester, which make up the headwaters of these three subwatersheds. The majority of the outfalls identified were 6” or less in diameter and were given a low impact rating. The location of identified pipe outfalls can be found in Figure 1-6.

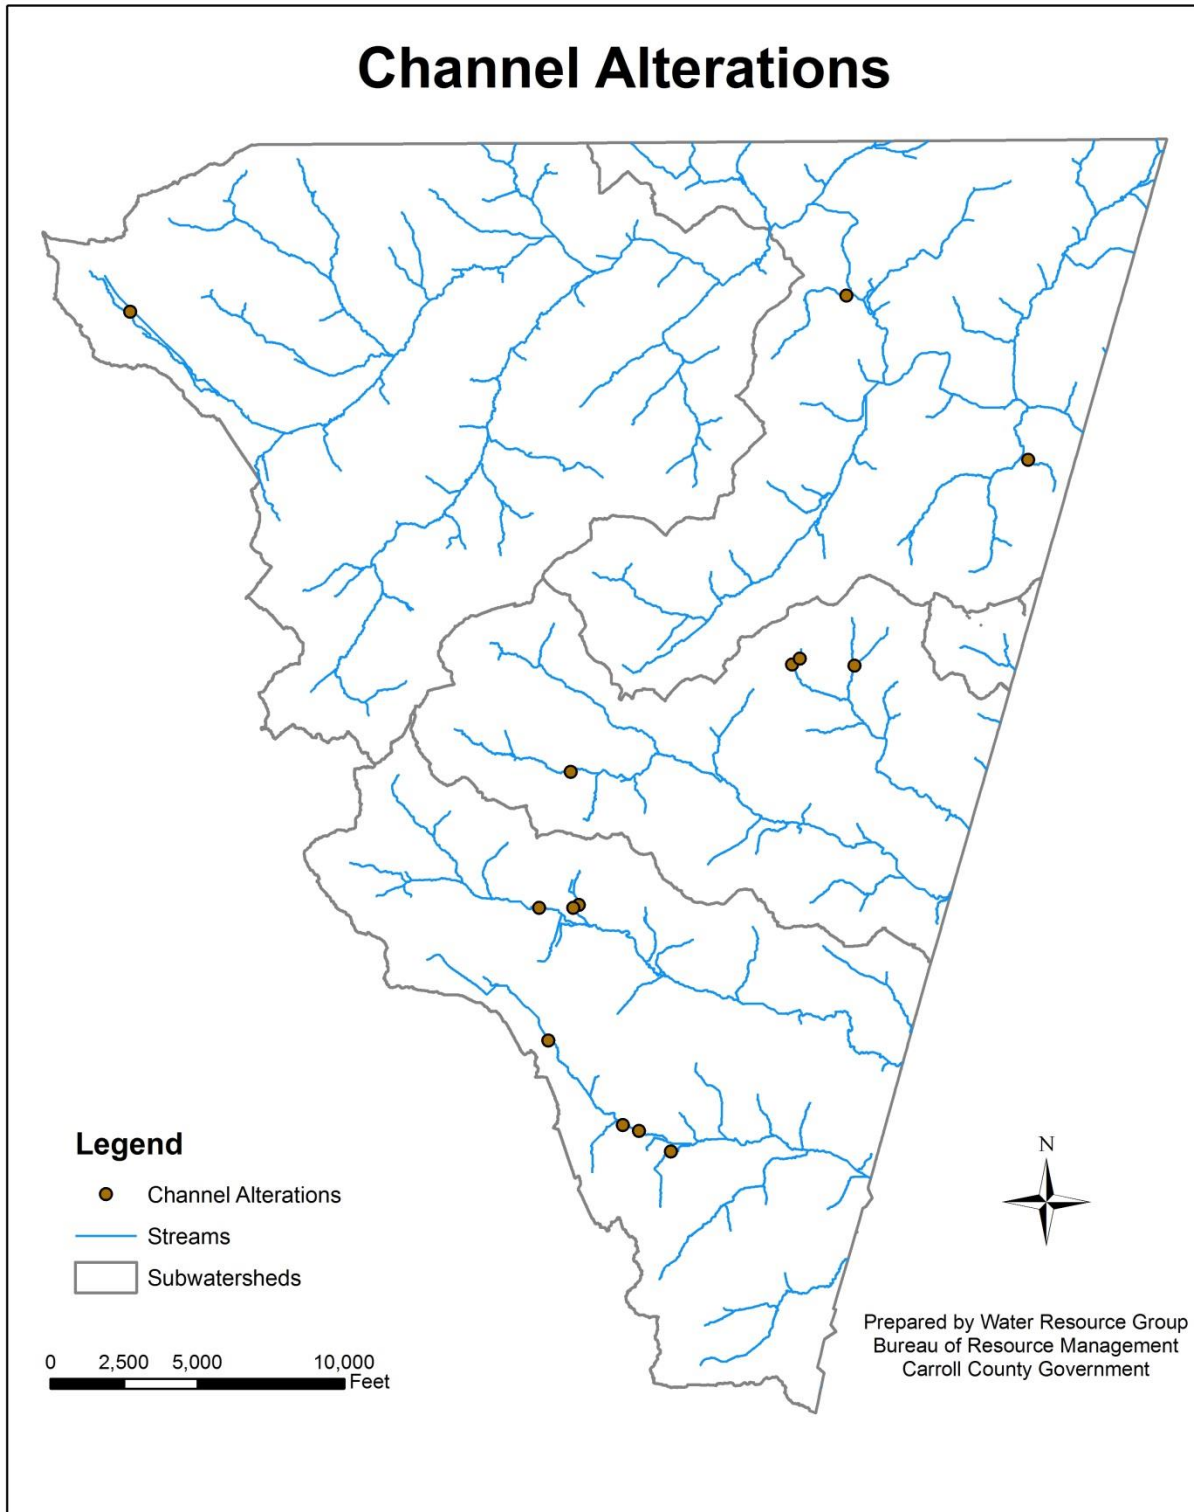
Figure 1-7: Channel Alterations

Impacts from channel alterations were found at 14 different sites within the watershed and totaled 11,809 linear feet. The alterations identified were associated with the protection of infrastructure and were given a minor severity ranking. Figure 1-7 shows the location of identified channel alterations within the watershed.

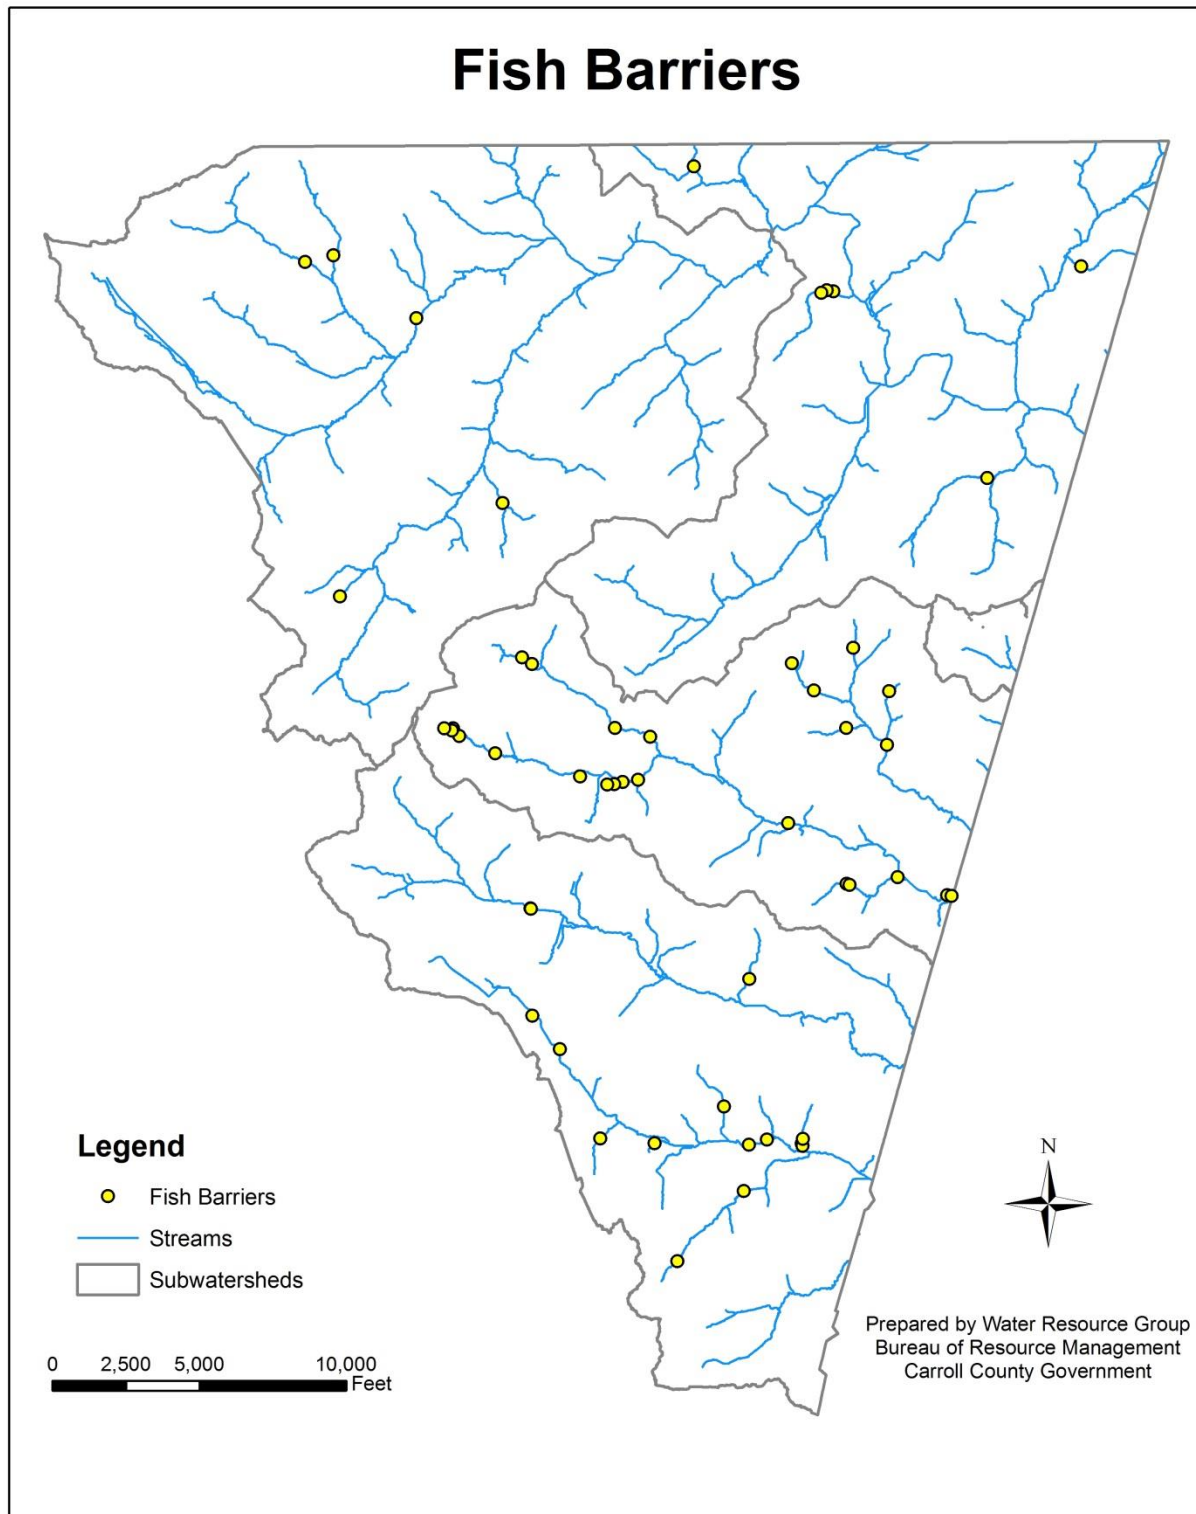
Figure 1-8: Fish Barriers

There were 52 fish barriers identified during the survey, 26 of which were in the Grave/Indian Run subwatershed. All of the sites were associated with either temporary debris dams or perched road culverts. Four of the sites identified significantly restricted fish movement upstream and received a moderate severity rating. Figure 1-8 shows the location of identified fish barriers.

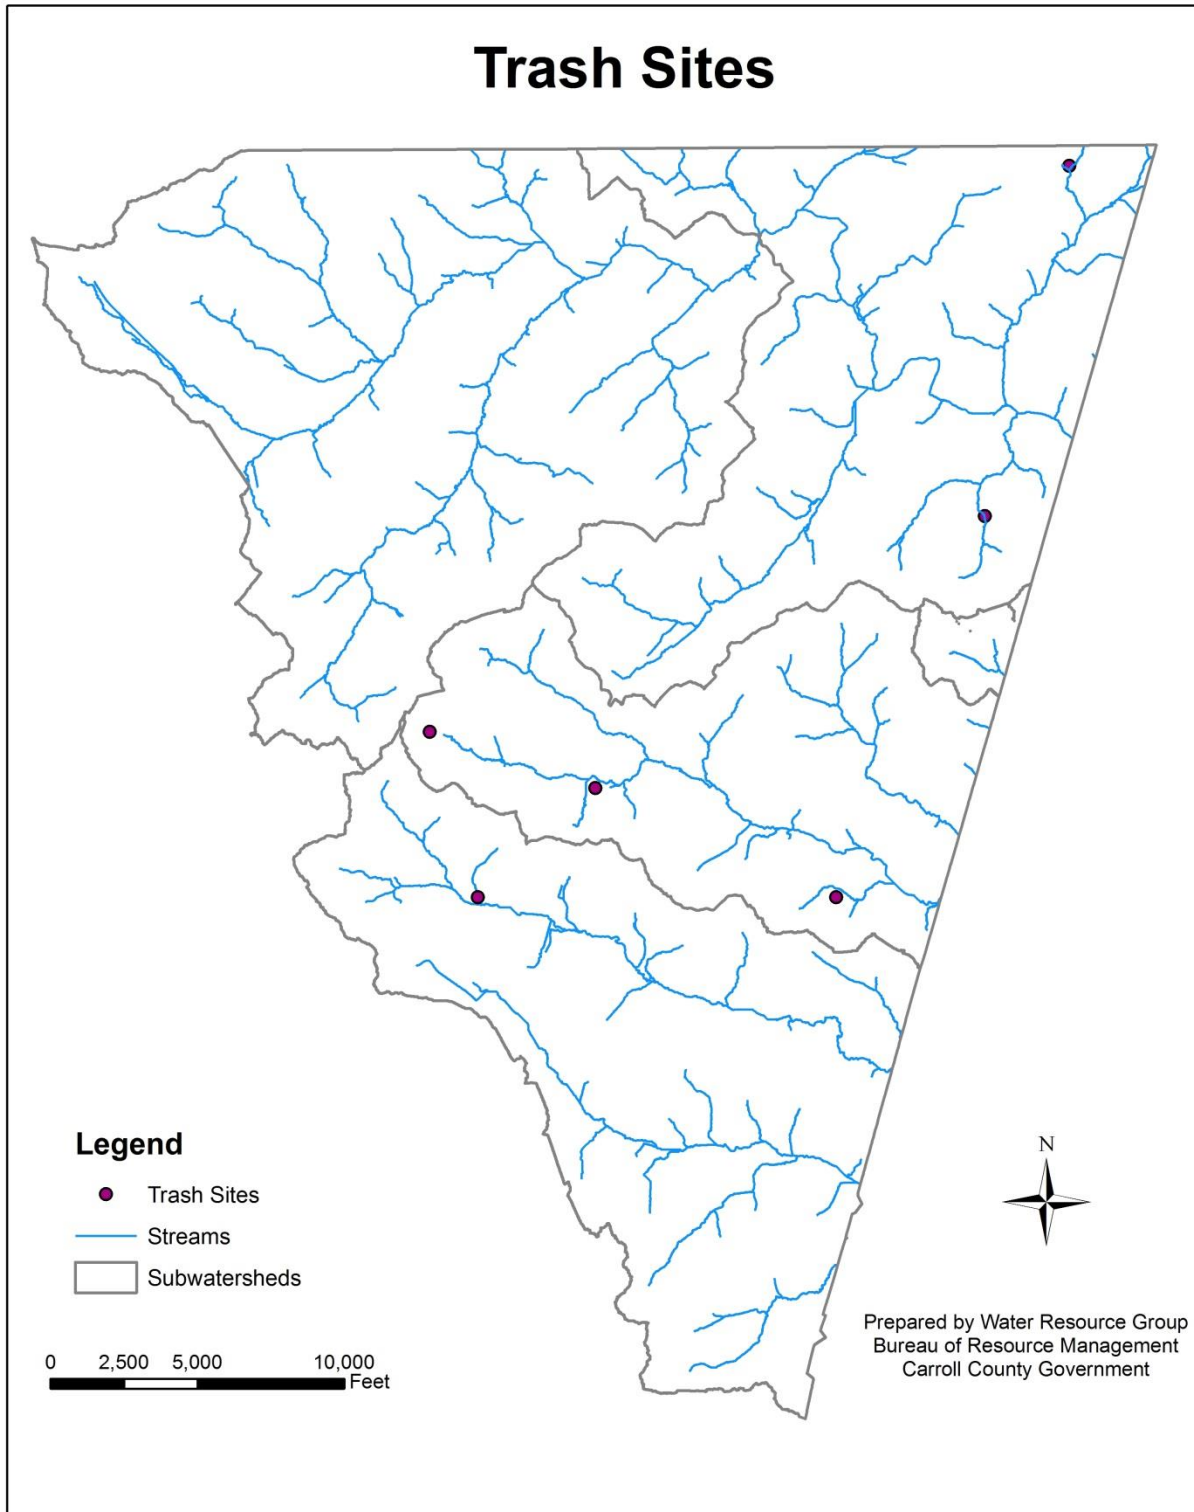
Figure 1-9: Trash Dump Locations

Impacts from trash were found at 6 different locations within the watershed; all of the sites had a moderate to minor severity rating, with the largest site estimated to have approximately 3 truckloads of waste. The location of identified trash sites can be found in Figure 1-9.

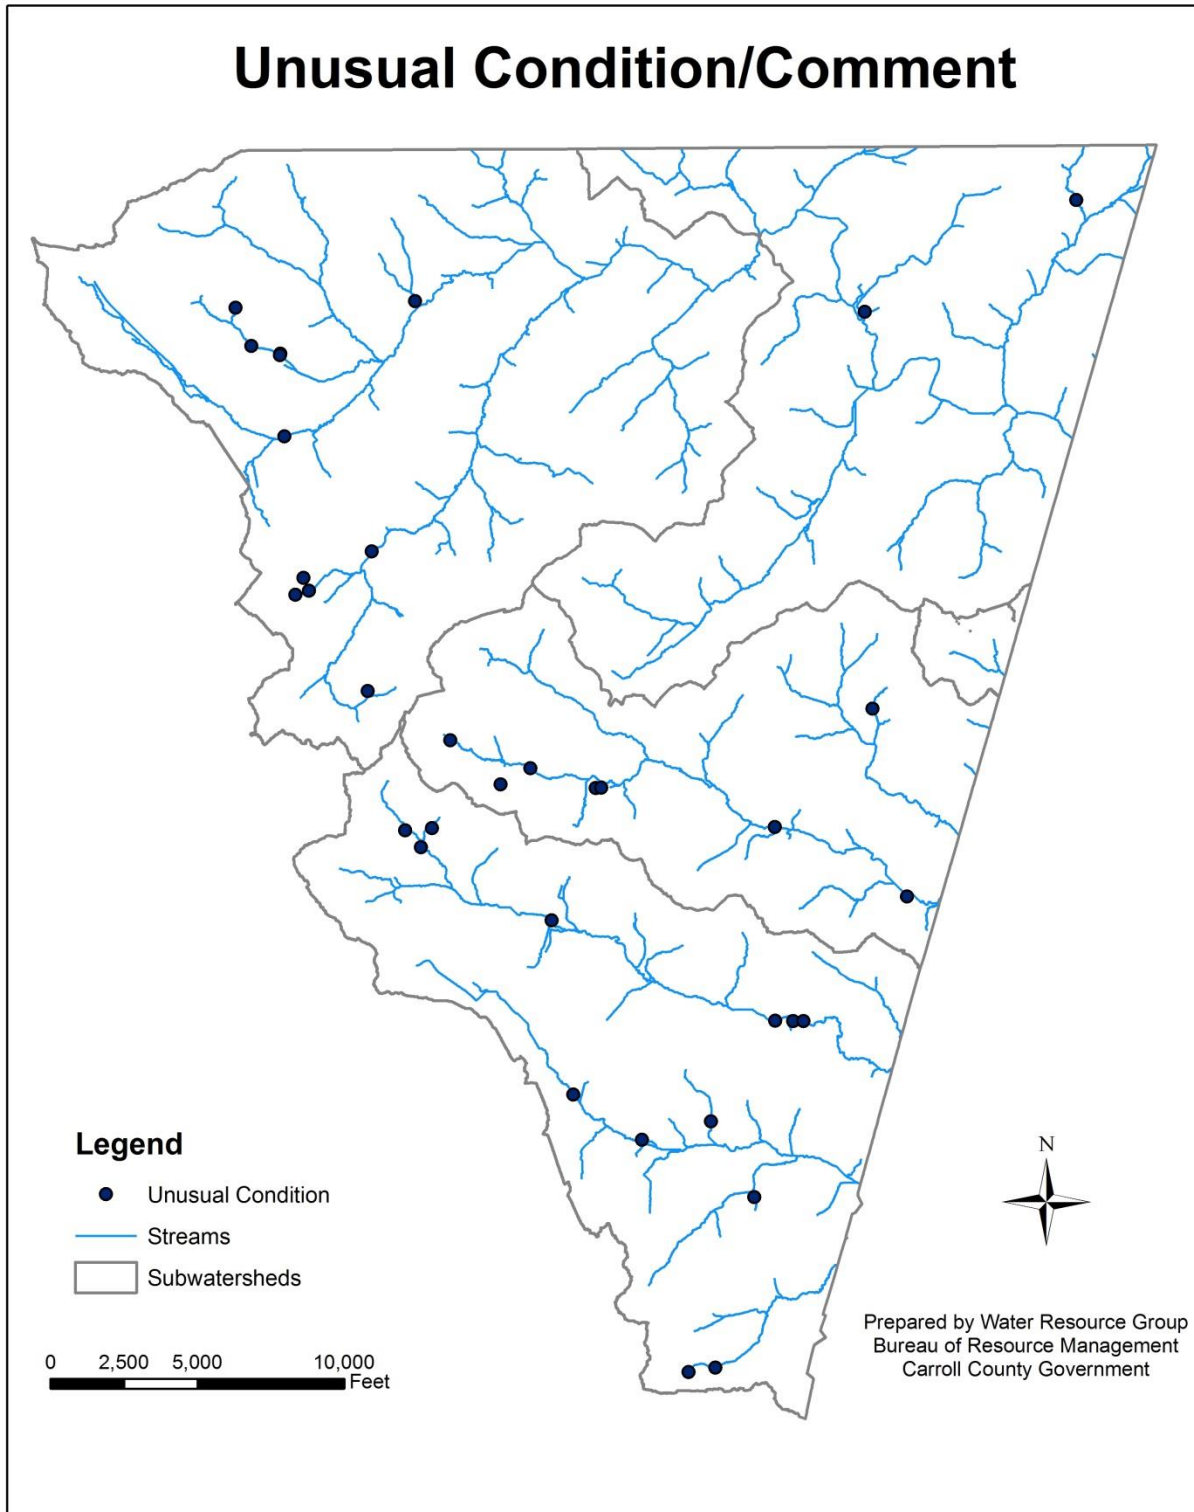
Figure 1-10: Unusual Conditions

Field crews identified 33 unusual conditions during the assessment. The majority of the unusual conditions were comment based, but one was associated with stormwater runoff that was causing an unusual headcut to develop on the edge of a crop field. The location of these can be found in Figure 1-10.
