**Loch Raven Reservoir  
Watershed  
Stream Corridor Assessment**

**Winter 2016**

**Prepared By  
Carroll County Bureau of Resource Management**

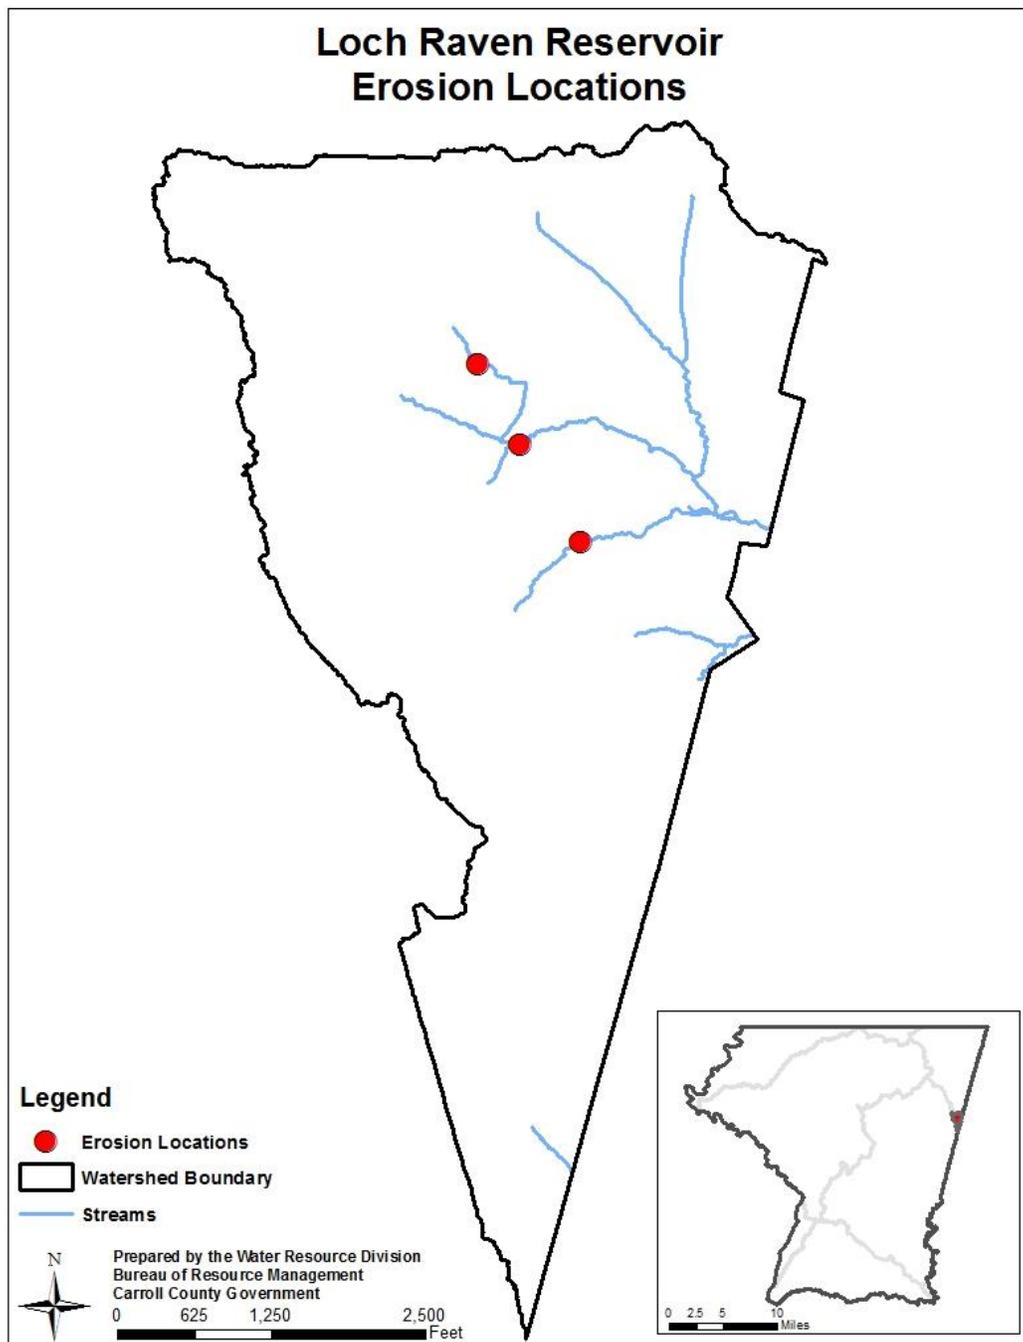
Figure 1-3: Erosion Locations

One of the most common problems identified through the Stream Corridor Assessment was erosion. A total of 1,990 linear feet or 0.38 miles (18%) of the 2.11 miles assessed were found to have an erosion problem, with approximately four percent of the watershed categorized as having a severe erosion problem. Figure 1-3 shows the location of active erosion sites identified during the Stream Corridor Assessment.

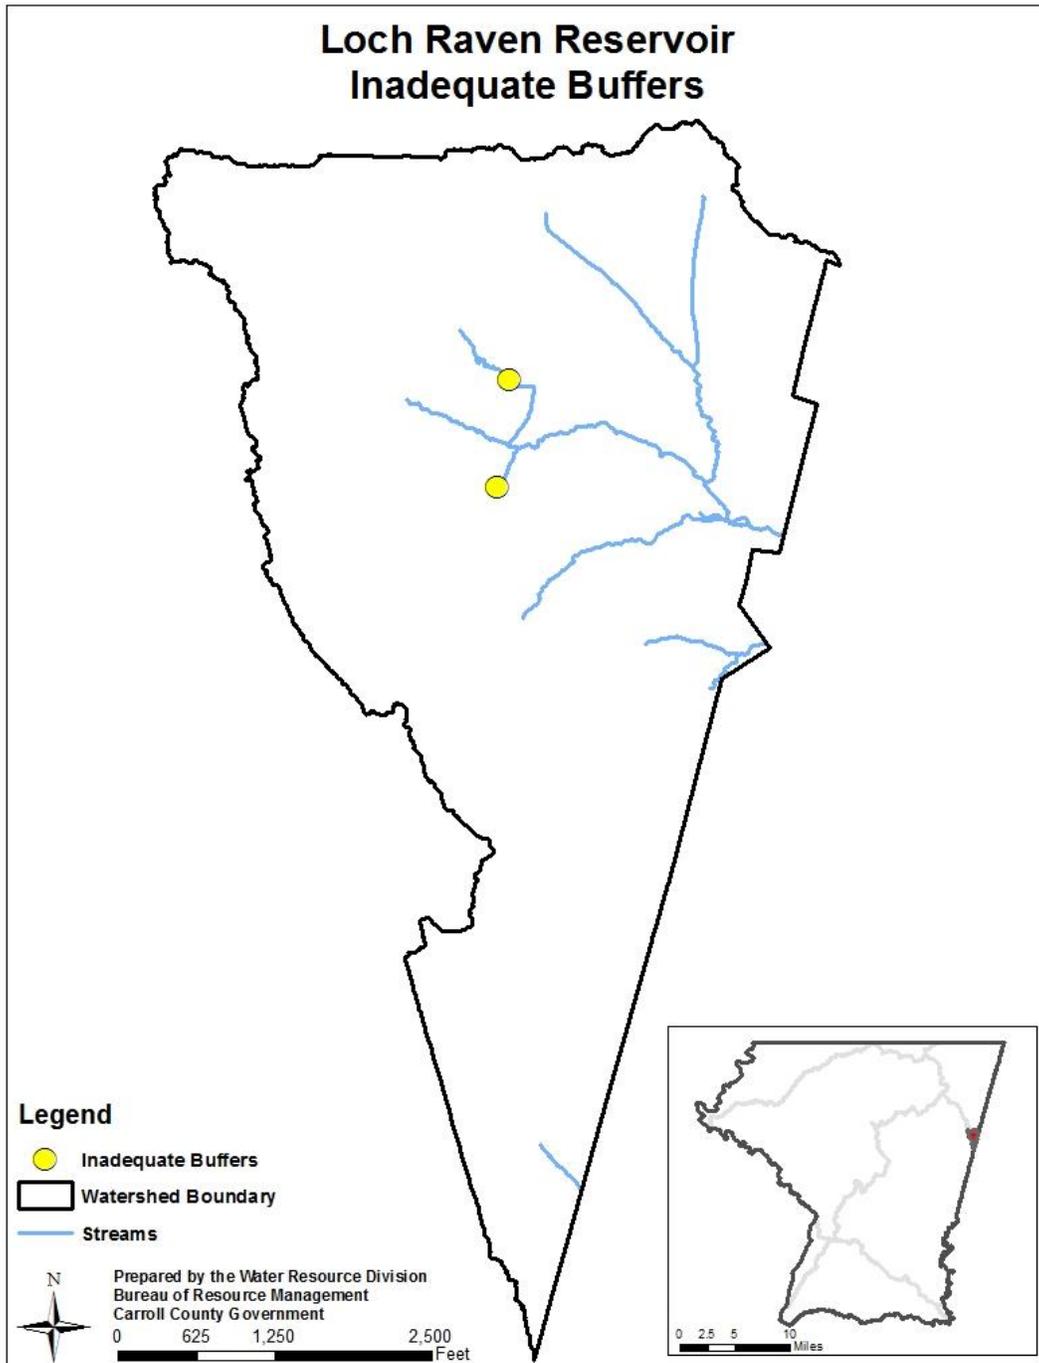
Figure 1-4: Inadequate Buffers

Buffer areas were identified as inadequate for 200 linear feet or 0.04 miles (2%) of the streams assessed, with none of the watershed classified as severely un-buffered. One of the two sites identified both sides of the stream as completely unshaded. Neither of the two sites identified had been recently planted. Figure 1-4 shows the location of identified inadequate buffers.

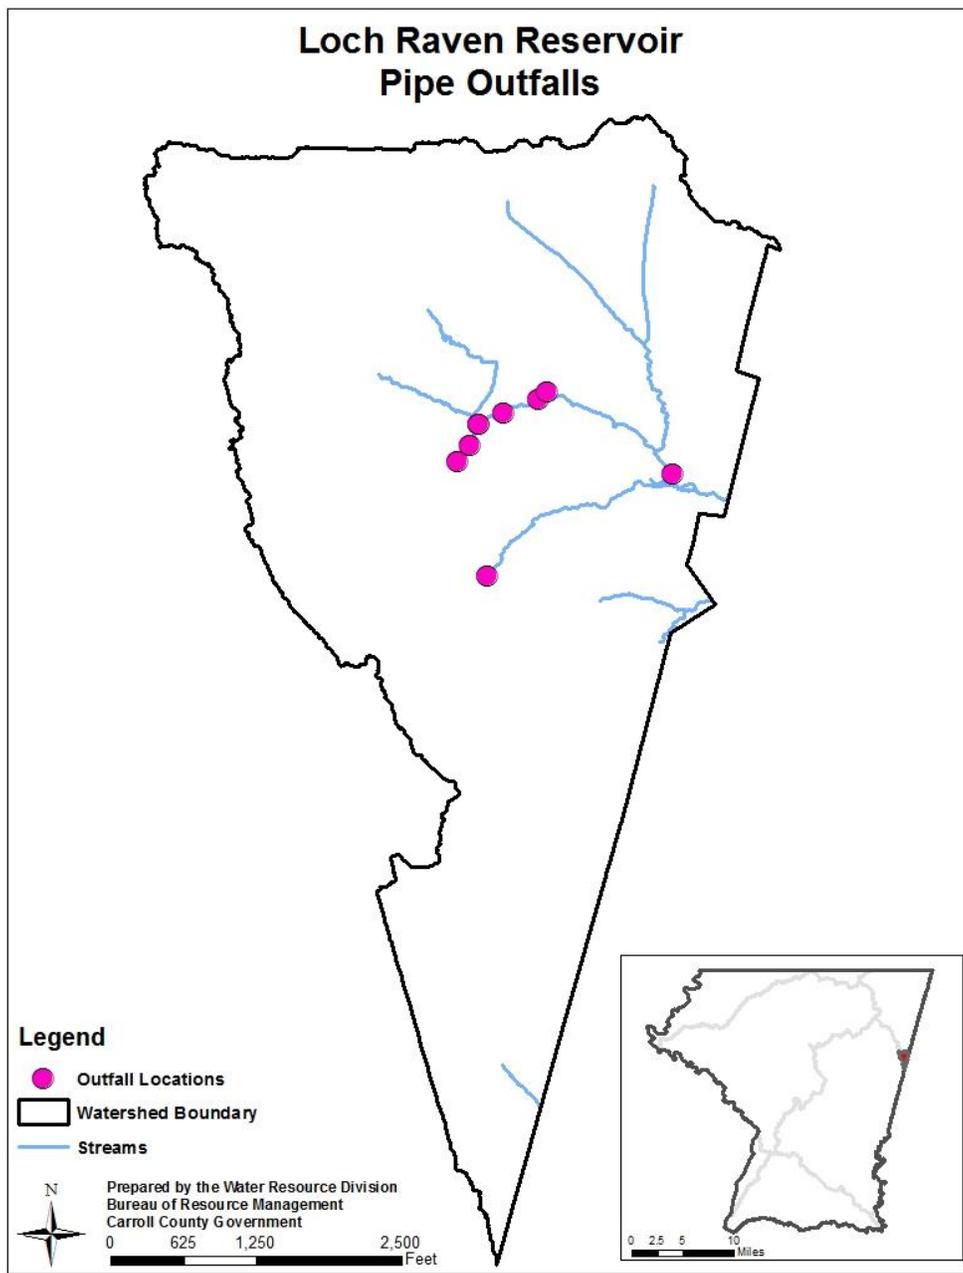
Figure 1-5: Pipe Outfalls

Outfalls were the most common problem identified during the assessment. The majority of outfalls were in an area of higher density residential land use and were 18" or larger in diameter, but the majority were given a low impact rating. The location of identified pipe outfalls can be found in Figure 1-5.

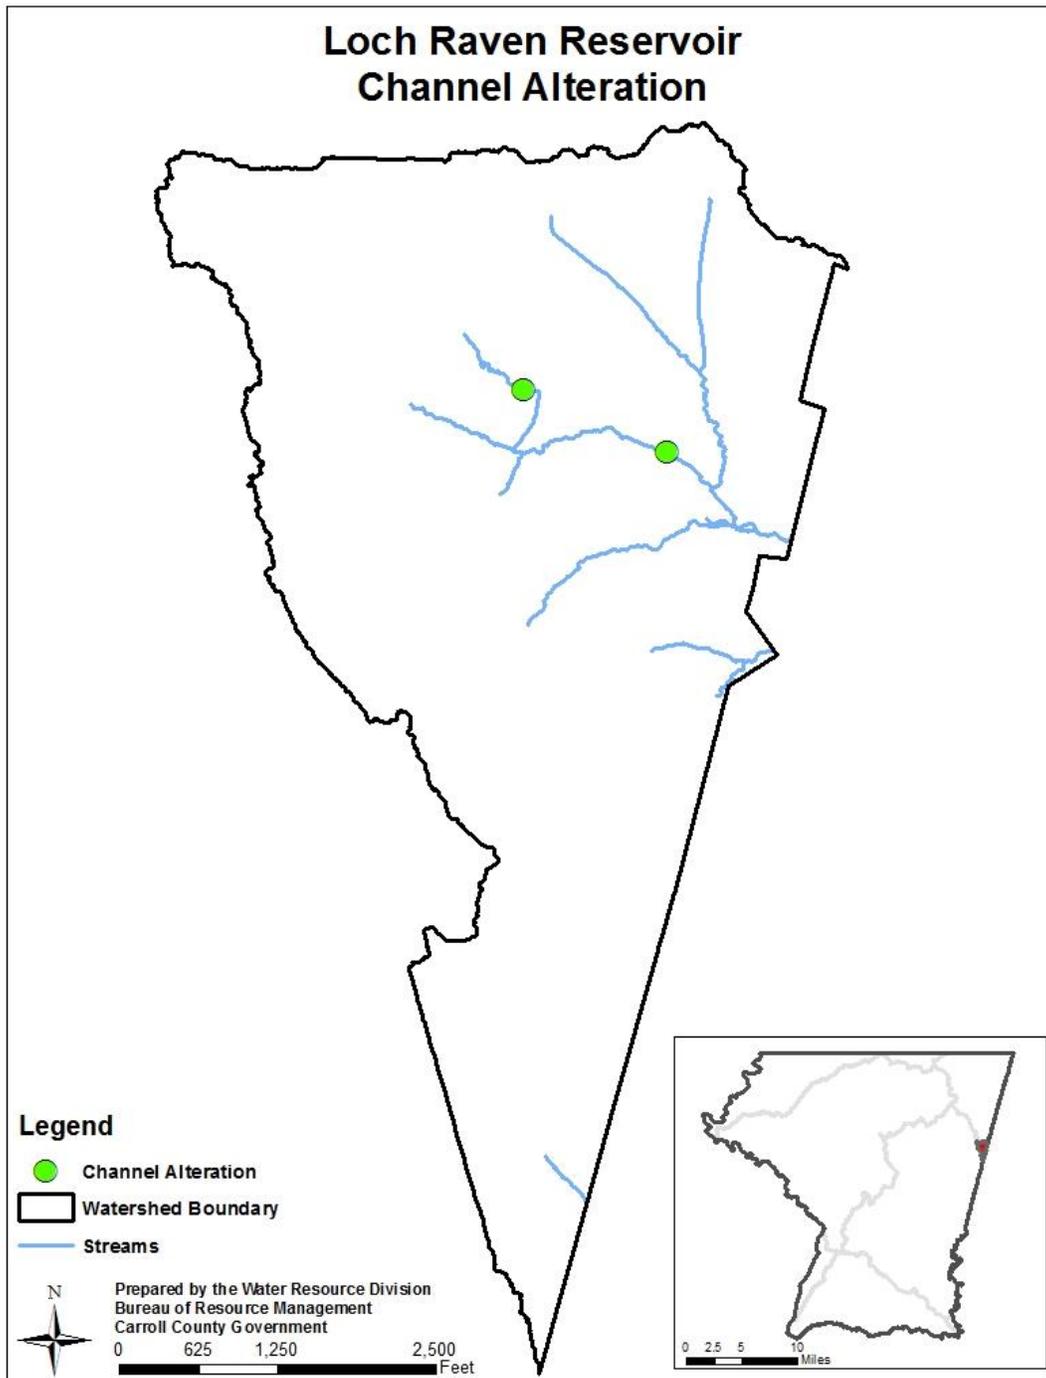
Figure 1-6: Channel Alteration

Impacts from channel alterations were found at two different sites within the watershed and totaled 140 linear feet. The alterations identified were associated with the protection of infrastructure and were given a minor severity ranking. Figure 1-6 shows the location of identified channel alterations within the watershed.

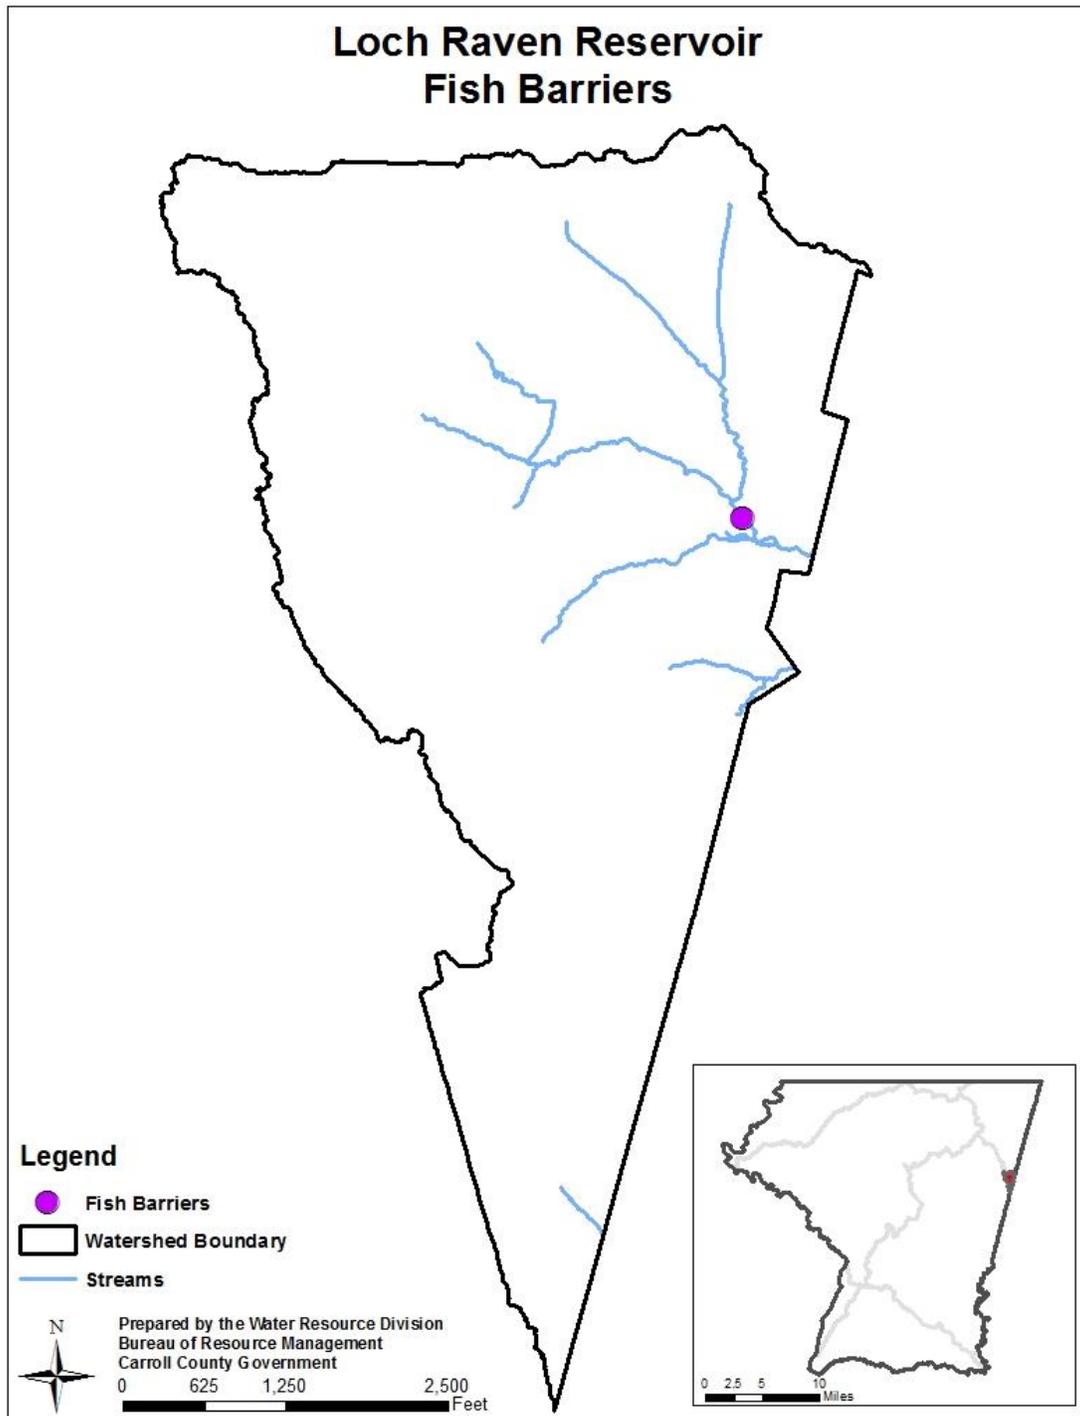
Figure 1-7: Fish Barriers

There was only 1 fish barrier identified during the survey which was a road crossing, causing the channel to become too shallow for fish migration. This barrier received a minor severity rating. Figure 1-7 shows the location of the identified fish barrier.

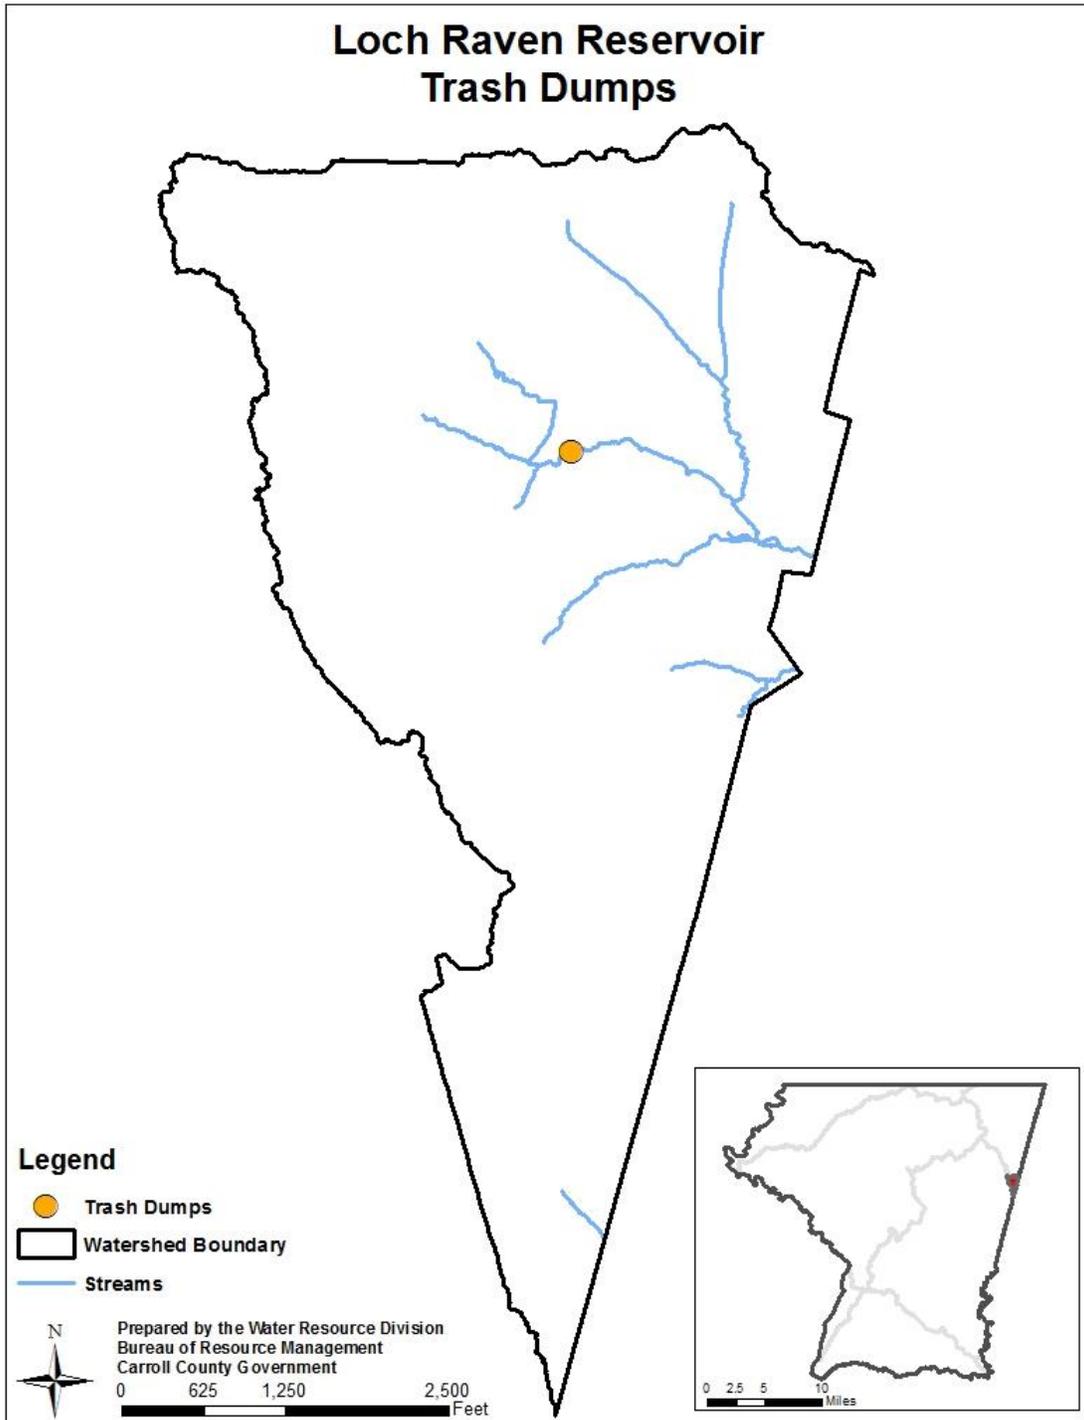
Figure 1-8: Trash Dumps

Impacts from trash were minimal with only one identified location within the watershed. This site received a minor severity rating and estimated to have only one truckload of trash. The location of identified trash site can be found in Figure 1-8.
