PINEY RUN WATERSHED STUDY

EXISTING SITE CONDITIONS

CARROLL COUNTY BUREAU OF RESOURCE
MANAGEMENT

Maryland Dam #139

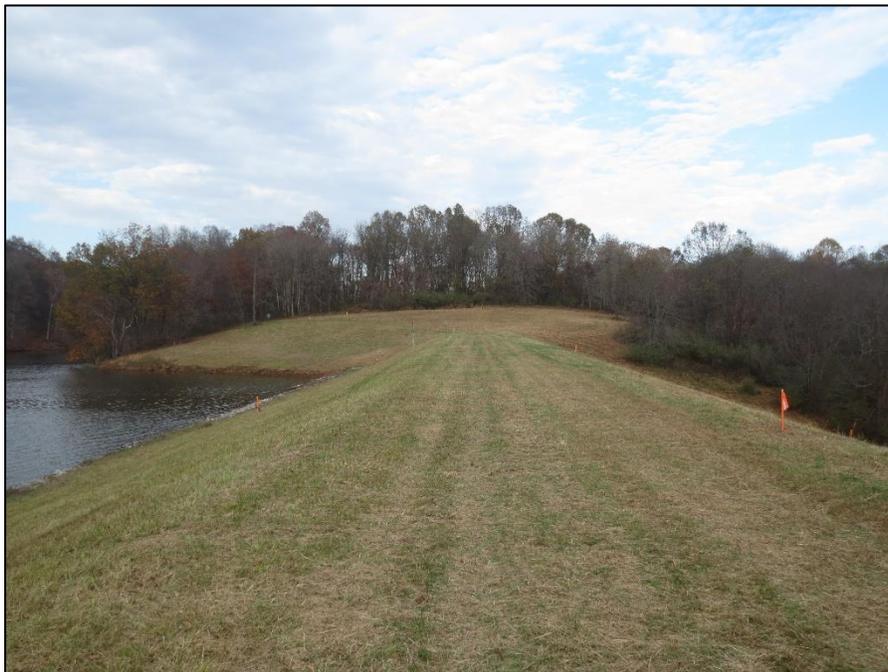
The dam crest shown in **Photograph 1** is approximately 22 feet wide with a design elevation of 539.5 feet and constructed top of dam elevation of 540.5 feet. There were no indications of recent cracking, settlement, or misalignment, and no apparent low spots in the dam crest.

Photograph 1: Dam crest looking towards left abutment.

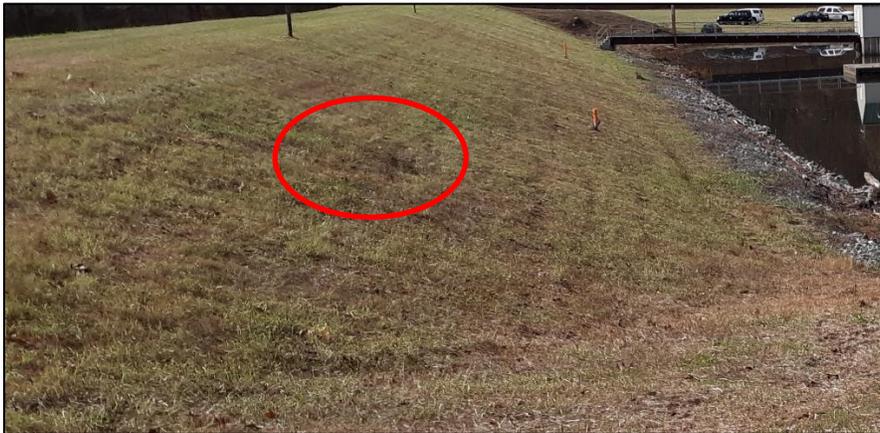
The upstream embankment surface was constructed with a three-horizontal-to-one-vertical (3H:1V) slope and was generally vegetated with turfgrass which was recently mowed. There was a bench at elevation 501.0 feet and riprap slope protection from the bench to elevation 527.0 feet. One depression was observed on the left side of the embankment upstream slope measuring approximately three feet in diameter and 6.5 inches deep, as shown in **Photograph 2**. This depression was reported to have developed since construction, but the cause and time of the

development was unknown. Several man-made trails were identified from the reservoir pool to the embankment crest. These were identified by noticeably displaced grasses, however, with minimal ground disturbance. Woody debris was observed extending approximately ten feet above the riprap section, including several very large logs along the reservoir rim. The riprap protection was minimal and consisted of small diameter stone. No signs of animal burrows, cracking, or bulges were observed at the time of inspection.

Photograph 2: Upstream embankment slope depression.

- Fill the upstream depression with compacted fill material and over seed. Monitor the depression on the downstream slope;
- Remove woody debris from the principal spillway riser taking care not to allow debris to fall into the bottom of the riser (completed December 20, 2019);
- Repair/replace the animal guards on the internal drain outlets;
- Repair/replace the damaged sections of observation wells #9 and #11;

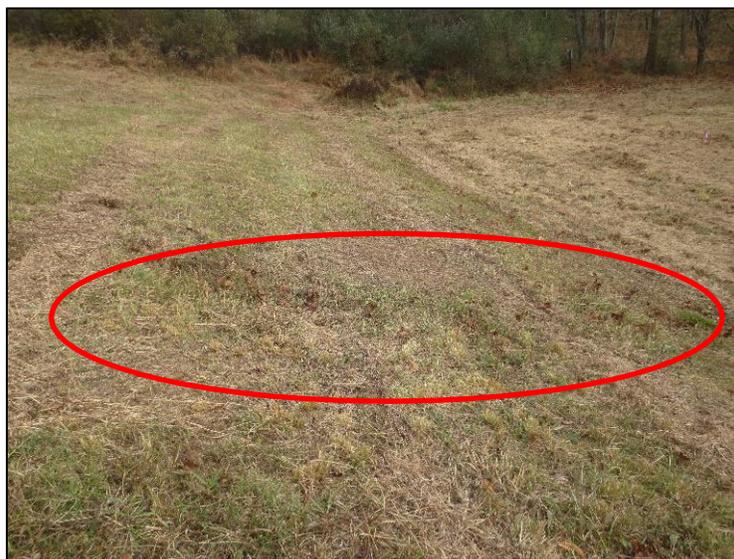
Like the upstream slope, the downstream embankment surface was constructed at 3H:1V slope and was vegetated with turfgrass which was recently mowed. A small depression was observed near the toe of the dam on the left side, as shown in **Photograph 3**. This was reported to possibly be the remains of an erosional feature that developed shortly after construction. Soft, wet areas were observed at the toe, which may have been due to a recent precipitation event and poor drainage. No animal burrows were observed on the downstream embankment slope. No cracks or signs of movement were observed.

Photograph 3: Downstream embankment slope depression.

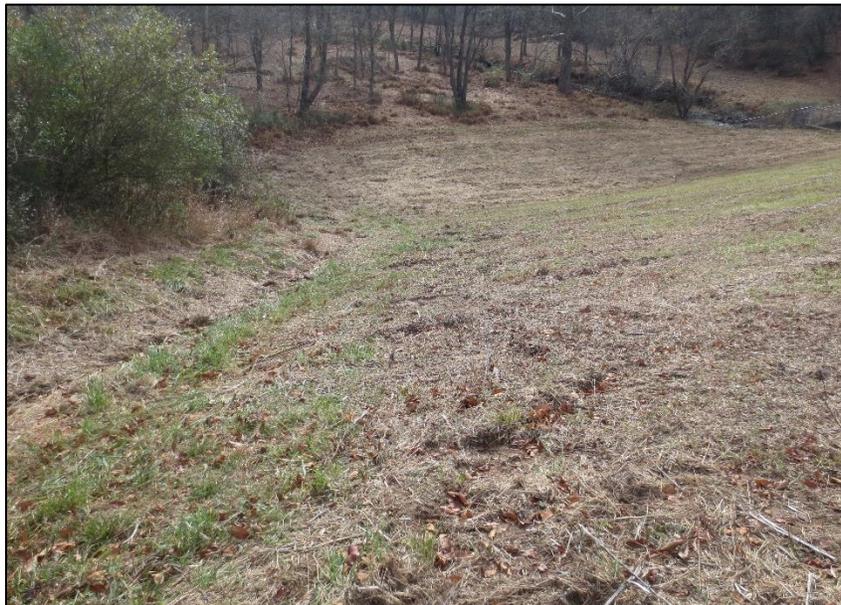
The downstream groins of the dam, defined as where the dam embankment and abutment meet, reportedly had some stone placed in them during construction, however, only some small diameter stones were barely visible in the groins during inspection and appeared to have either been overgrown or transported downstream. Minor erosion was observed on the left upstream groin, and a few minor bare areas were observed on the left abutment above the upstream groin. Multiple areas of minor erosion, rutting, and exposed soil were observed along both left and right downstream groins. These appeared to be from mower turning movements and can be seen in **Photograph 4**. Several trees were observed growing within 15 feet of the downstream groins.

Photograph 4: Disturbance of left downstream slope, likely by grass cutting equipment.

The downstream slope had areas of rutting, erosion, and bare soil along the groins. These are minor and do not require repair at this time but should be monitored.

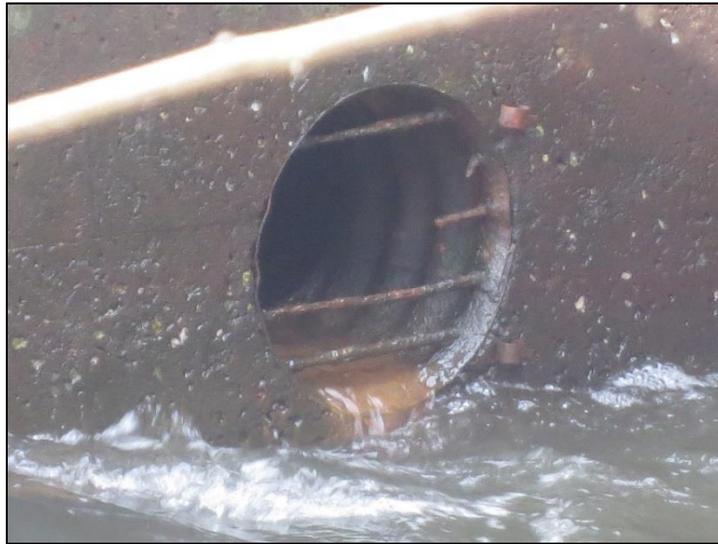
The dam was constructed with a chimney drain, which is aligned along the downstream side of the embankment crest, and a foundation drain, which is located under the downstream slope of the dam. The drains were primarily constructed of fine filter material with zones of coarse filter material surrounding the perforated corrugated metal pipe drainage pipes which outlet at the impact basin. At the time of inspection, the right and left drains were visually estimated to be flowing at approximately one to two gallons per minute. Both drain outlets were corroded, and the animal guards for both drains were broken, as shown in **Photograph 5**. No seepage was observed on the upstream or downstream embankment slopes. The drainage conduits were inspected by camera using a remotely-operated vehicle under a separate inspection.

Photograph 5: Damage to right drain animal guard.

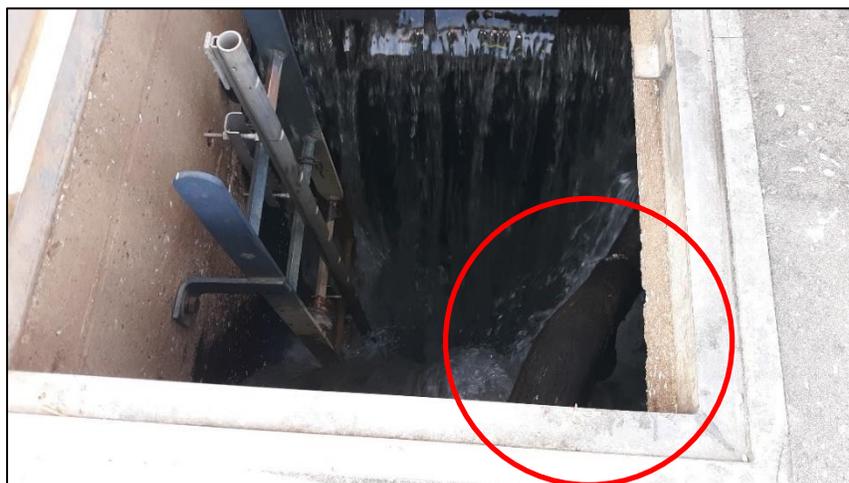
Trash racks are located at the top of the riser along the two intake weirs. The trash racks on the intake are made of horizontal steel bars below elevation 522.5 feet and grated metal openings above elevation 522.5 feet. The side grates were observed to be intact and free of corrosion but, were obstructed by leaf litter. A log was lodged in the horizontal slotted trash rack, extending several feet into and out of the riser, as shown in **Photograph 6**. The anchor bolts connecting the trash rack to the riser appeared to be in overall good condition.

Photograph 6: Log lodged in principal spillway riser.

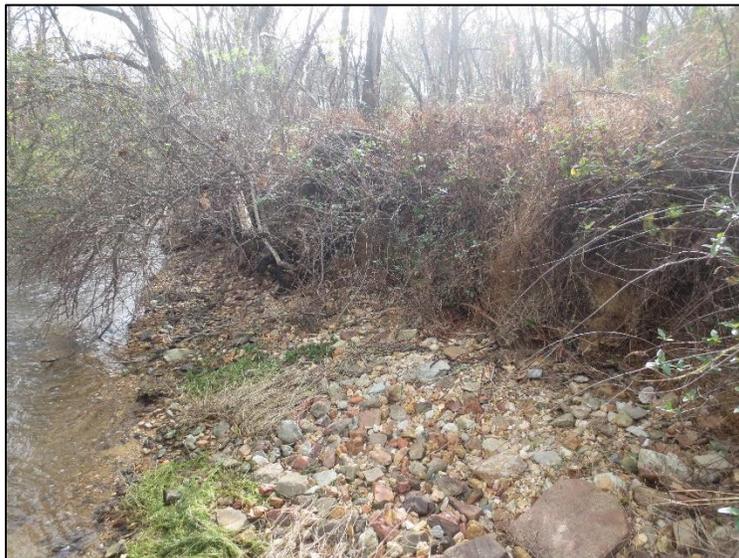
The principal spillway conduit outlets at an invert elevation of approximately elevation 467.16 feet into the impact basin at the downstream toe of the embankment. A 36-inch reinforced concrete pipe discharges into the impact basin and then into riprap and stone lined stream channel. Some pitting was observed at the edges of both concrete wingwalls. Undermining and erosion were observed in the native soil banks along both sides of the outlet channel, extending approximately 50 feet downstream of the outlet and up to approximately five feet in height, as shown in **Photograph 7**. There were minor erosion channels leading from the right downstream groin to the outlet channel which have eroded the right channel slope. The principal spillway pipe was flowing less than half-full at the time of inspection. The interior of the conduit was not visible at the time of inspection due to the high flow but was inspected by camera using a remotely-operated vehicle under a separate inspection.

Photograph 7: Erosion and undermining on right outlet channel slope.

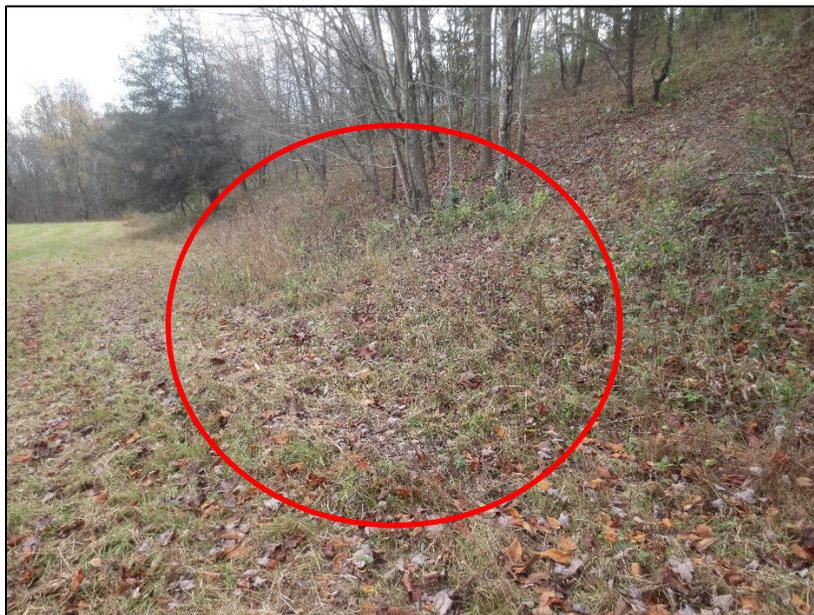
During inspection, a possible man-made trail was observed running up the auxiliary spillway outside slope. Some sloughing and/or erosion was observed at the bottom of this trail, accumulating into a small colluvial pile at the base of the slope as shown in **Photograph 8**. The inlet to the auxiliary spillway channel had little to no shoreline protection and showed signs of erosion. Trees and brush were observed along the inside and outside slopes within 15 feet of the auxiliary spillway.

Photograph 8: Colluvial pile on outside auxiliary spillway slope.

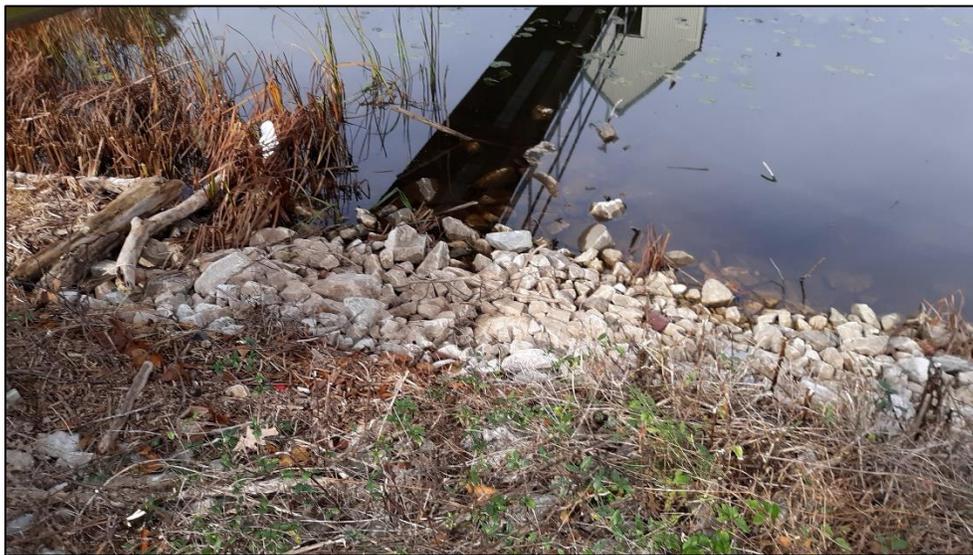
The Piney Run Dam reservoir is maintained at the normal pool elevation of 523.0 feet as the water intake function of the dam is not used. The reservoir shoreline contained woody debris including large logs. This debris has the potential to block the principal spillway opening, impeding the flow of water through the principal spillway. Impediment could lead to premature and/or unnecessary activation of the auxiliary spillway, reducing the designed flood control capabilities. As detailed in Section 5.0, the existing riprap cover on the upstream embankment slope was minimal and consisted of small diameter stone. Both are shown in **Photograph 9**.

Photograph 9: Reservoir upstream slope riprap and debris.

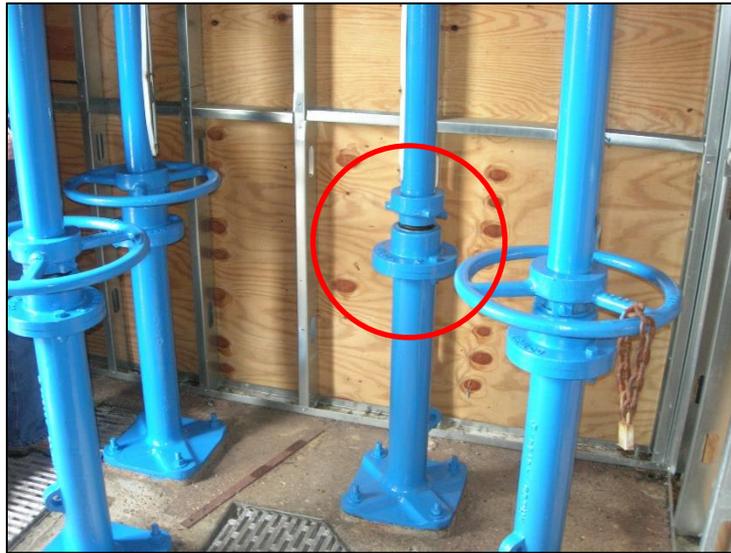
The water intake structure riser is located to the right of the principal spillway riser and is accessible via a short concrete staircase and steel catwalk protected by a locked gate. The catwalk was in generally good condition, but the support beams were beginning to corrode and the sign on the catwalk gate was faded. The steps leading to the catwalk had minor cracks along the bottom on both sides. A frame structure was constructed on top of the intake structure to prevent access and vandalism to the equipment on the top of the riser. There were eight rising stem gate operators inside the structure with hand operators. The hand operators generally were in good working condition, and the handles which were turned during inspection did so freely. However, multiple hand operator handles had broken spokes connecting the handles to the operating shafts including one handle with all broken spokes. These are shown in **Photograph 10**. The damage was reportedly due to vandalism prior to the construction of the structure.

Photograph 10: Handle broken off the hand operator handle.

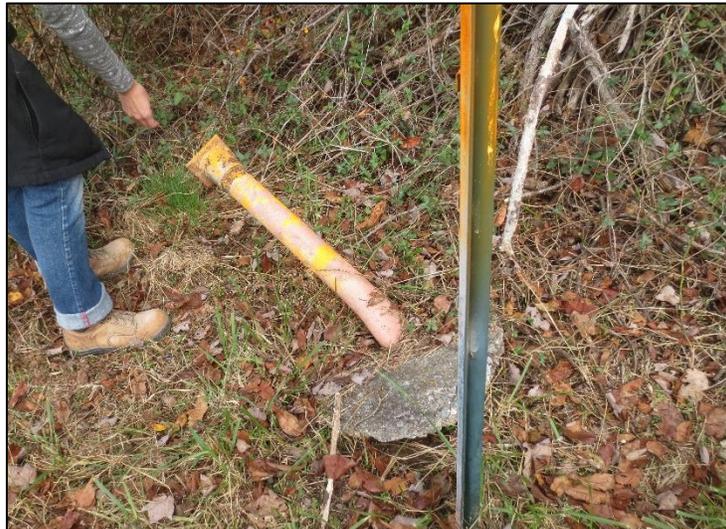
Photograph 11: Damage to observation well #11.

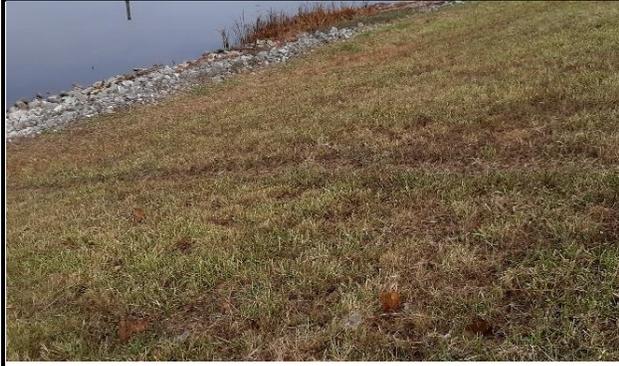
Image 3: Worn path from crest to Normal Pool Elevation

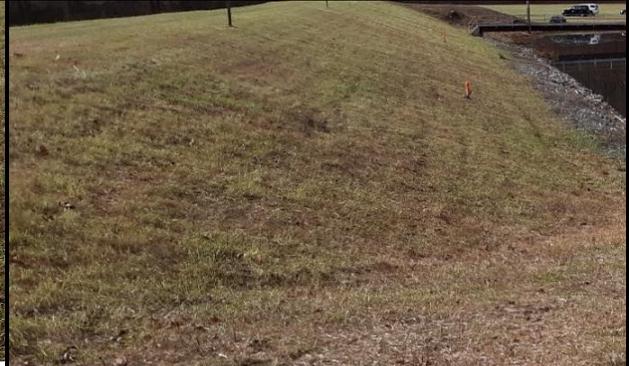
Image 4: Upstream slope from left groin. Note depression on left side of slope

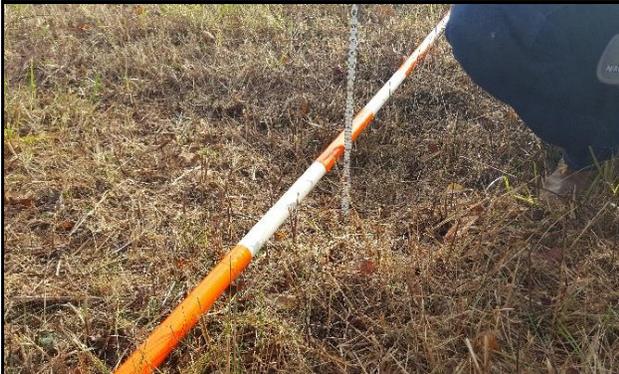
Image 5: Depression in left side of upstream slope

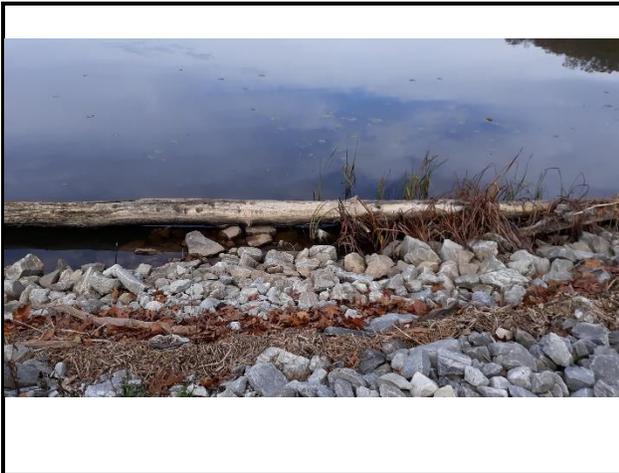
Image 7: Debris and small riprap at upstream waterline

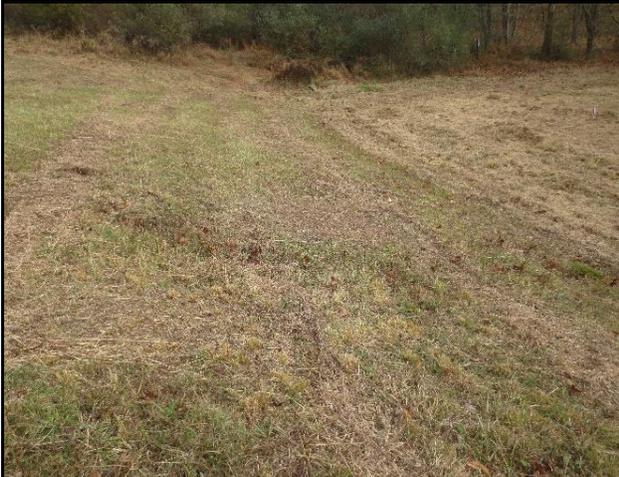
Image 9: Depression in downstream slope near toe

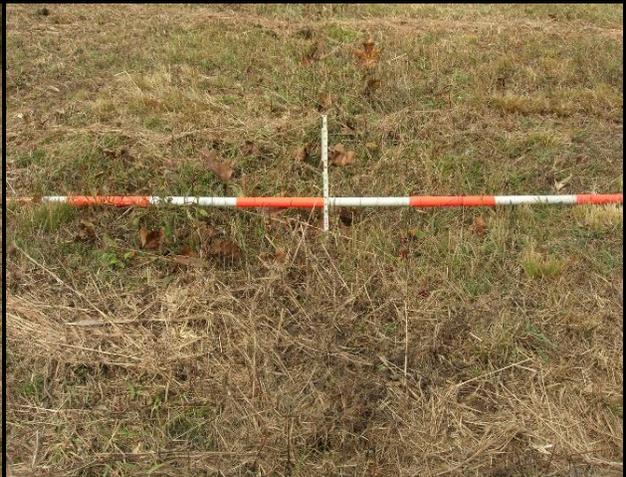
Image 10: Depression in downstream slope near toe, looking upstream

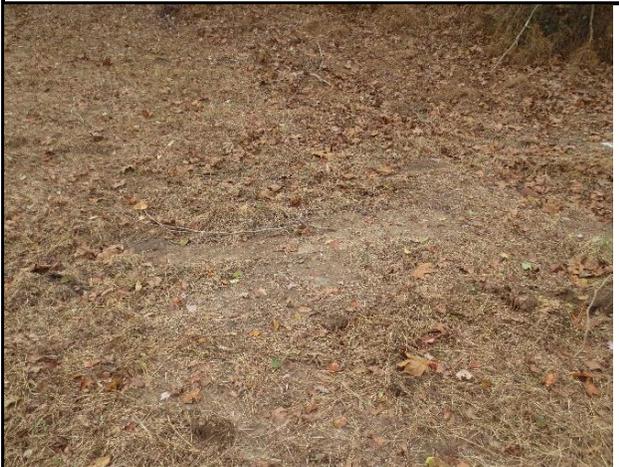
Image 11: Bare spot at right toe

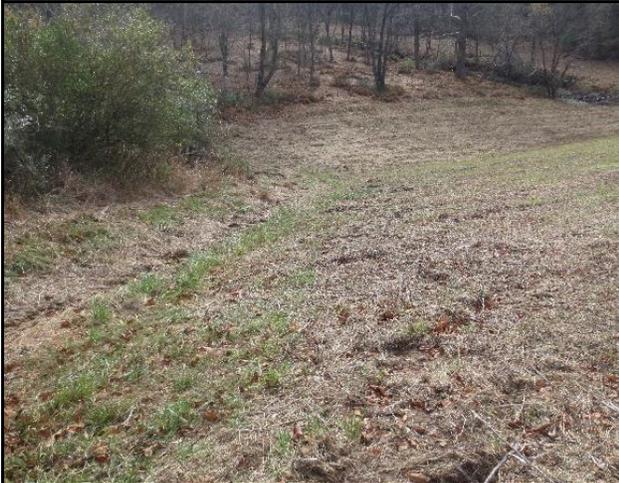
Image 15: Left downstream groin. Note rutting

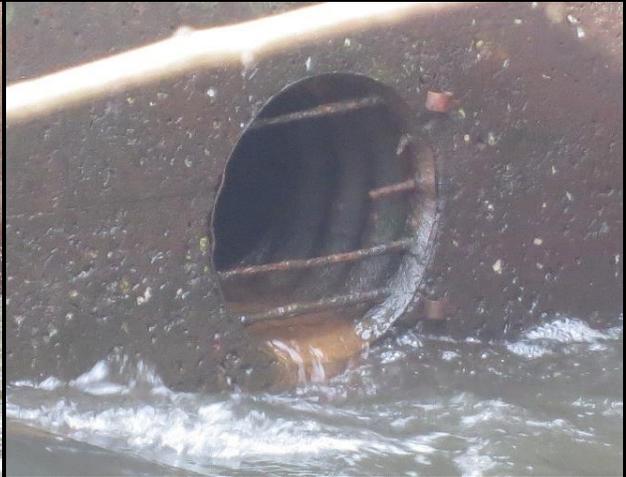
Image 24: Damaged right toe drain animal guard

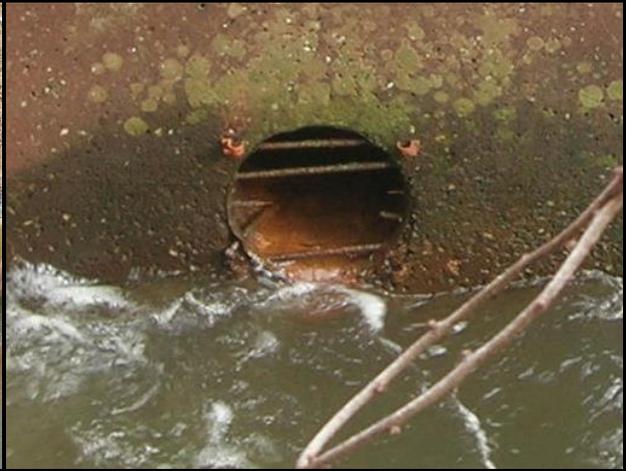
Image 26: Damaged left toe drain animal guard

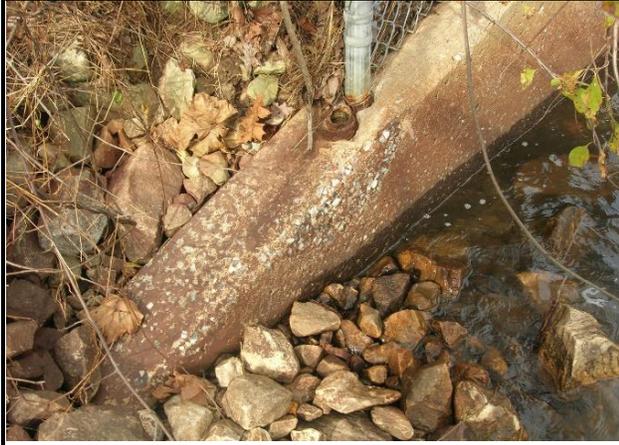
Image 27: Pitting in right impact basin wingwall

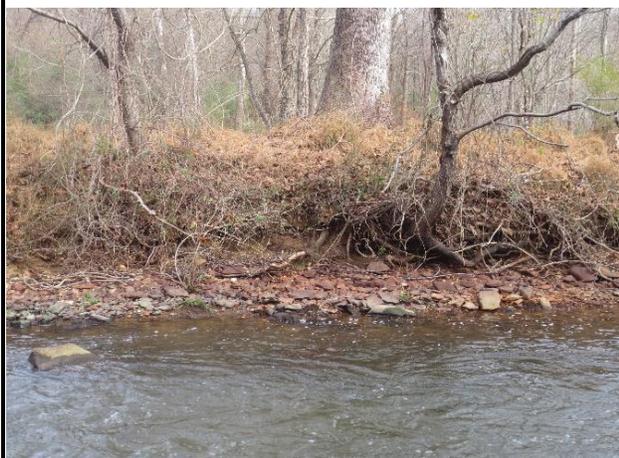
Image 29: PSW outlet left slope undermining

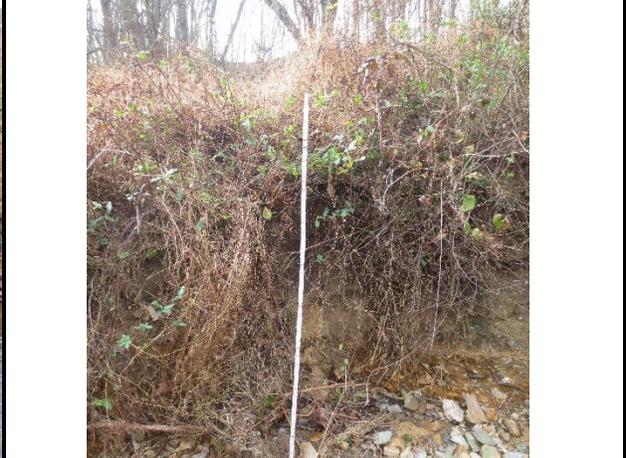
Image 30: Close-up of PSW outlet channel right slope head cutting

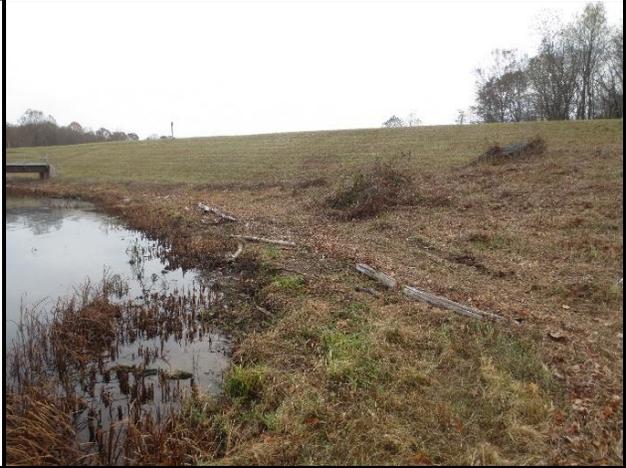
Image 32: Woody debris and logs along ASW inlet

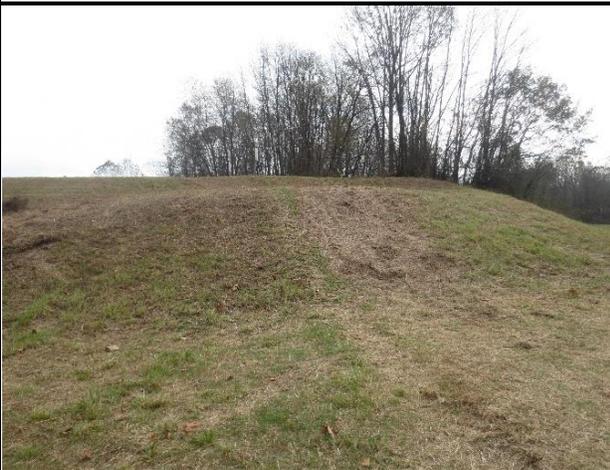
Image 33: ASW training dike slope. Note vehicle path and bare areas

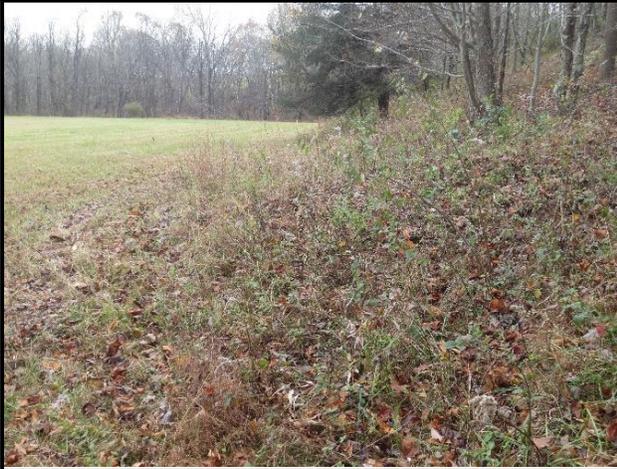
Image 37: Slough from outside ASW slope

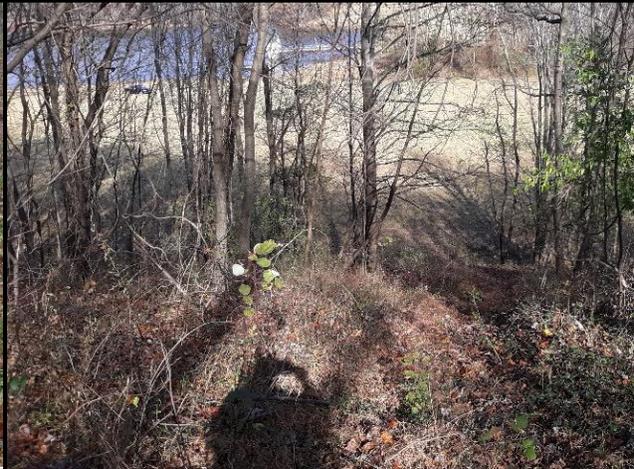
Image 38: View from top of ASW outside slope likely ATV path

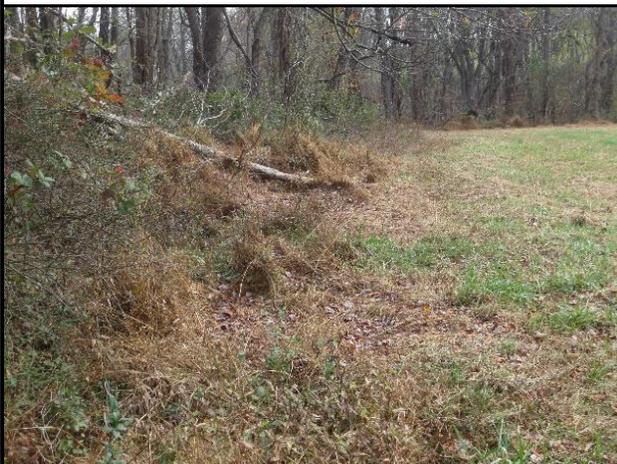
Image 41: ASW inside slope, training dike facing downstream. Note trees within 15 feet of channel

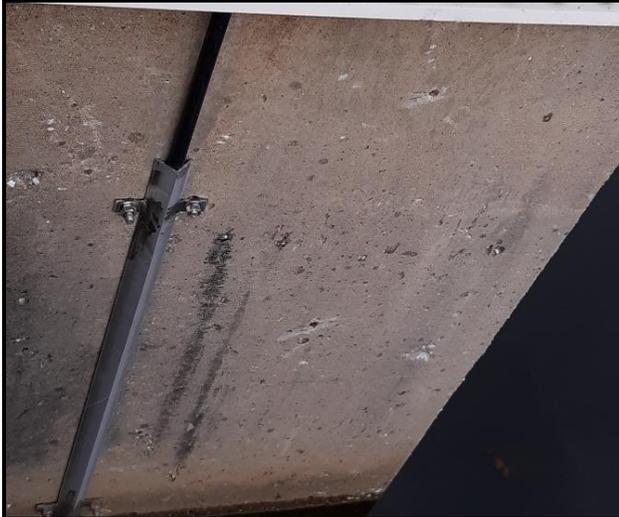
Image 43: Water intake tower minor concrete damage

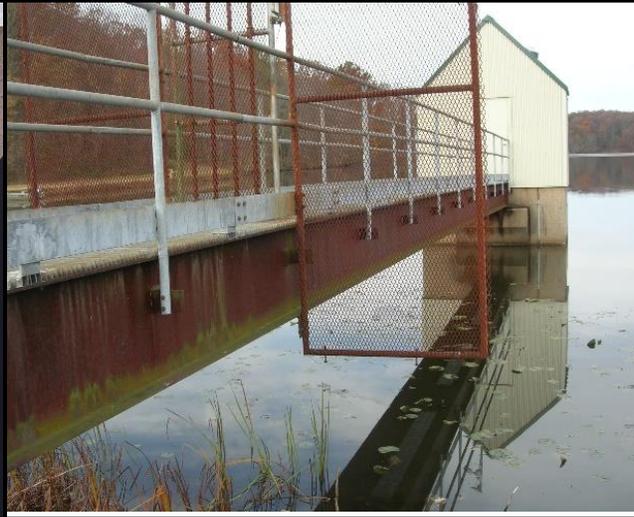
Image 44: Catwalk support beams; rusted gate

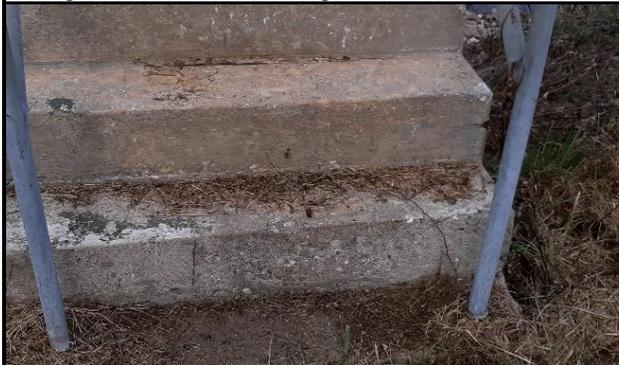
Image 47: Stairway to water intake tower catwalk. Note deterioration in concrete

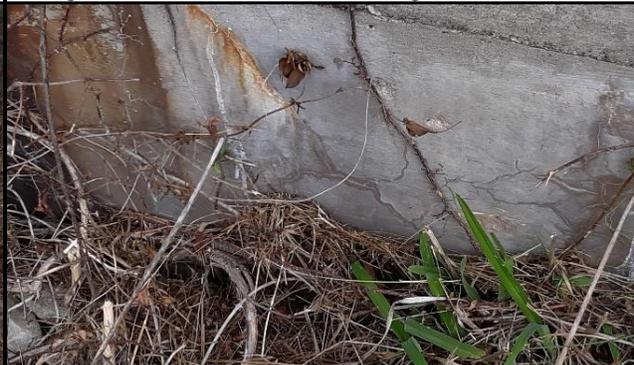
Image 48: Cracks and efflorescence at base of right side of stairway

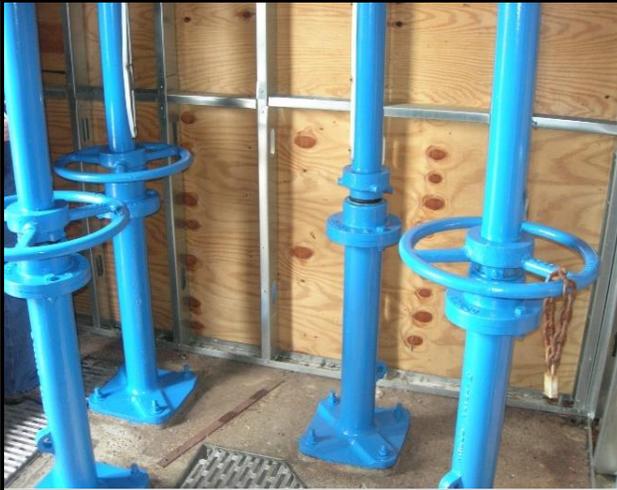
Image 49: Inside water intake structure, intake slide gate operators on right side. Note broken operator handle

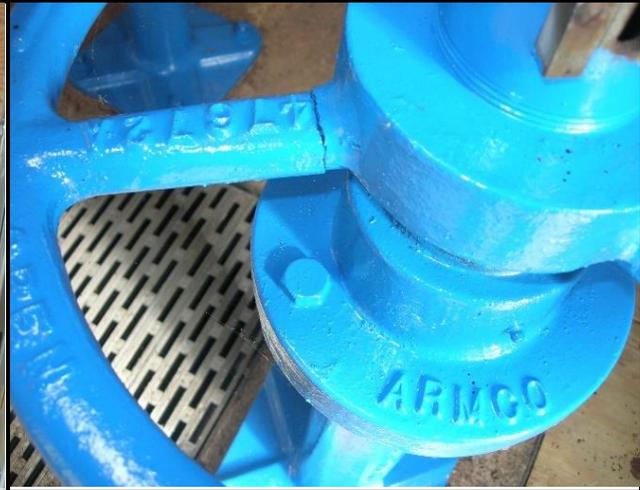
Image 50: Close-up on one of the multiple slide gate operator's broken spoke

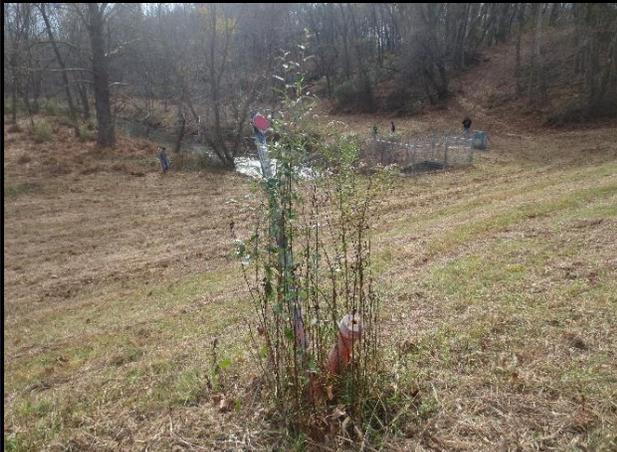
Image 53: Damage to observation well #9

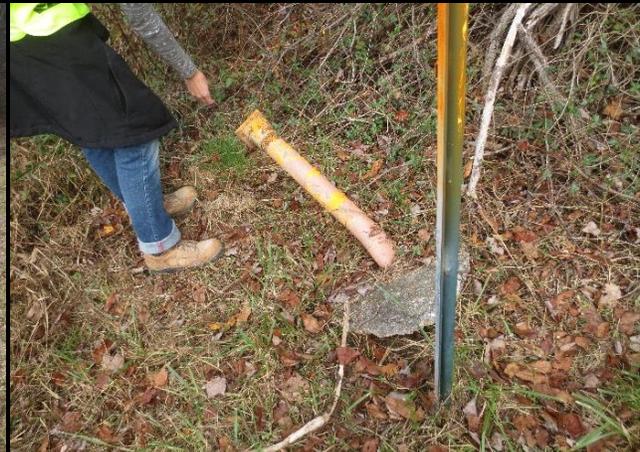
Image 54: Damage to observation well #11
