**Lower North Branch
Patapsco River Watershed
Stream Corridor Assessment**

Winter 2014

**Prepared By
Carroll County Bureau of Resource Management**

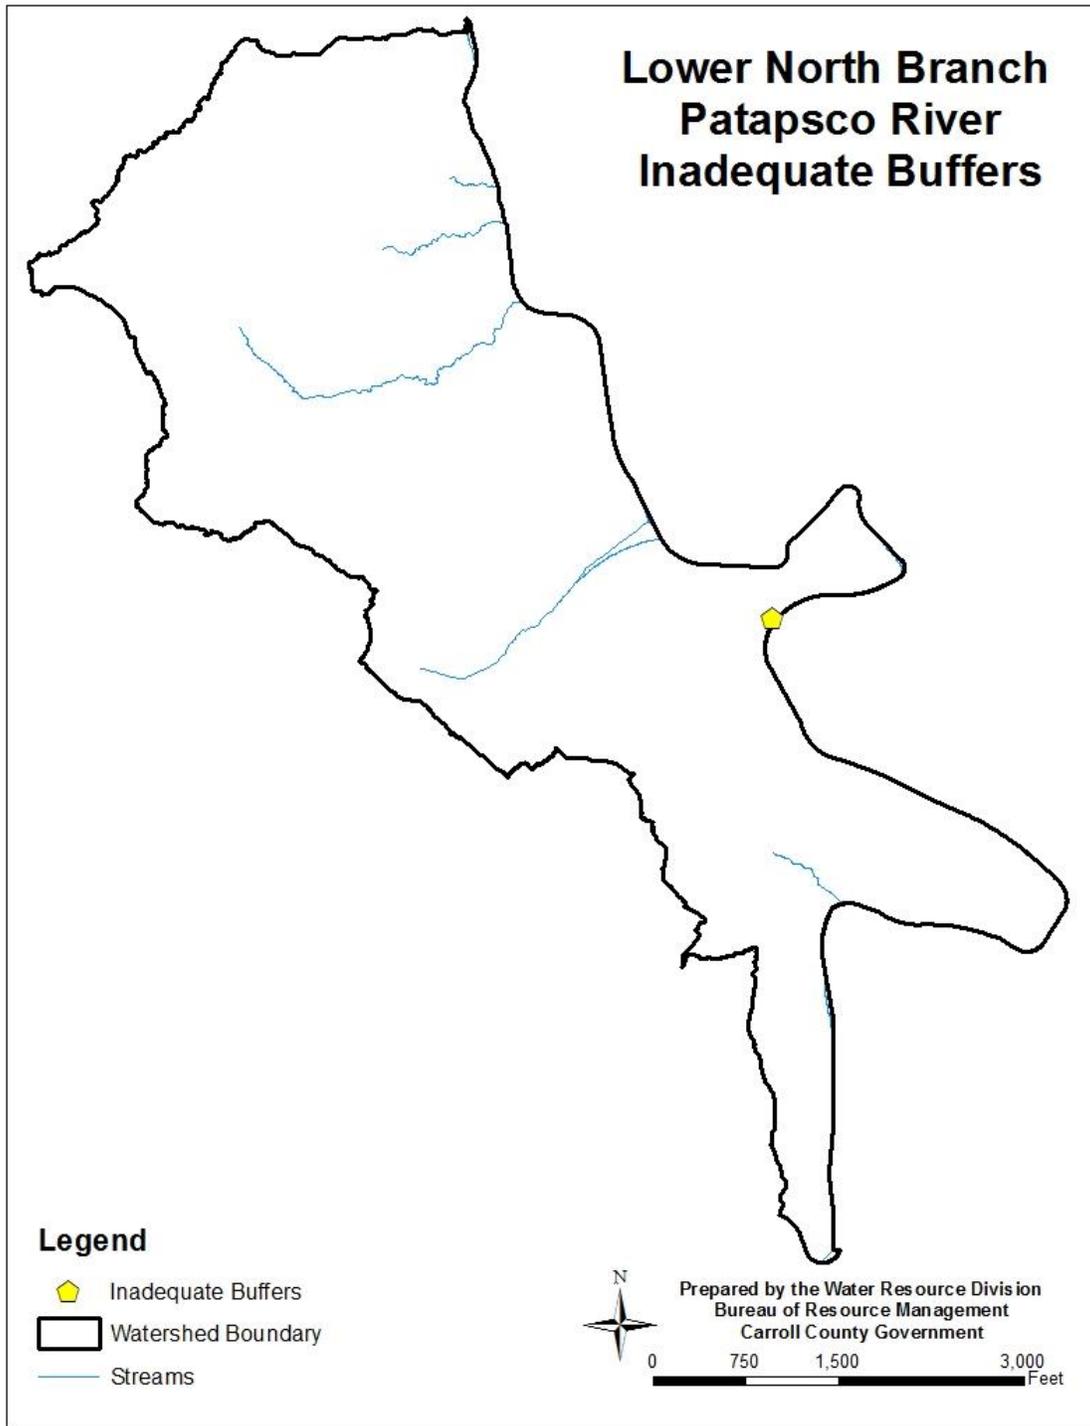
Figure 1-3: Inadequate Buffers

Streamside buffer areas were identified as inadequate for 600 linear feet or 0.11 mile (3.7%) of the streams assessed, with none of the watershed classified as severely un-buffered. The site identified neither sides of the stream as completely unshaded. The site had not been recently planted. Figure 1-3 shows the location of identified inadequate buffers.

North Branch Patapsco River (021309061019): The only identified impact noted during the stream corridor assessment was a moderate streamside buffer. The point was noted to be about 600 feet long with buffer extending 20 feet wide. Both sides of the stream were noted to be shaded and surrounded by forest.
