**South Branch Patapsco  
Stream Corridor Assessment**

**Winter 2013**

**Carroll County Bureau of Resource Management**

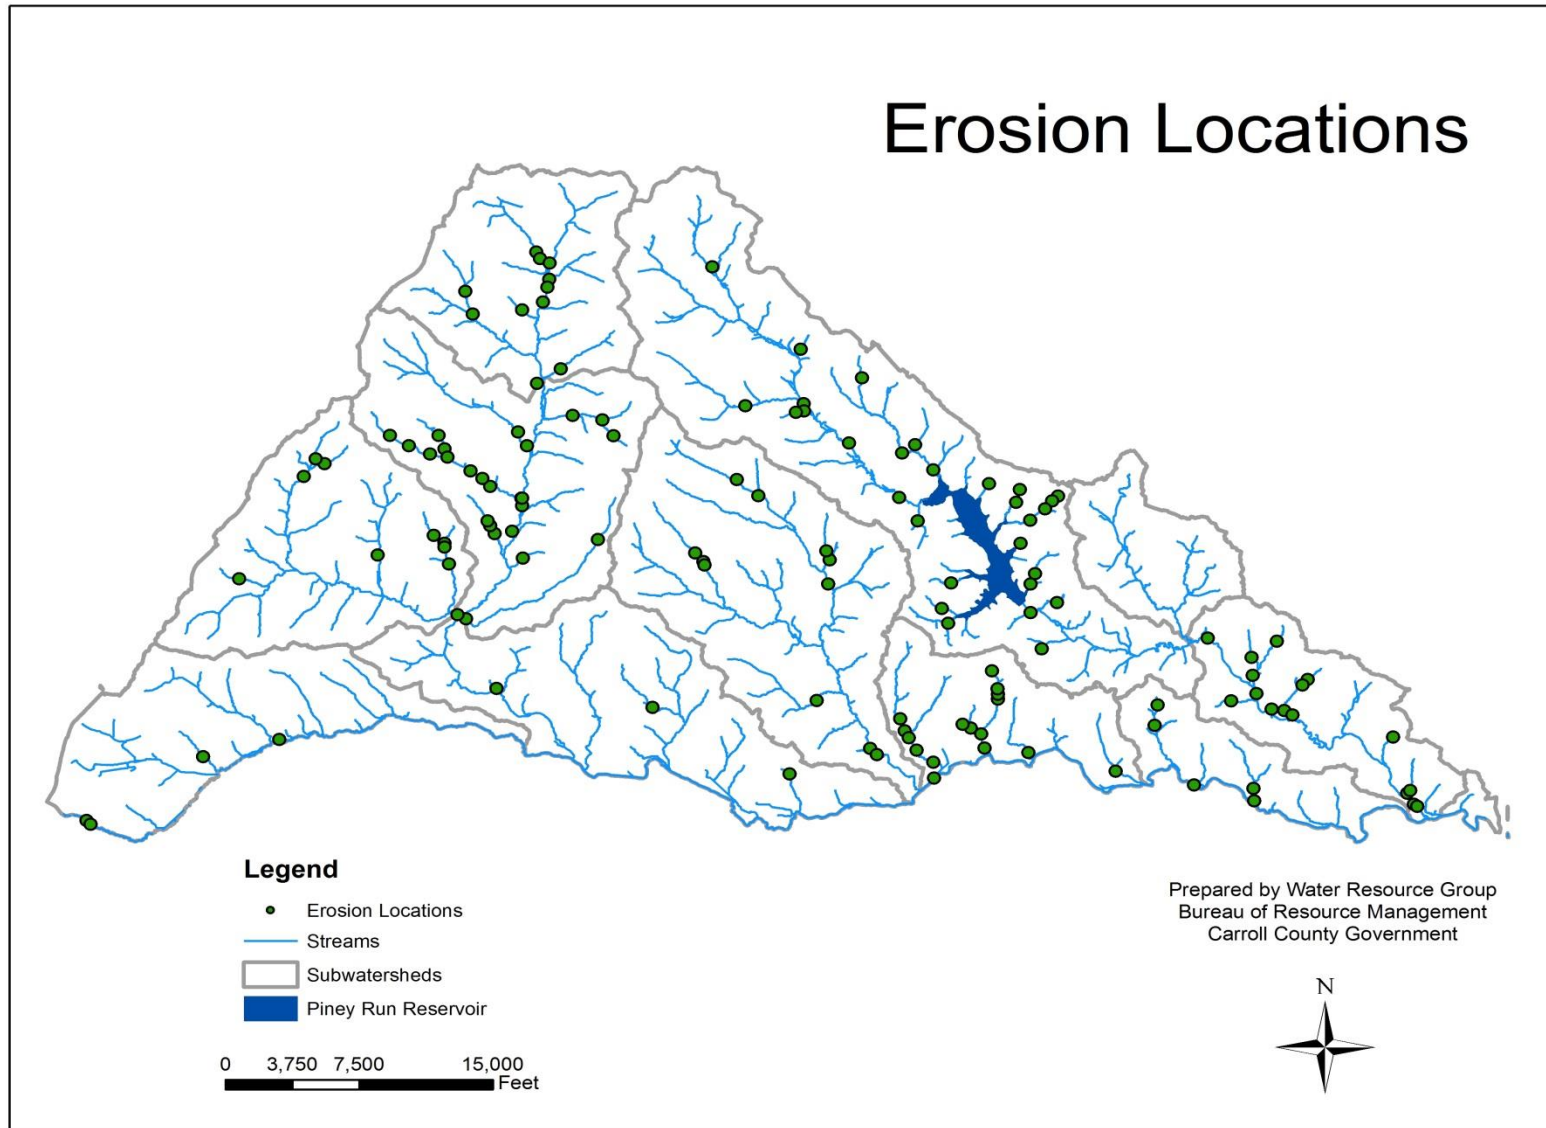
Figure 1-4: Erosion Locations

The most common problem identified through the Stream Corridor Assessment was erosion. A total of 10.32 miles (7%) of the 156 miles assessed were found to have an erosion problem, with approximately 3 percent of the watershed categorized as having a severe erosion problem. Figure 1-4 shows the location of active erosion sites identified during the Stream Corridor Assessment.

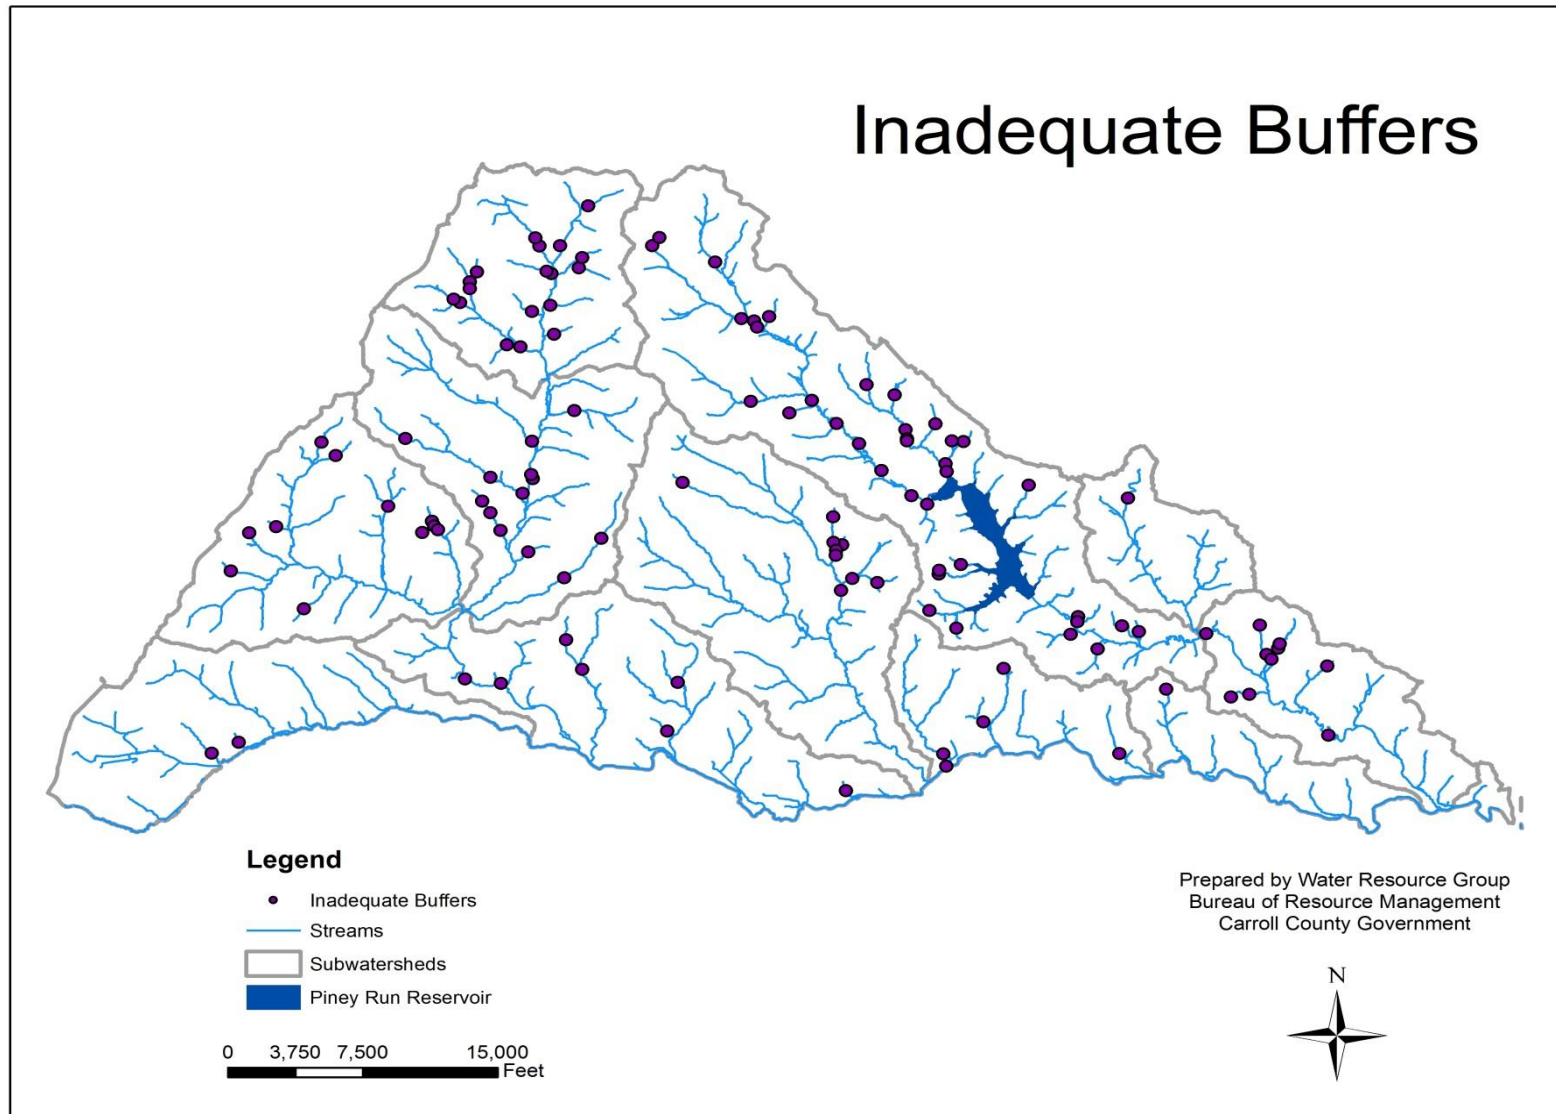
**Figure 1-5: Inadequate Buffers**

Buffer areas were identified as inadequate along 8% of the streams assessed, with 3 percent of the entire watershed classified as severely un-buffered. 43 of the sites identified both sides of the stream as completely unshaded, and livestock was noted to be present at 14 different sites. Of the 114 sites identified, 8 had been recently planted but were not yet established. Figure 1-5 shows the location of identified inadequate buffers.

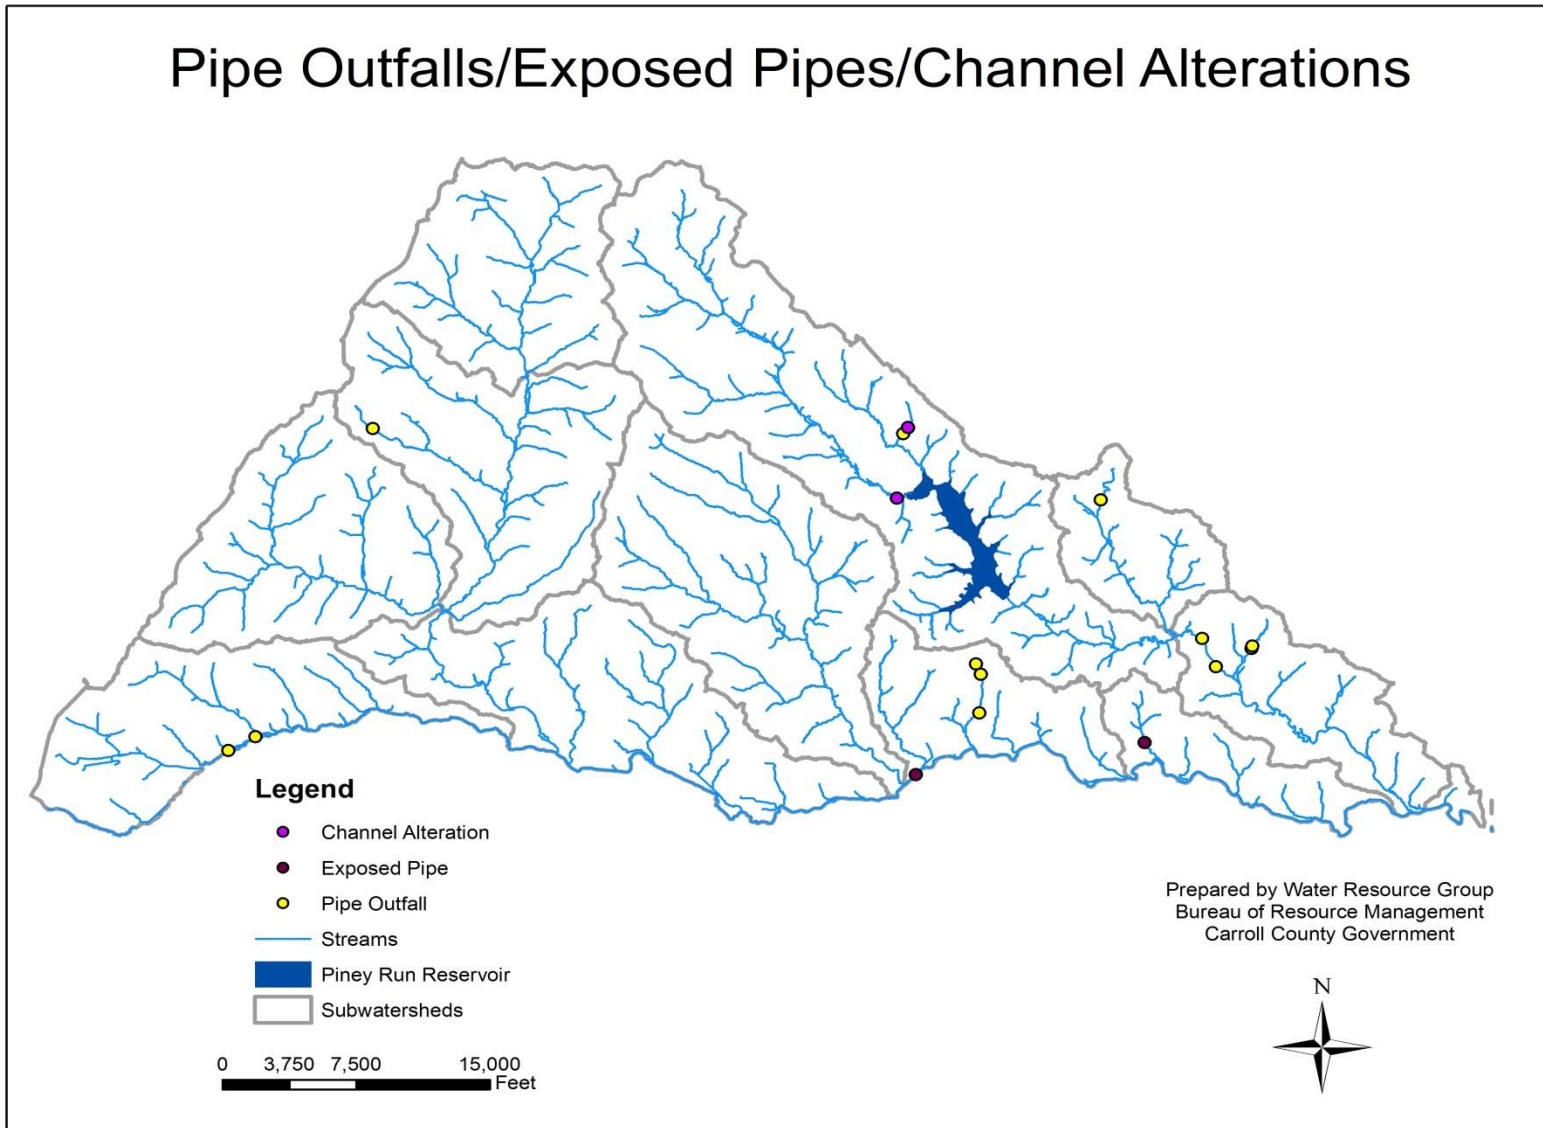
Figure 1-6: Pipe Outfalls, Exposed Pipes, and Channel Alterations

Outfalls were found throughout the entire watershed, but the highest concentrations were located in the Piney Run subwatershed. This higher concentration can be attributed to a higher residential density. The majority of the outfalls identified were associated with stormwater conveyance and were given a low impact rating.

Exposed pipes were identified at 2 different locations within the watershed. Any exposed pipe identified during the SCA is reported to the appropriate public works department for additional investigation.

Impacts from channel alterations were found at 2 different sites within the watershed and totaled 520 linear feet. The alterations identified were associated with the protection of infrastructure and were given a minor severity ranking.

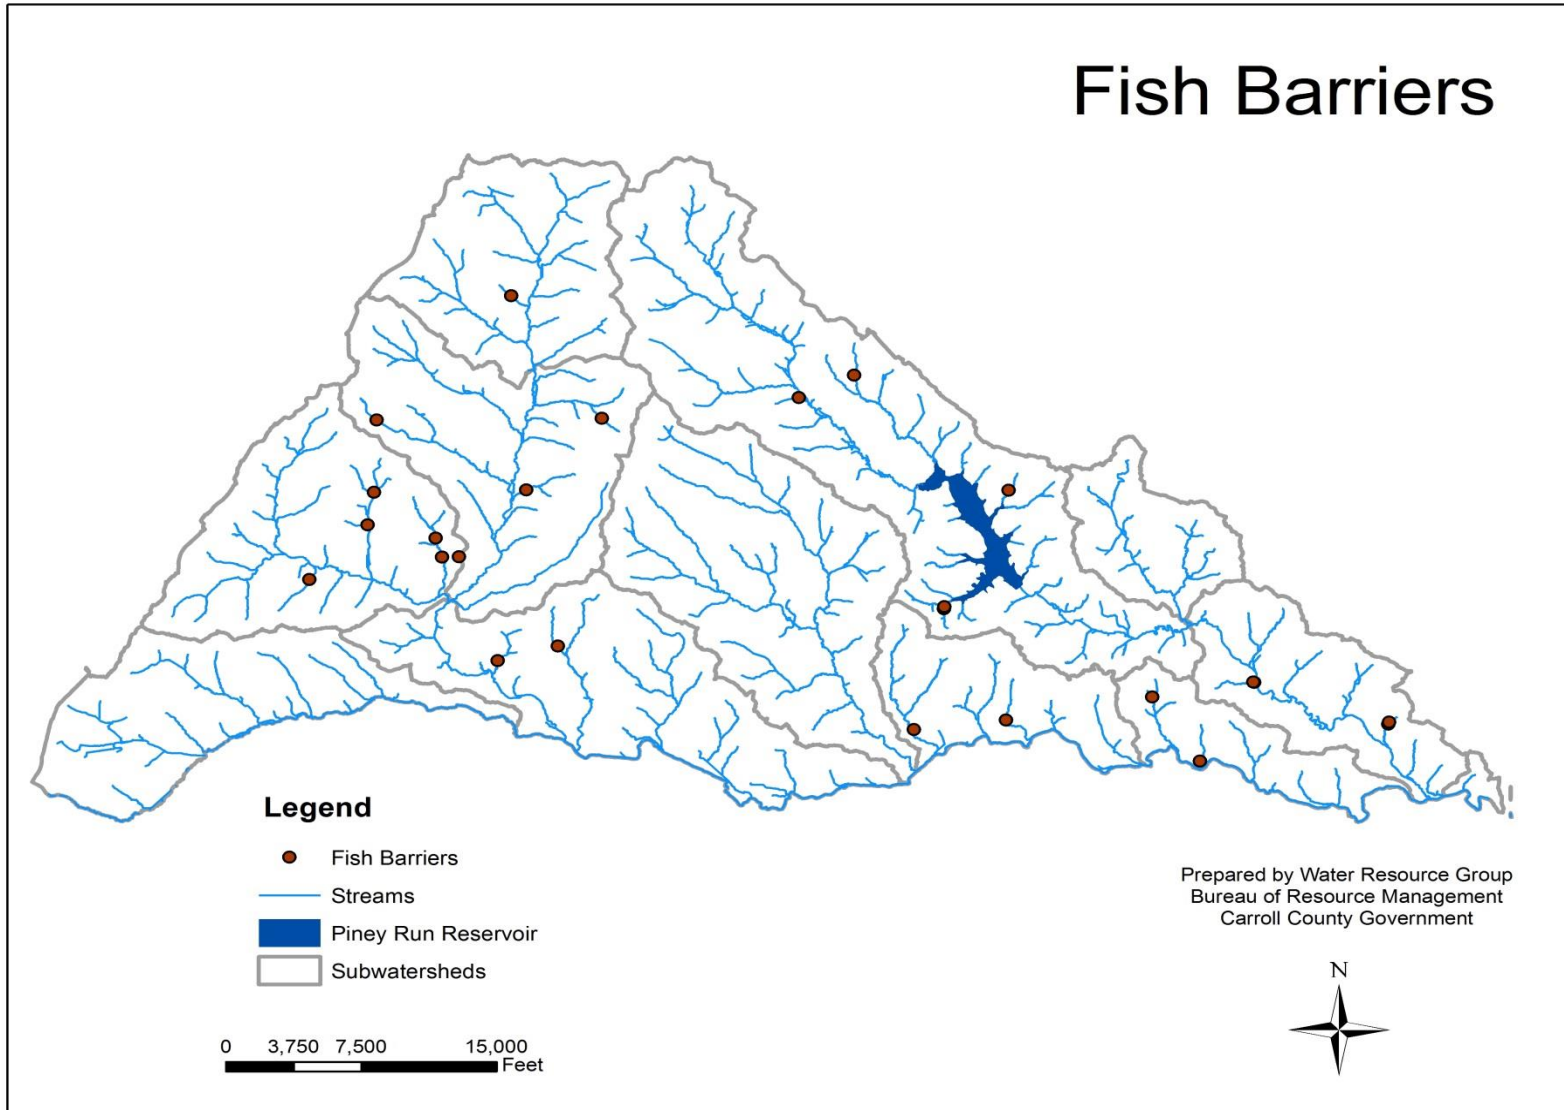
Figure 1-7: Fish Barriers

There were 25 fish barriers identified during the survey; all of the sites were associated with temporary debris dams, perched road culverts, or natural falls. Six of the identified sites significantly restricted upstream fish movement and received a moderate to severe rating. Figure 1-7 shows the location of identified fish barriers.

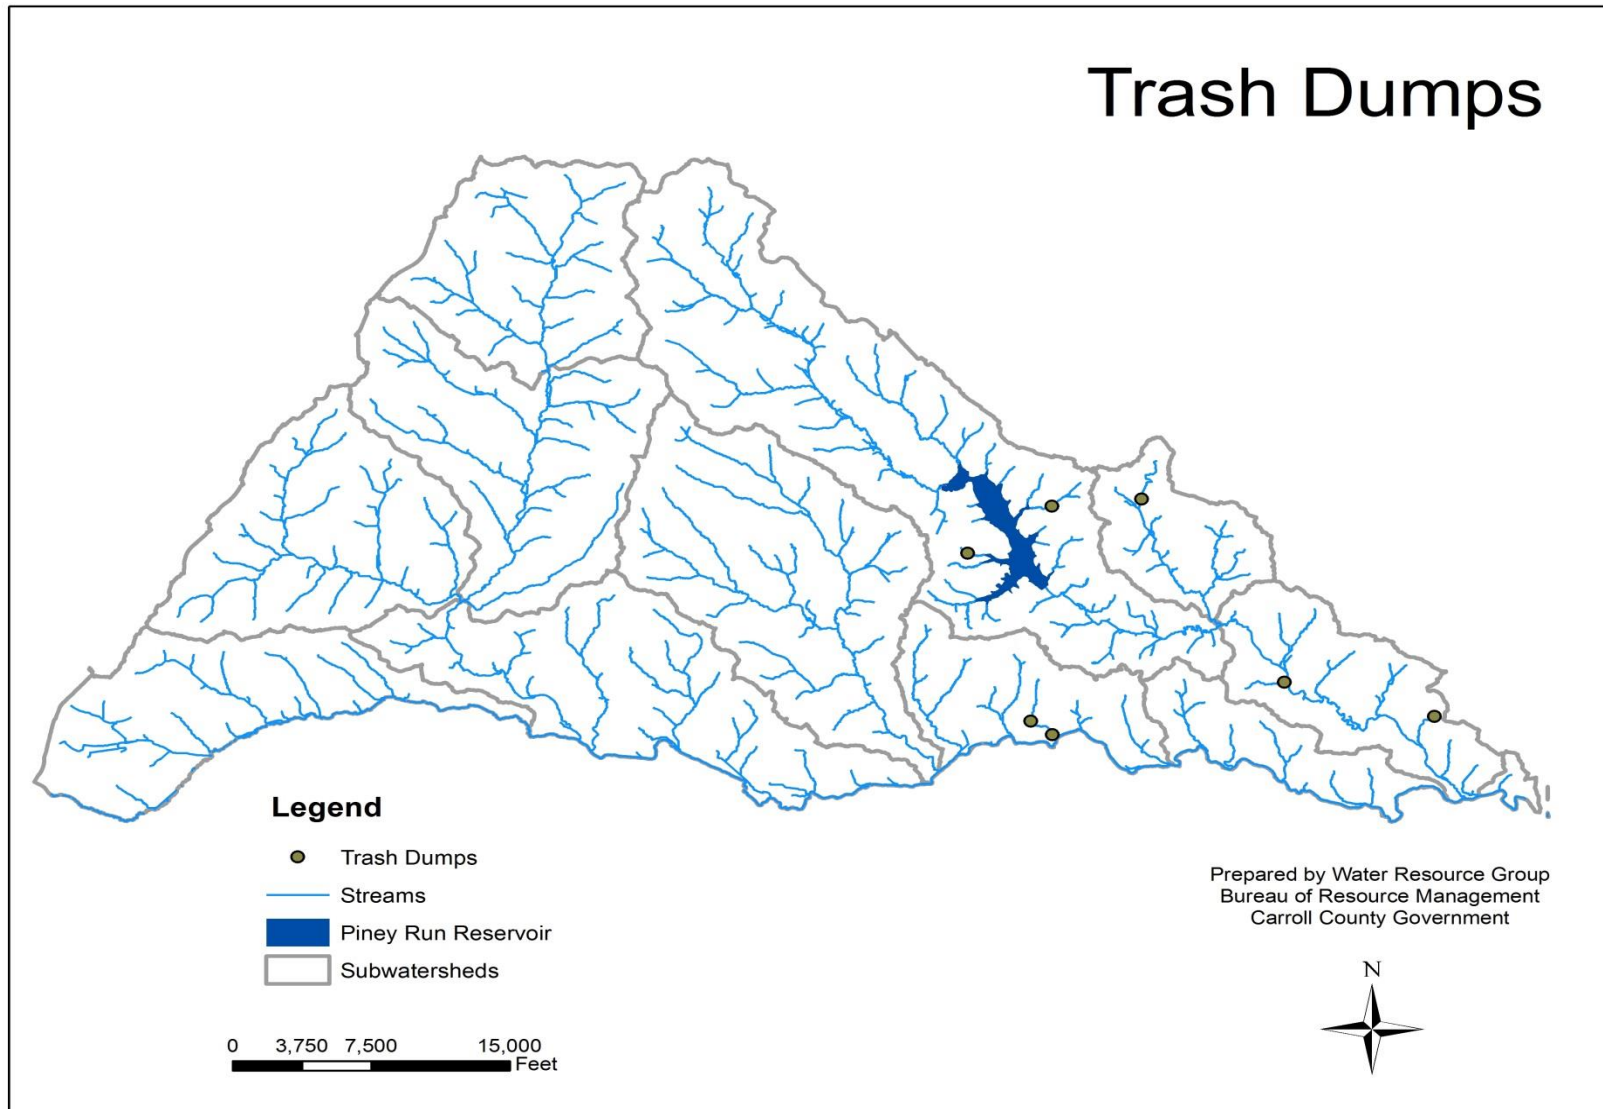
Figure 1-8: Trash Dumps

Impacts from trash were minimal with 7 identified locations within the watershed; all of the sites had a moderate to minor severity rating, with the largest site estimated to have approximately 5 truckloads of waste. The location of identified trash sites can be found in Figure 1-8.

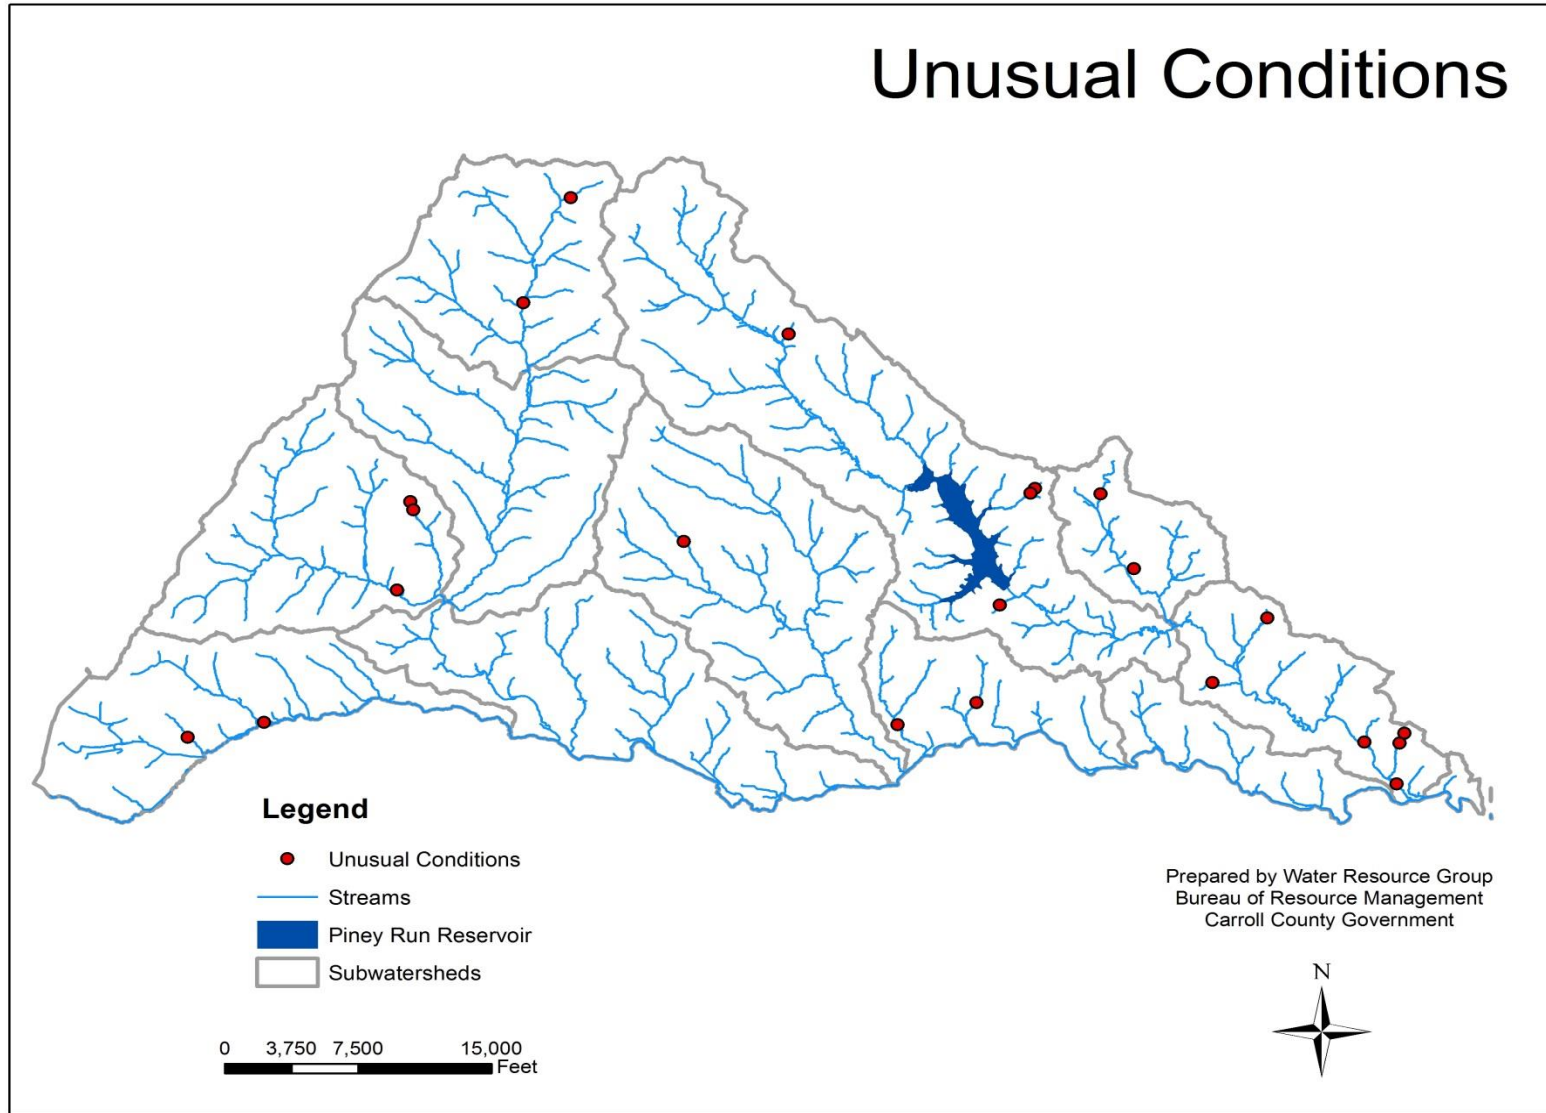
Figure 1-9: Unusual Conditions

Field crews identified 22 unusual conditions during the assessment. The majority of the unusual conditions were comment based, noting or describing something out of the ordinary. The location of these can be found in Figure 1-9.
