Upper Monocacy Watershed Stream Corridor Assessment

Winter 2015

**Prepared By
Carroll County Bureau of Resource Management**

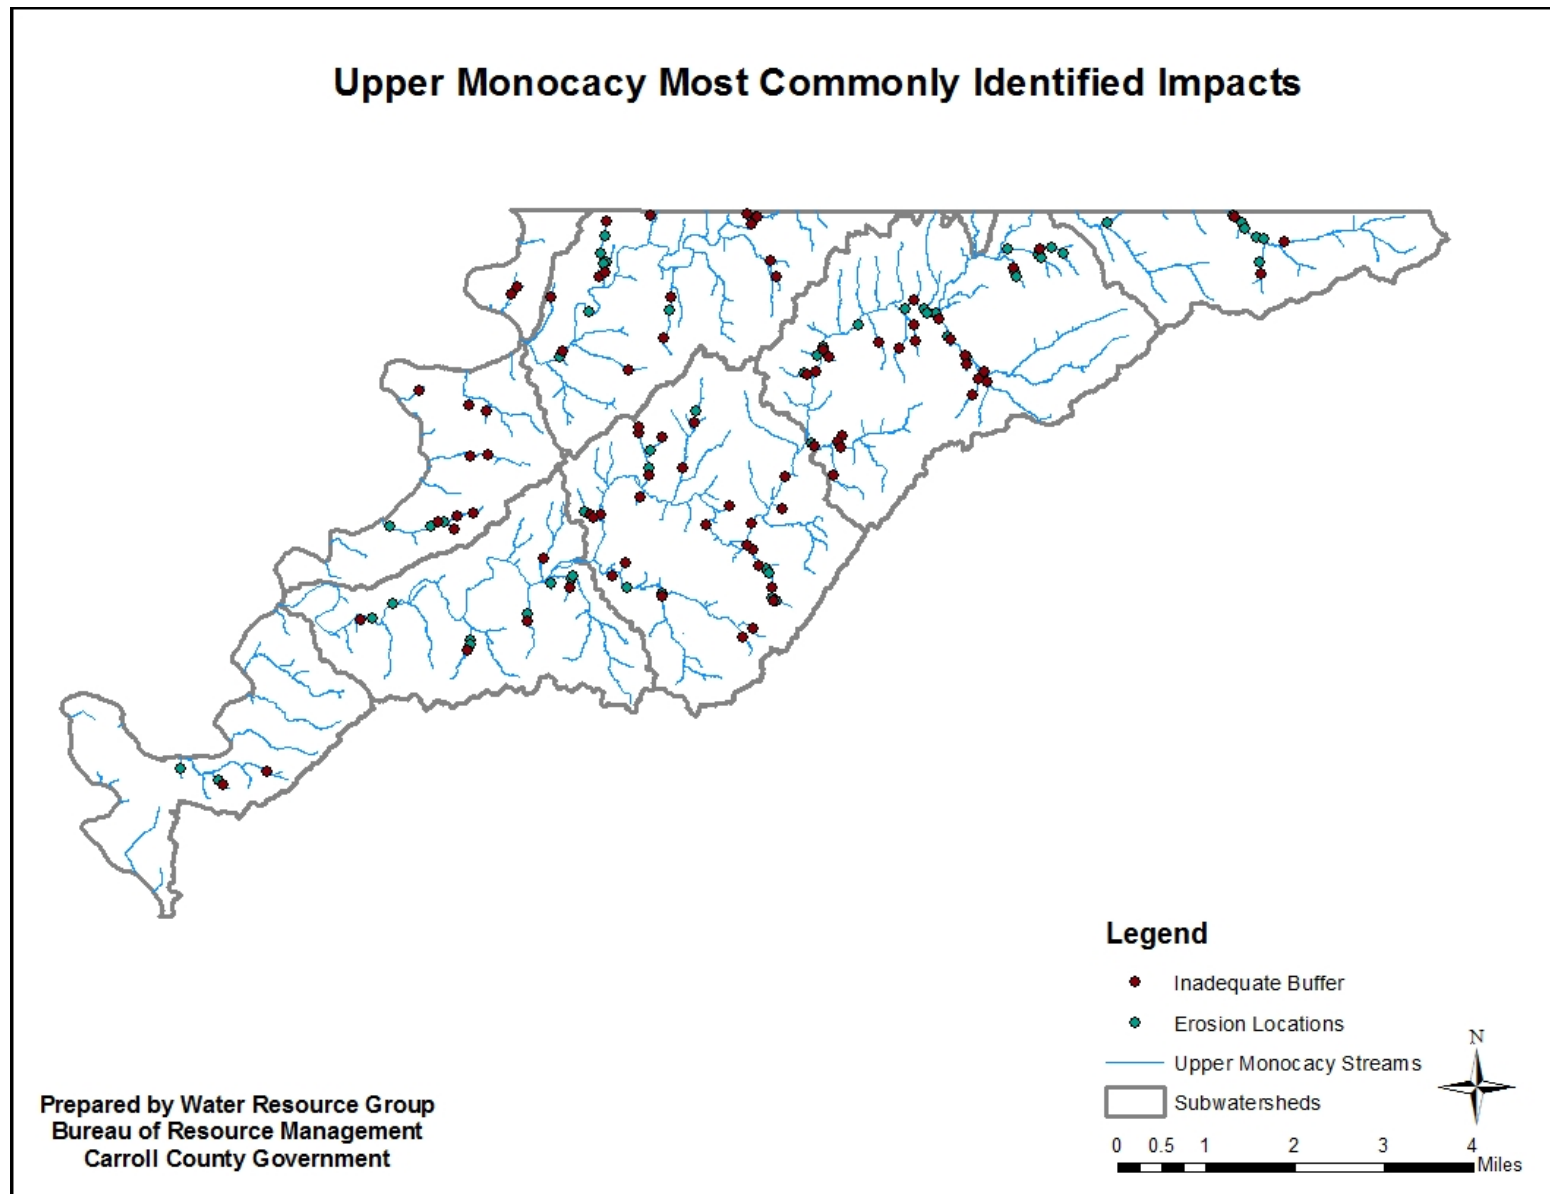
Figure 1-3: Most Commonly Identified Impacts

A total of 271 data points were collected across the watershed. Inadequate buffers and stream bank erosion were the most frequently identified problems. Fish blockages were also regularly present throughout the watershed. Table 1-2 lists the data points by severity across the entire watershed. The most commonly identified impacts are shown in Figure 1-3, and Table 1-3 presents a summary of the number of impacts identified in each subwatershed. Criteria for ranking each impairments severity can be found in Appendix B.

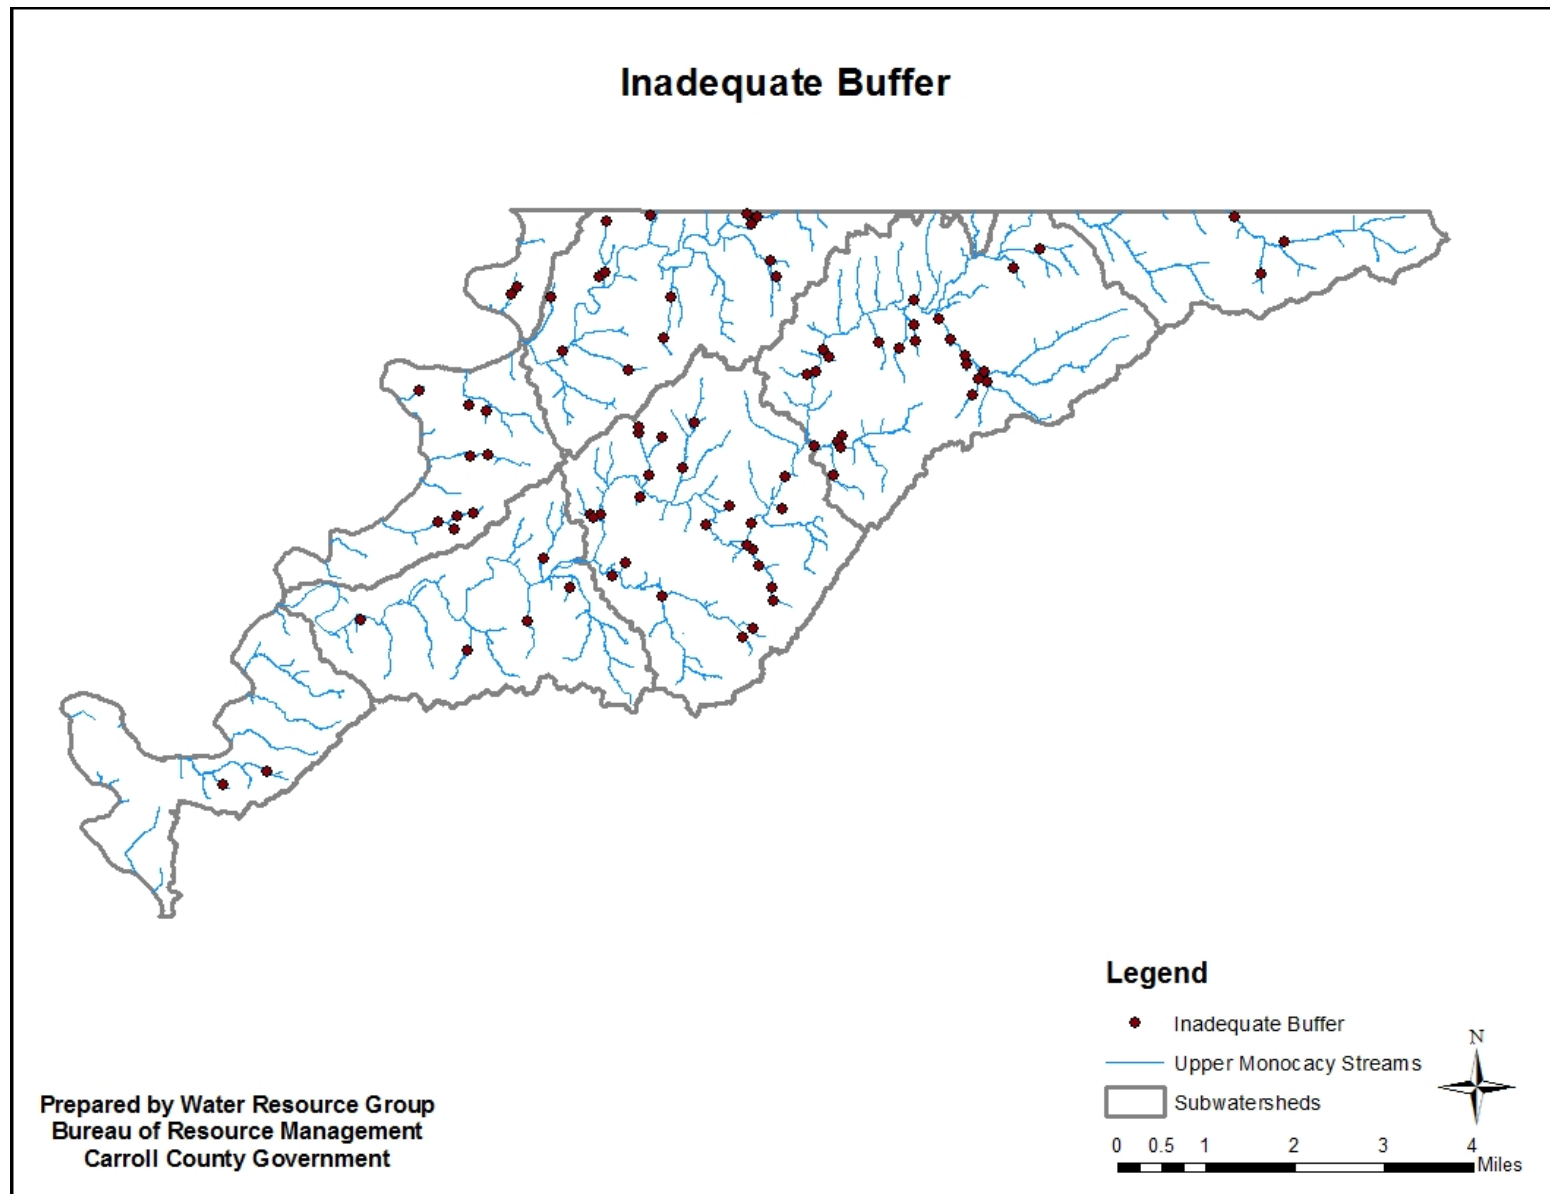
Figure 1-4: Inadequate Buffers

The most common problem identified through the Stream Corridor Assessment was inadequate stream side buffers. Buffer areas were identified as inadequate along 44% of the streams assessed, with 7 percent of the entire watershed classified as severely un-buffered. 50 of the sites identified both sides of the stream as completely unshaded, and livestock was noted to be present at 5 different sites. Of the 84 sites identified, 2 had been recently planted but were not yet established. Figure 1-4 shows the location of identified inadequate buffers.

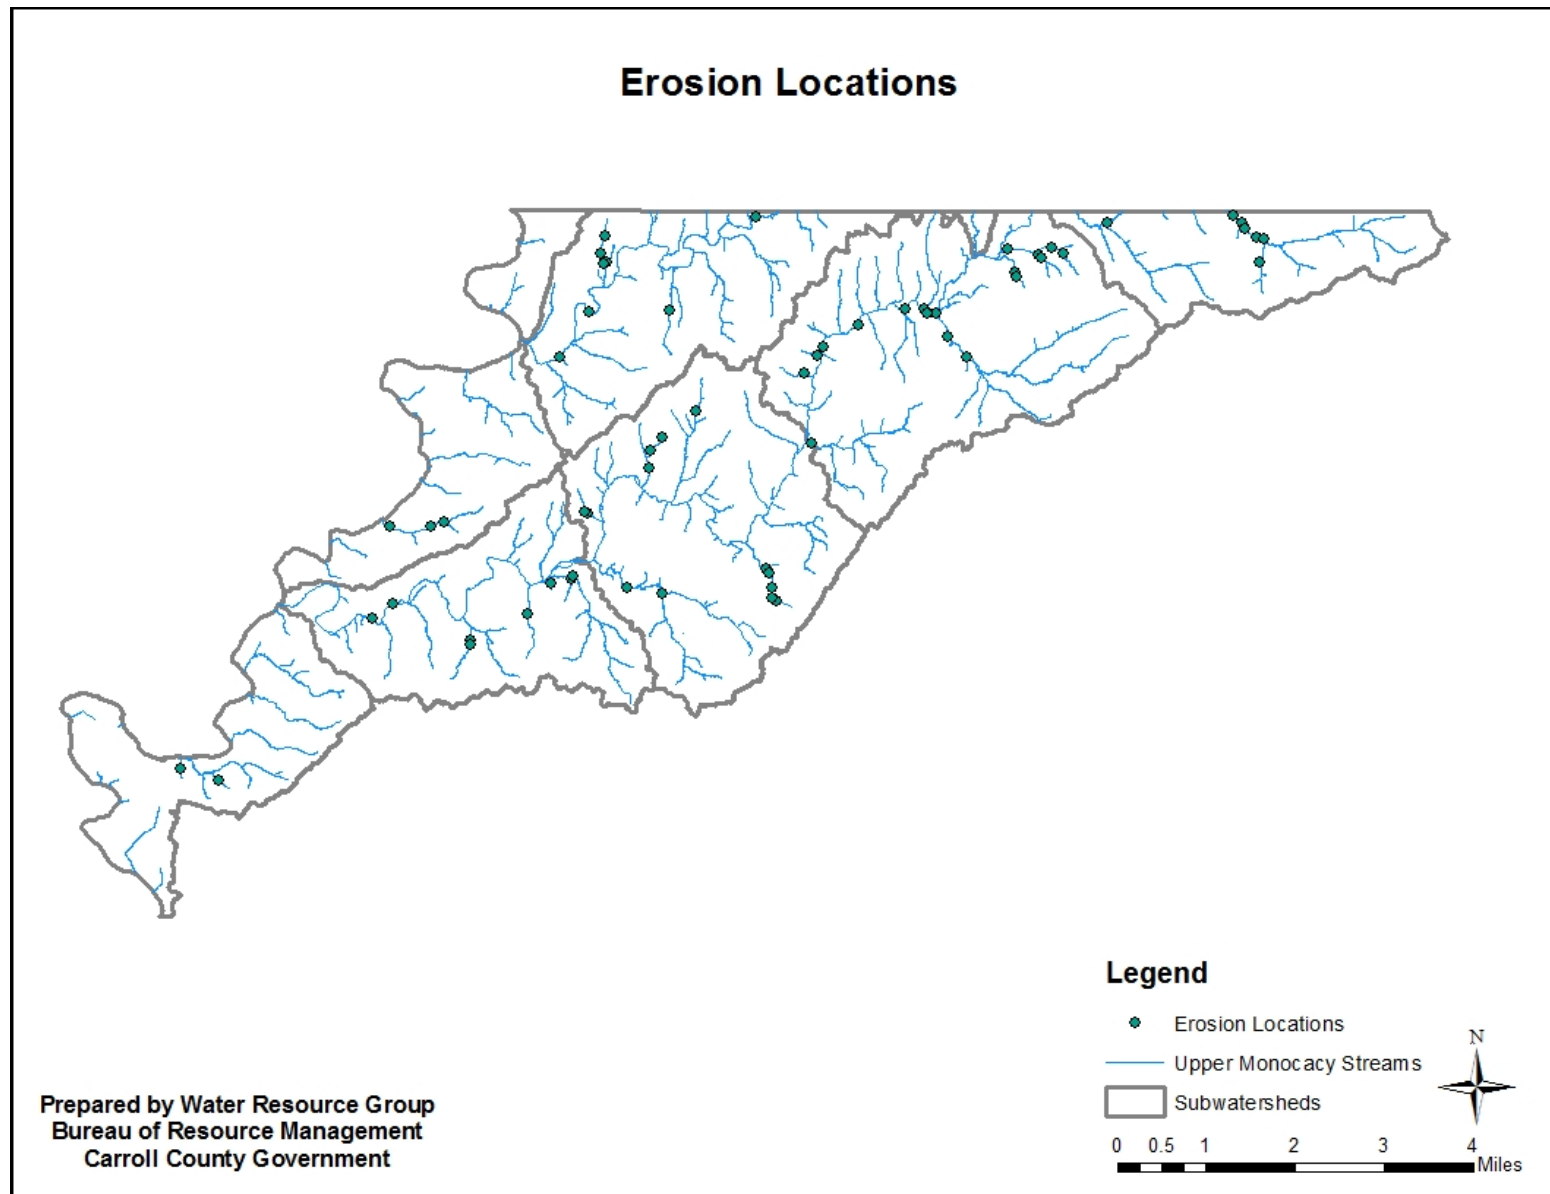
Figure 1-5: Erosion Locations

The second most common problem identified through the Stream Corridor Assessment was erosion. A total of 4.8 miles, or 7 percent, of the 67 miles assessed were found to have an erosion problem, with approximately 1 percent of the watershed categorized as having a severe erosion problem. Figure 1-5 shows the location of active erosion sites identified during the Stream Corridor Assessment.

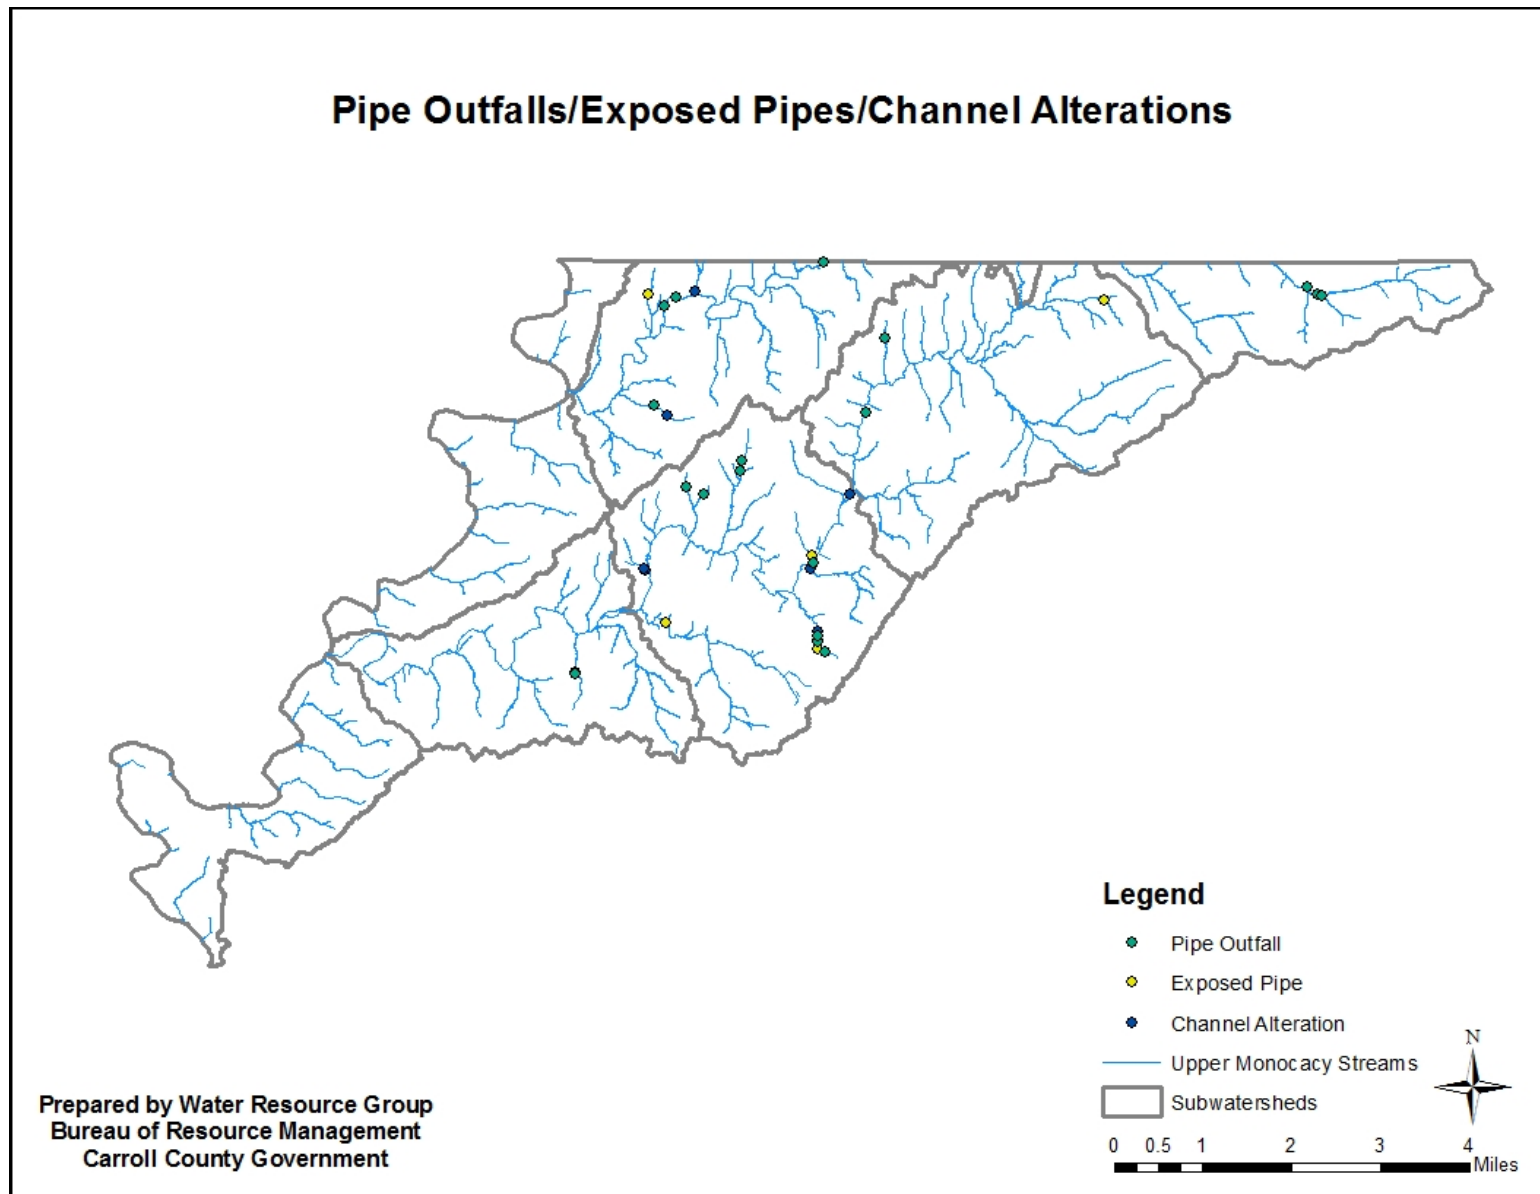
Figure 1-6: Pipe Outfalls, Exposed Pipes, and Channel Alterations

Outfalls were found throughout the entire watershed, with the highest concentration located in the Piney Creek D (0255) subwatershed. The majority of the outfalls identified were associated with agricultural use or stormwater conveyance and were given a low impact rating.

Five exposed pipes were identified during the stream corridor assessment, 3 of which were located in the Piney Creek D (0255) subwatershed. Any exposed pipe identified is reported to the appropriate public works department for additional investigation.

Impacts from channel alterations were found at 8 different sites within the watershed and totaled 1,050 linear feet. The alterations identified were primarily associated with the protection of infrastructure and were given a minor severity ranking.

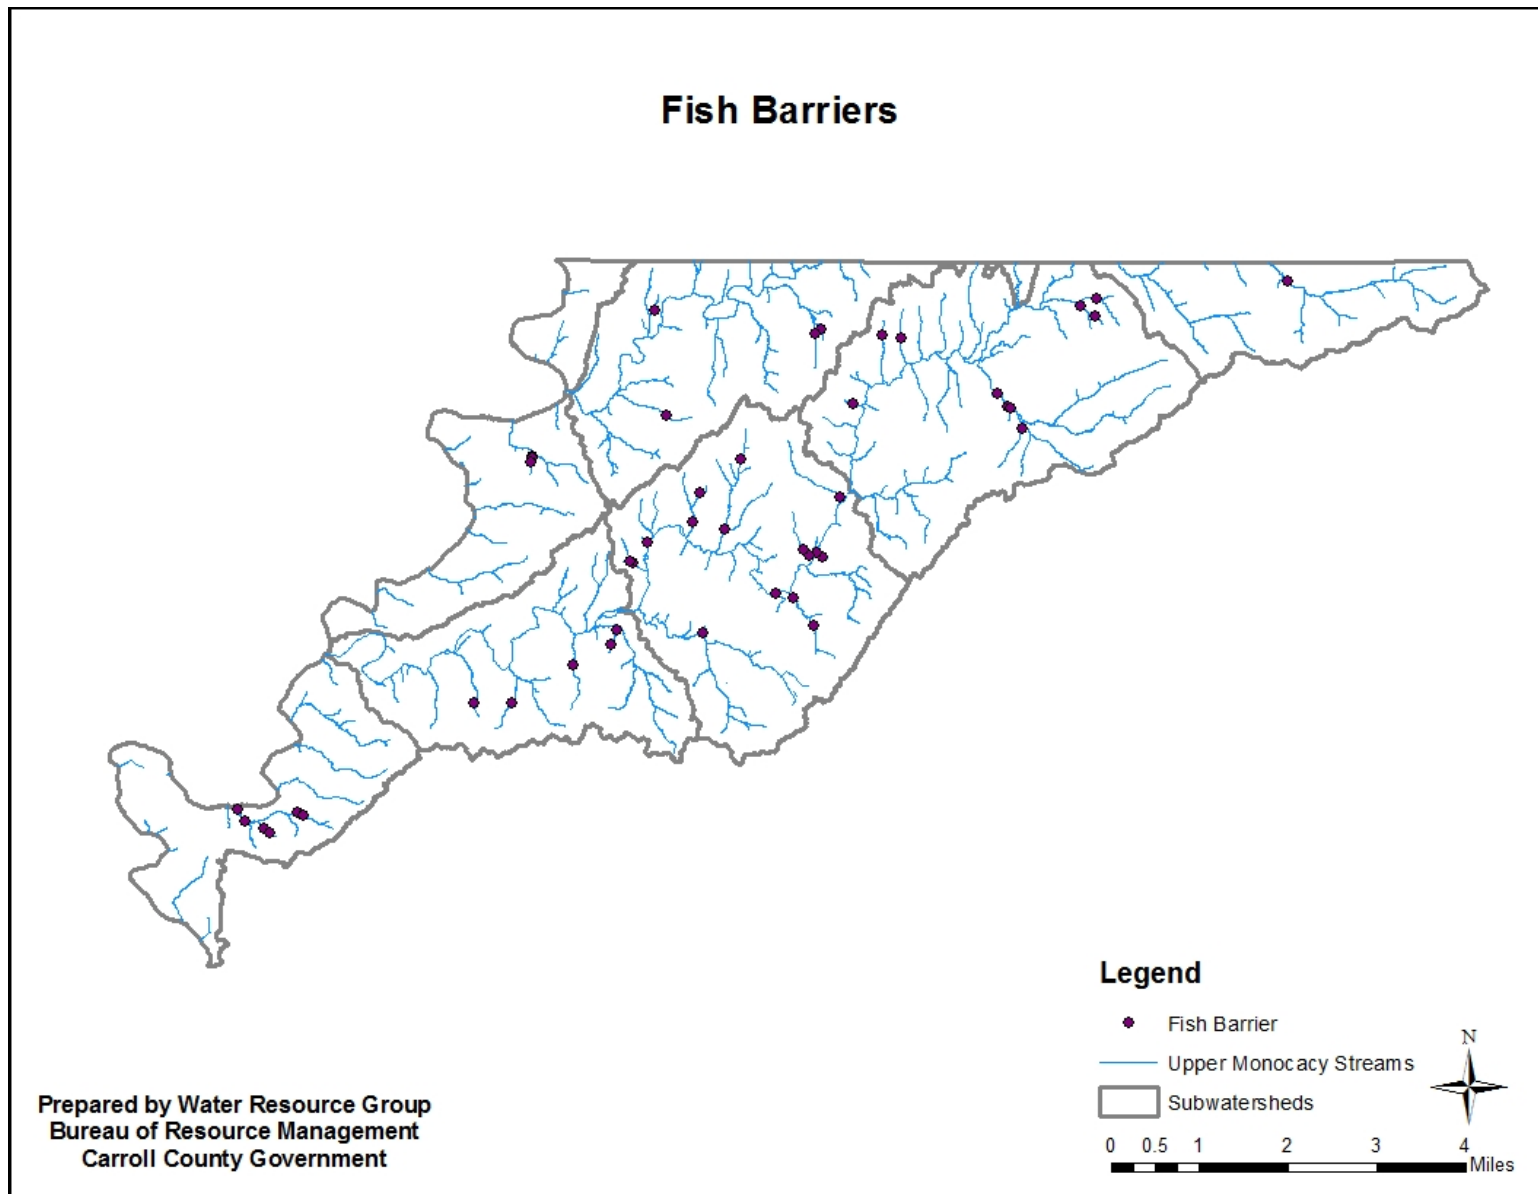
Figure 1-7: Fish Barriers

There were 45 fish barriers identified during the survey; all of the sites were associated with temporary debris dams (17), perched road culverts (15), or natural falls (13). Six of the identified sites significantly restricted upstream fish movement and received a moderate to severe rating. Figure 1-7 shows the location of identified fish barriers.

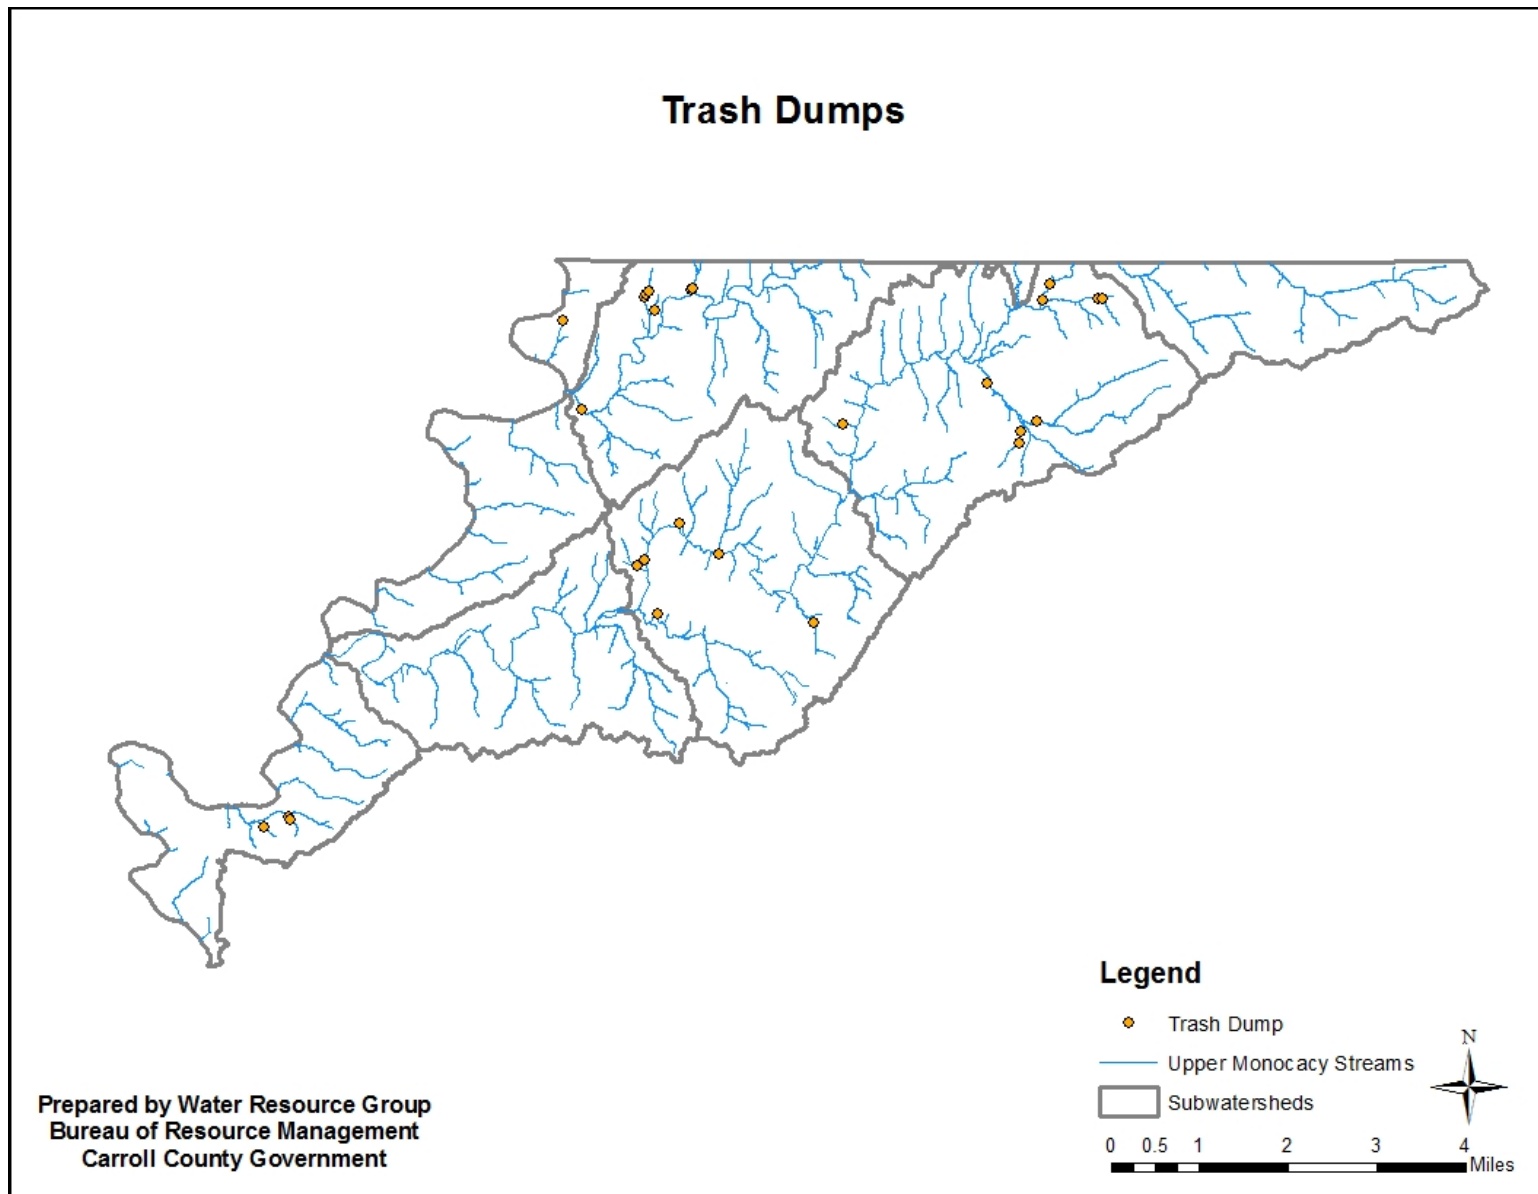
Figure 1-8: Trash Dumps

Impacts from trash were identified in 26 locations within the watershed; most of the sites had a moderate to minor severity rating. The largest site estimated to have approximately 6 truckloads of waste. The location of identified trash sites can be found in Figure 1-8.

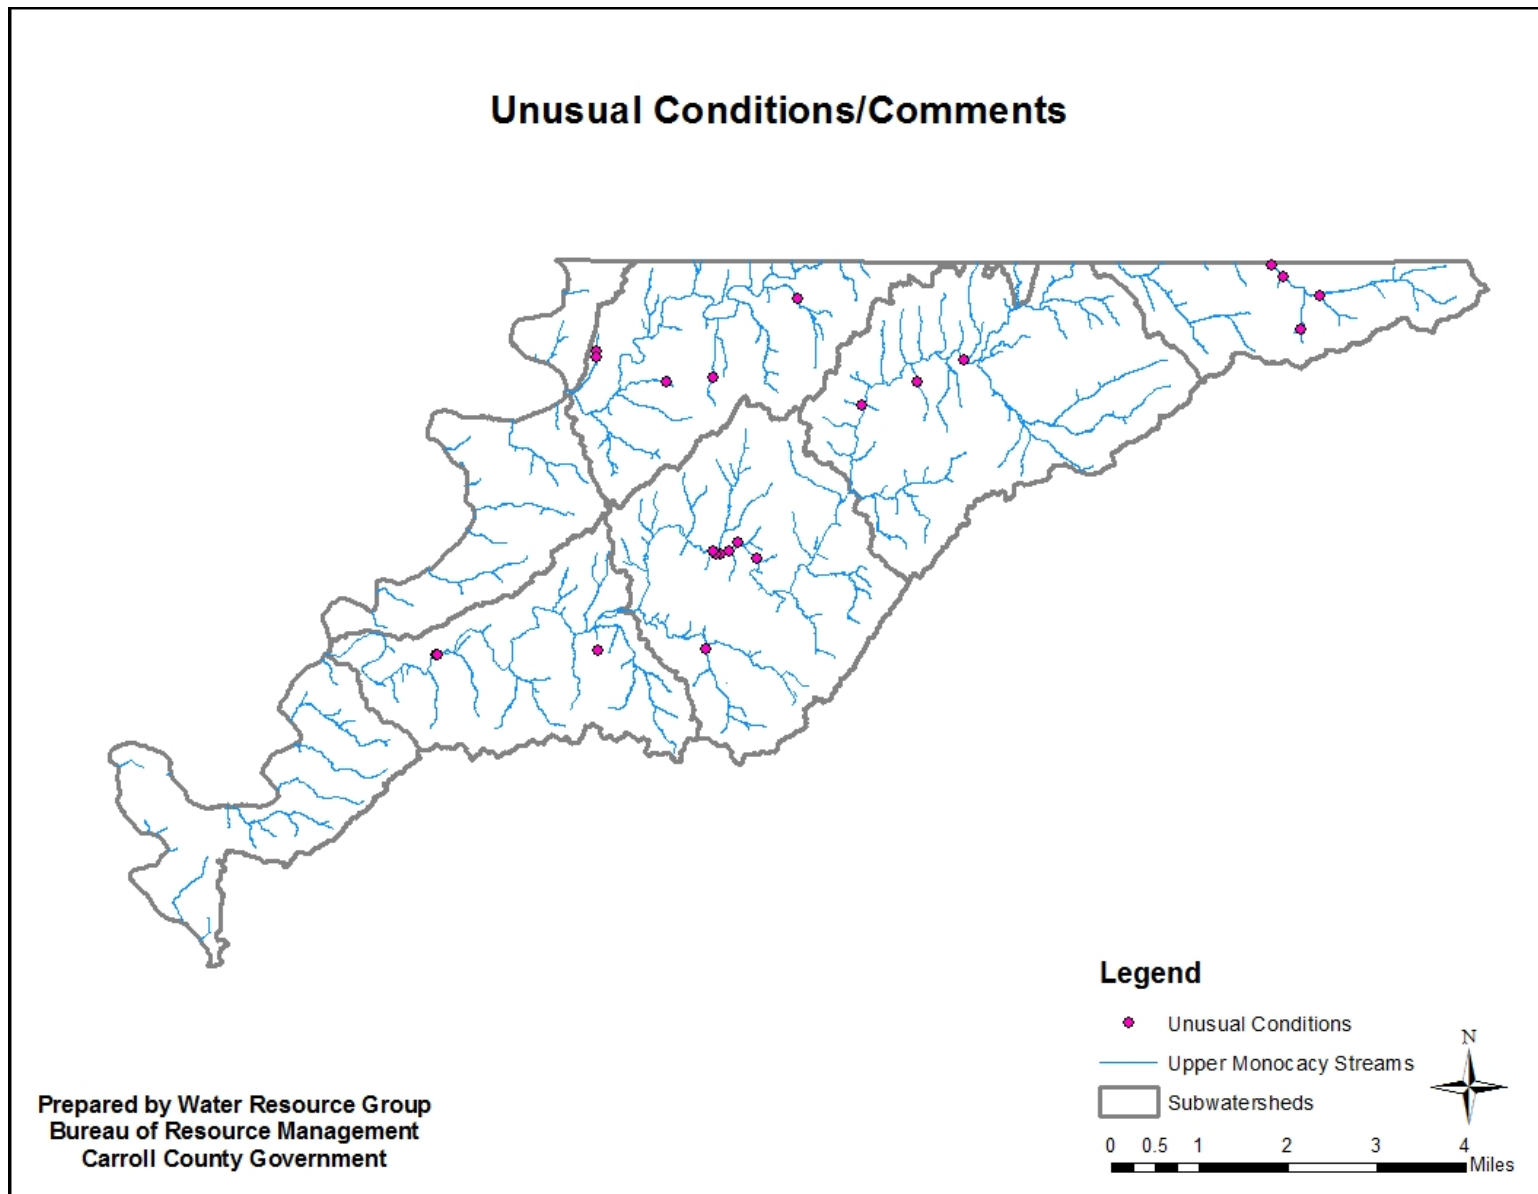
Figure 1-9: Unusual Conditions

Field crews identified 22 unusual conditions during the assessment. The majority of the unusual conditions were comment based, noting or describing something out of the ordinary. The location of these can be found in Figure 1-9.
