Lower Monocacy River Watershed Stream Corridor Assessment

A stream corridor assessment of the Lower Monocacy River Watershed was conducted during the winter of 2014 by Carroll County Bureau of Resource Management staff. The goal of this assessment was to identify current impairments within the watershed, as well as identify locations to implement restoration practices.

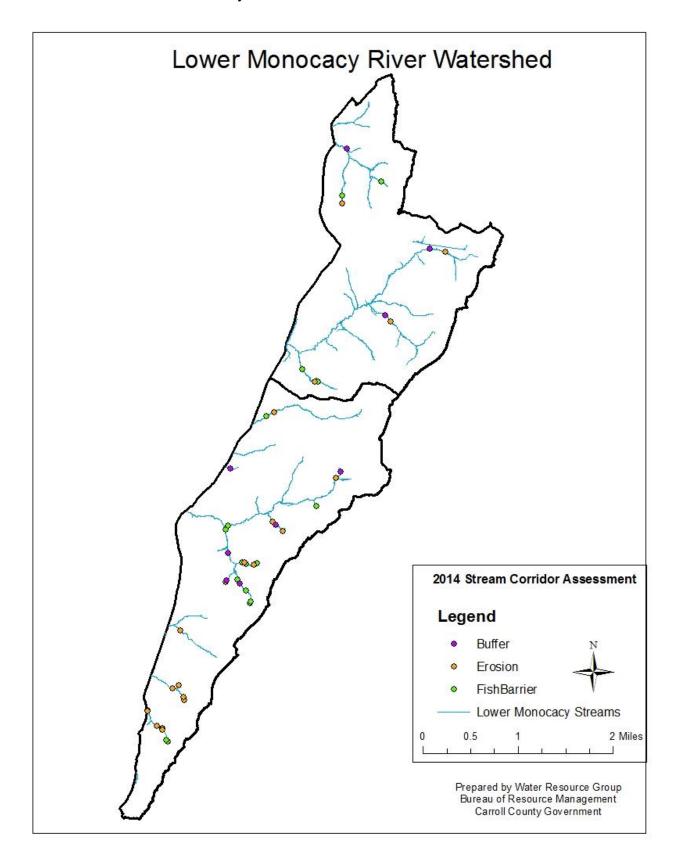
Figure 1-3: Most Commonly Identified Impact

A total of 57 data points were collected across the watershed. Stream bank erosion and fish barriers were the most frequently identified problems. Inadequate stream-side buffers were also regularly present throughout the watershed. Table 1-2 lists the data points by severity across the entire watershed. The most commonly identified impacts are shown in Figure 1-3. Criteria for ranking each impairments severity can be found in Appendix B.
