## NATIONAL POLLUTANT DISCHARGE ELIMINATION SYSTEM MUNICIPAL SEPARATE STORM SEWER SYSTEM DISCHARGE PERMIT

2017 ANNUAL REPORT

# 2017 NPDES MS4 Permit Annual Report

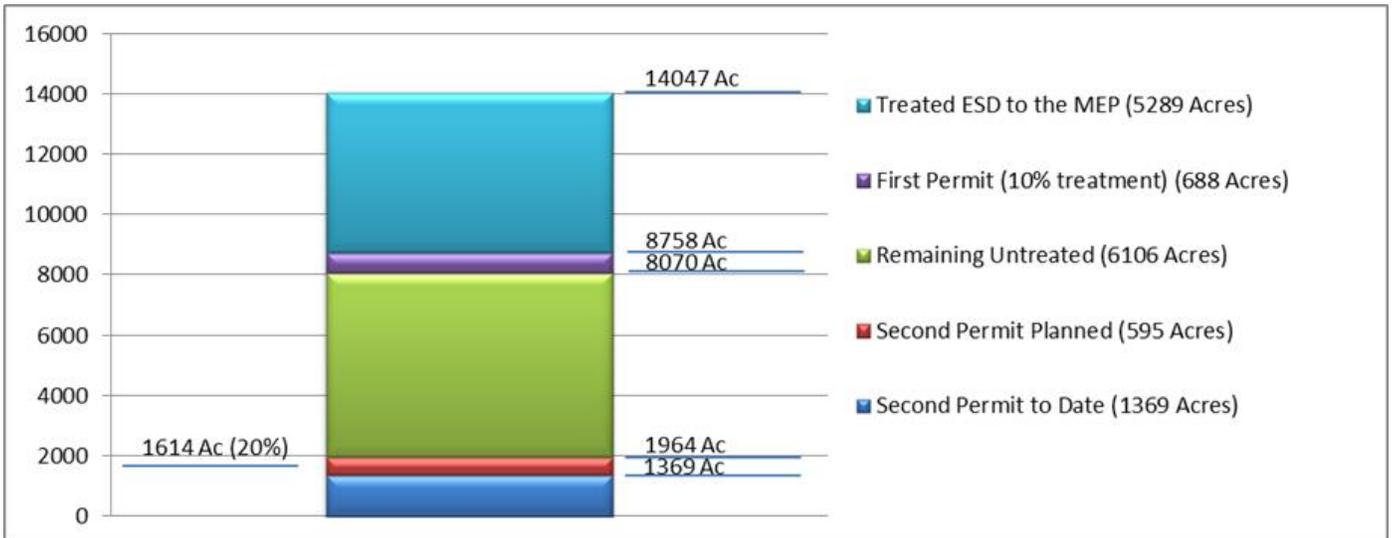
**Figure 1: Carroll County Fourth Generation Permit Impervious Surface Analysis**

Activities associated with treatment efforts which have been taken during this permit term are listed in **Table 11** “Listing of Watershed Restoration Efforts July 2017 NPDES”. Impervious acres treated to date are 1,369 and there are projects under construction or in design, scheduled for completion in 2018 and 2019 which will treat an additional 595 acres bringing the anticipated County total for this permit to 1,964 acres, which is 122 percent of our 20 percent permit requirement of 1,614 acres.

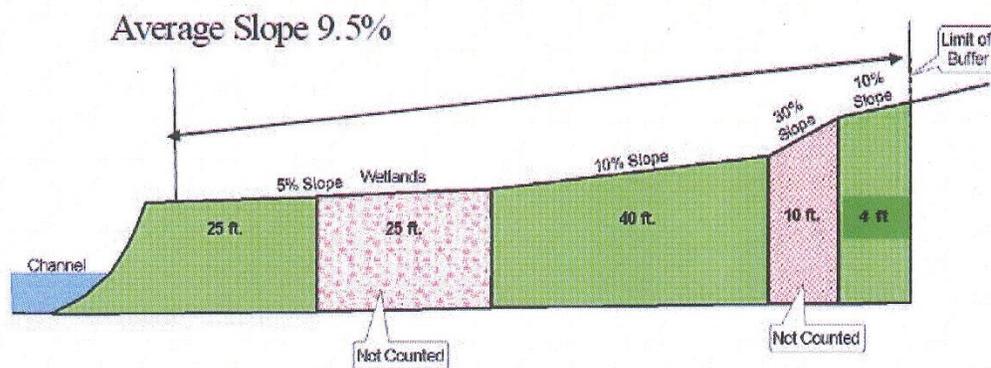
In the example below, the average slope of the bank is 9.5 percent, which corresponds to a buffer width for one side of the stream of 69 feet. (50 foot minimum + 19 feet). Since there are 25 feet of wetlands in the example and 10 feet of steep slope, the total buffer is determined to be 104 feet.

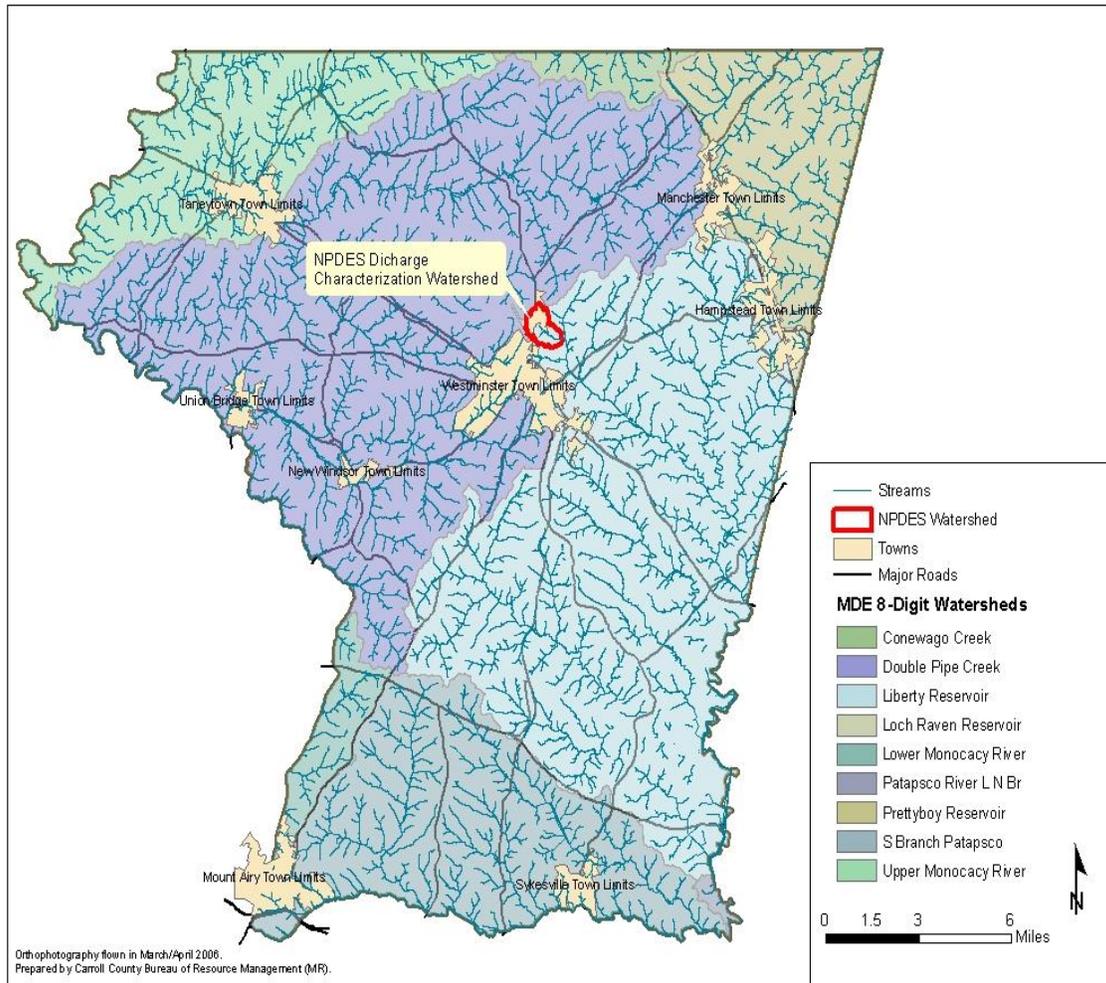
**Figure 7: Carroll County NPDES Discharge Characterization Location**

The discharge characterization is completed in a first order stream that is a tributary to the West Branch of the North Branch Patapsco River. The location of the watershed where monitoring is conducted within the County is shown in **Figure 7**, while the location of the monitoring stations and other watershed features are shown in **Figure 8**. The study area is located near the topographic divide separating the eastern and western piedmont physiographic provinces. As shown in **Figure 7**, the unnamed tributary drains the upper-most extent of first order tributary and is located in the Liberty Reservoir watershed.

The Air Business Center regional stormwater management facility discharges via a constructed outfall to a small stream that travels southeast to the confluence with the West Branch. The stream receives the majority of water from the pond, with contribution from overland flow from the drainage basin during precipitation events. A new stormwater management pond at the West Branch Trade Center has been constructed adjacent to and east of the Air Business Center stormwater management facility. This facility drains to the stream, just downstream of the outfall station.

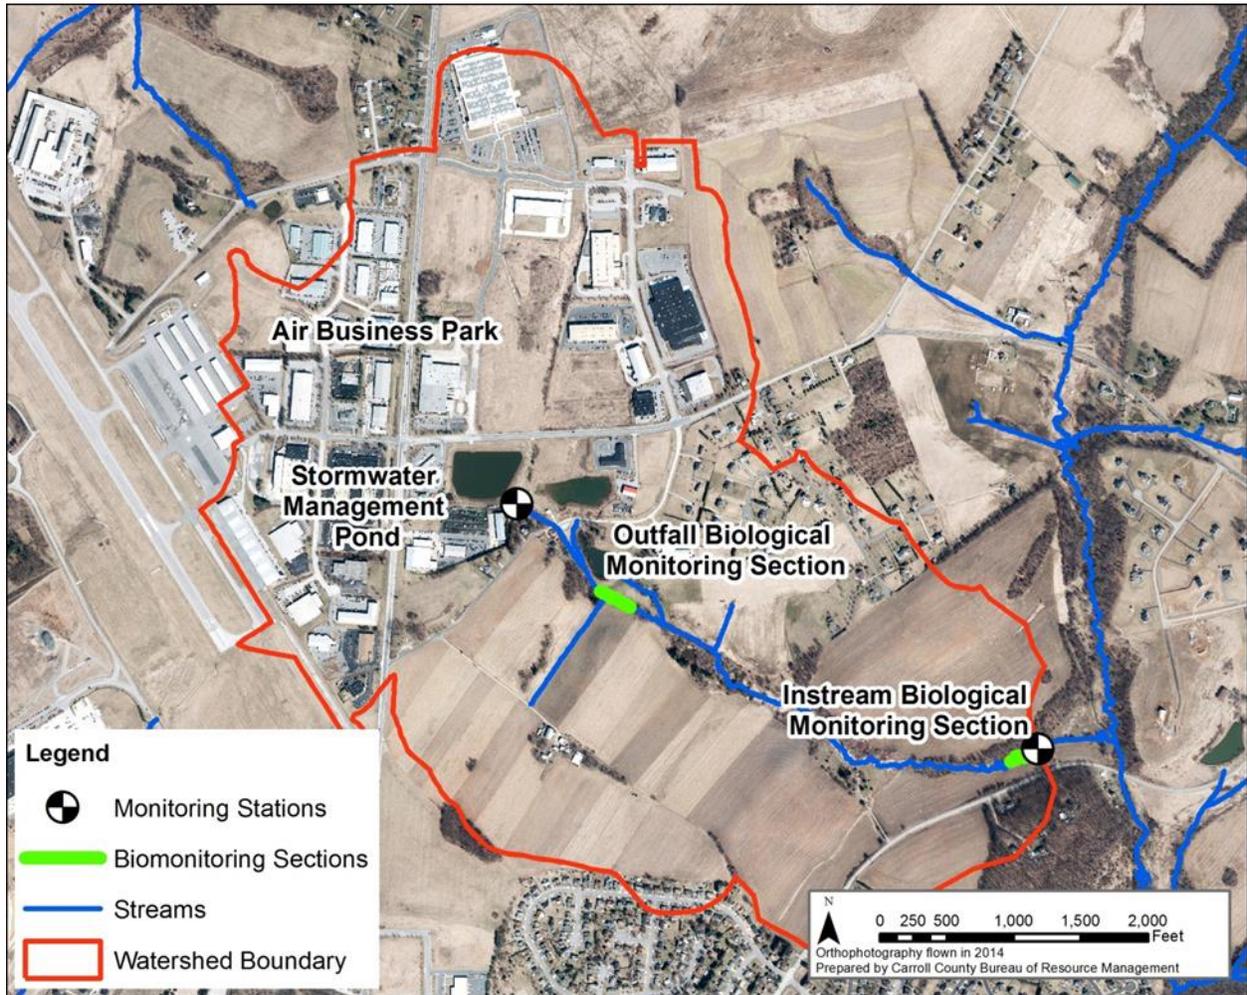
Figure 9: Biological Monitoring Station Locations

Two monitoring sites corresponding to the Outfall and Instream stations have been characterized since the 2000 reporting period. The 75-meter sampling sites, shown in **Figure 9**, were not randomly selected. Results from the data gathered over the years may reflect changes in stream conditions downstream of the regional stormwater management facility.

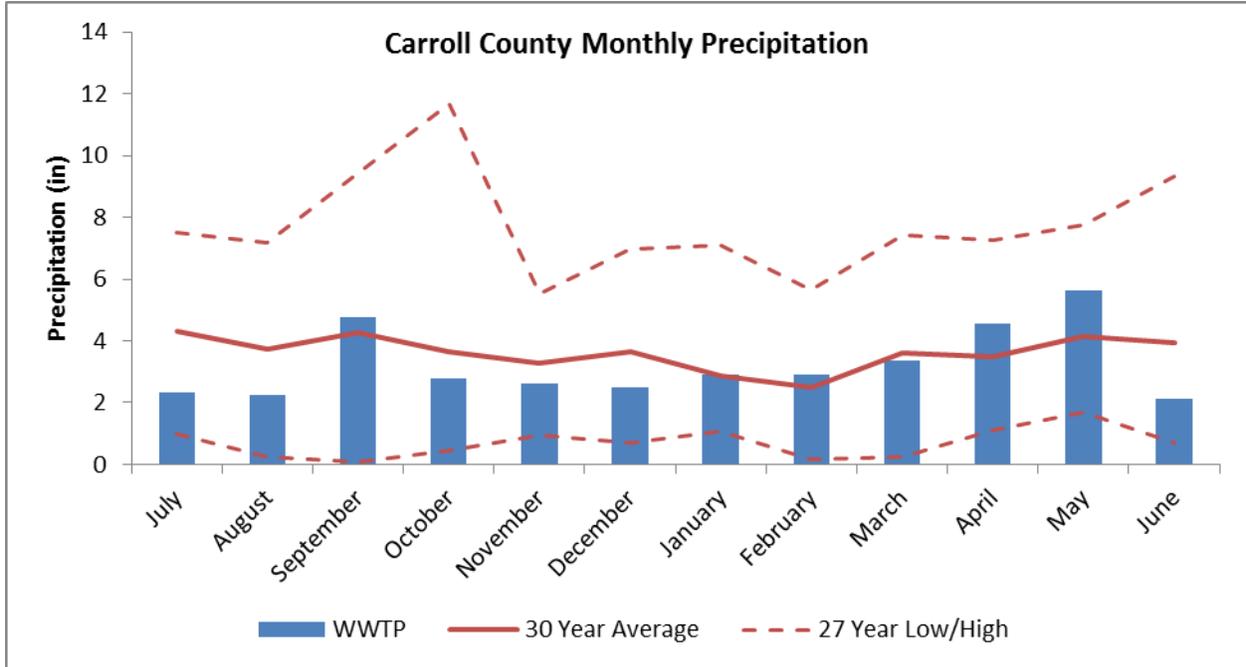
**Figure 10: Monthly Precipitation Summary for the 2016 – 2017 Reporting Period**

while July 2016 was the driest month with a deficit of 2.01 inches. This reporting year was the fifth driest year for total precipitation since reporting began at this station in 2000.

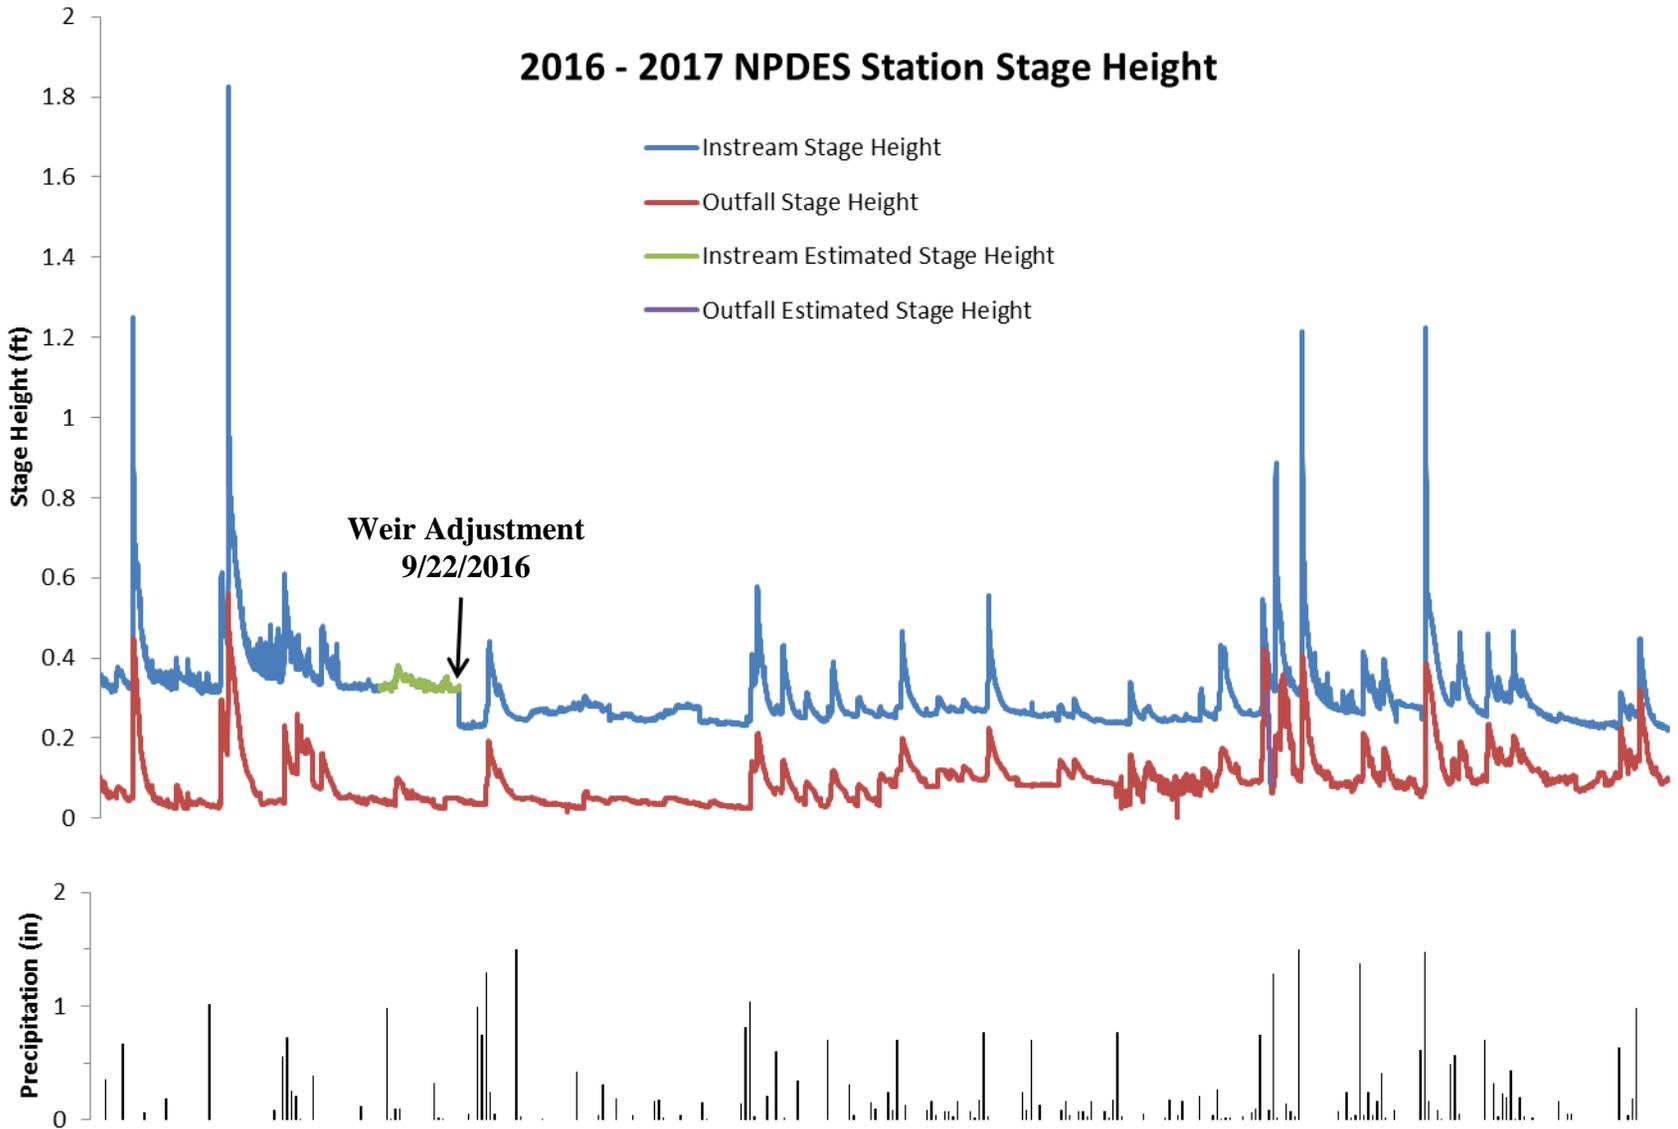
Figure 12: Stage Heights and Daily Precipitation for NPDES Monitoring Stations for the 2016 – 2017 Reporting Year

Storage by the stormwater facility results in peak stage heights less than 0.5 feet at the outfall station except for the storm event on July 30-31, 2016 when 2.39 inches of precipitation was recorded. The stage reached peak height at close to 0.56 feet with a maximum discharge of 2,070 gallons per minute (gpm). Baseflow at the outfall monitoring station was marginal, typically with a stage height of 0.09 feet. The resulting baseflow discharge was approximately 37 gpm. In general, the storm events were fewer and less intense than previous years with a lower than normal baseflow.

Typical stage heights observed for the instream monitoring station were approximately 0.28 feet, or 183 gpm. During the July 30-31 storm event, stage height reached the peak for the reporting year at 1.83 feet. The resulting discharge was 18,153 gpm. There were three other storm events during this time where stage heights above 1 foot (6,600 gpm) were observed. These occurred on July 8, 2016, April 6, 2017, and May 5, 2017, with peak discharges of 10,116 gpm, 11,604 gpm, and 11,832 gpm, respectively.

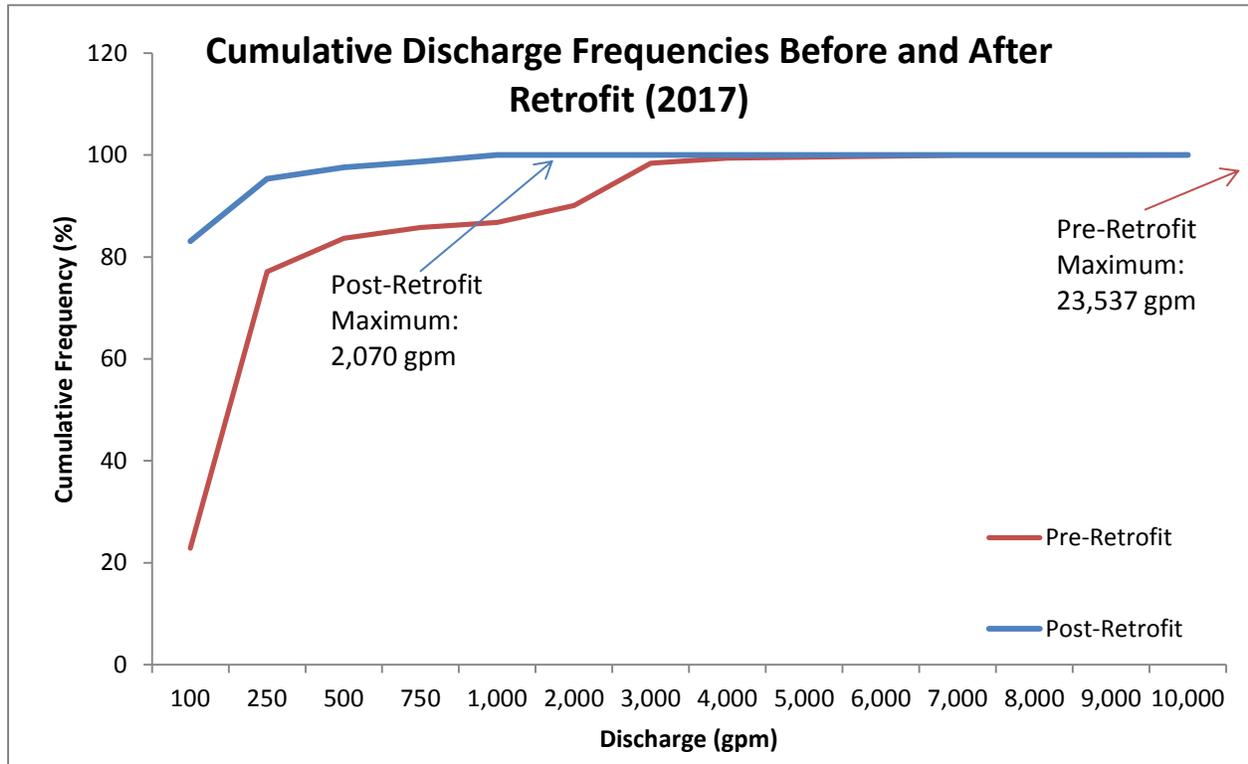
**Figure 14: Outfall Discharge Frequencies for 2007 and 2016**

To compare pre and post pond retrofit hydrology, cumulative discharge frequency was plotted in **Figure 14**. This figure compares the discharge frequencies from the outfall monitoring station for the 2006 – 2007 and 2016 – 2017 reporting years. The maximum discharge during the pre-retrofit period (2007) was an order of magnitude higher than the post-retrofit period (2017). The maximum discharge in 2007 was 23,537 gpm while the maximum in 2017 was only 2,070 gpm. Additionally, the frequency and magnitude of high discharge events was greater during the pre-retrofit period. 83 percent of all discharge measurements were below or equal to 100 gpm. This contrasts with the pre-retrofit measurements where only 23 percent of measurements were below 100 gpm. Ten percent of all measurements in 2007 were greater than 2,000 gallons per minute, which are greater in magnitude than the most of the highest discharges from 2017. Only 1.25 hours during one storm event did the outfall discharge exceed 2,000 gallons per minute in the 2017 reporting year.

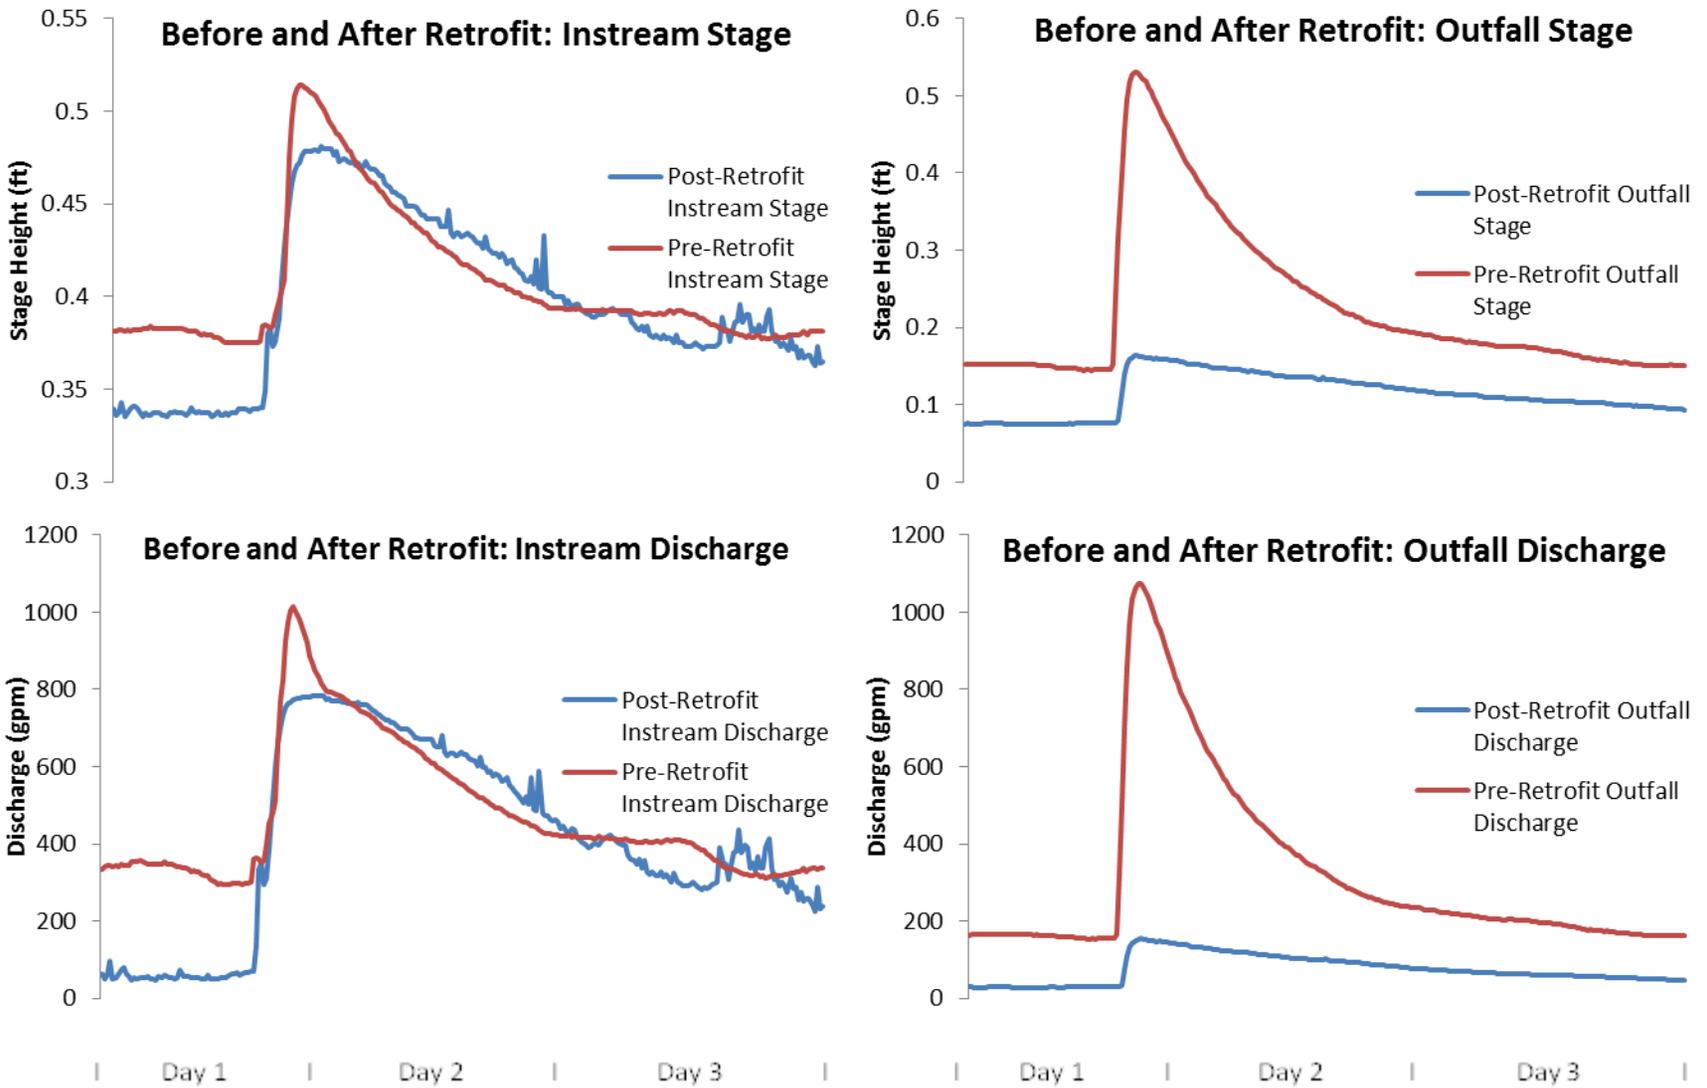
Figure 15: Characteristics of Analogous Storms Pre-Retrofit (7/23/2006, 0.39") and Post-Retrofit (8/21/2016, 0.6")

Looking at individual components of the hydrograph allows one to observe the distinct mechanism behind any changes in cumulative frequencies throughout the year. **Figure 15** represents two analogous storm events, one before and one after the stormwater retrofit, and a hydrological comparison therein. This figure contains hydrographs before and after retrofit for instream and outfall stage heights and discharges. Unlike previous years which compared storm events with nearly identical precipitation totals, this comparison is of a larger storm event to the same pre-retrofit storm. The pre-retrofit event had 0.39 inches of precipitation observed while the post-retrofit event had 0.6 inches of precipitation observed. Despite the higher precipitation total and intensity, the ascending limb for the post-retrofit outfall station still had a lower slope and peak discharge than the hydrograph of the pre-retrofit outfall station with a smaller storm event. The outfall to instream station discharge ratio for the post-retrofit storm event maintained a ~18 percent contribution as was roughly the case for the overall discharge and separated stormflow for the reporting period. During the pre-retrofit storm however, the outfall station contributed ~70 percent of the total instream discharge. The lesser contribution during the post-retrofit storm event is evident in the instream station hydrographs. The post-retrofit storm event at the instream station has a similar volume discharged compared to the pre-retrofit storm even with less volume discharged from the outfall station. The period of baseflow recession after the storm event was much shorter during the pre-retrofit storm as well. Overall, longer baseflow recessions and lower peak discharges were observed with the current stormwater configuration.

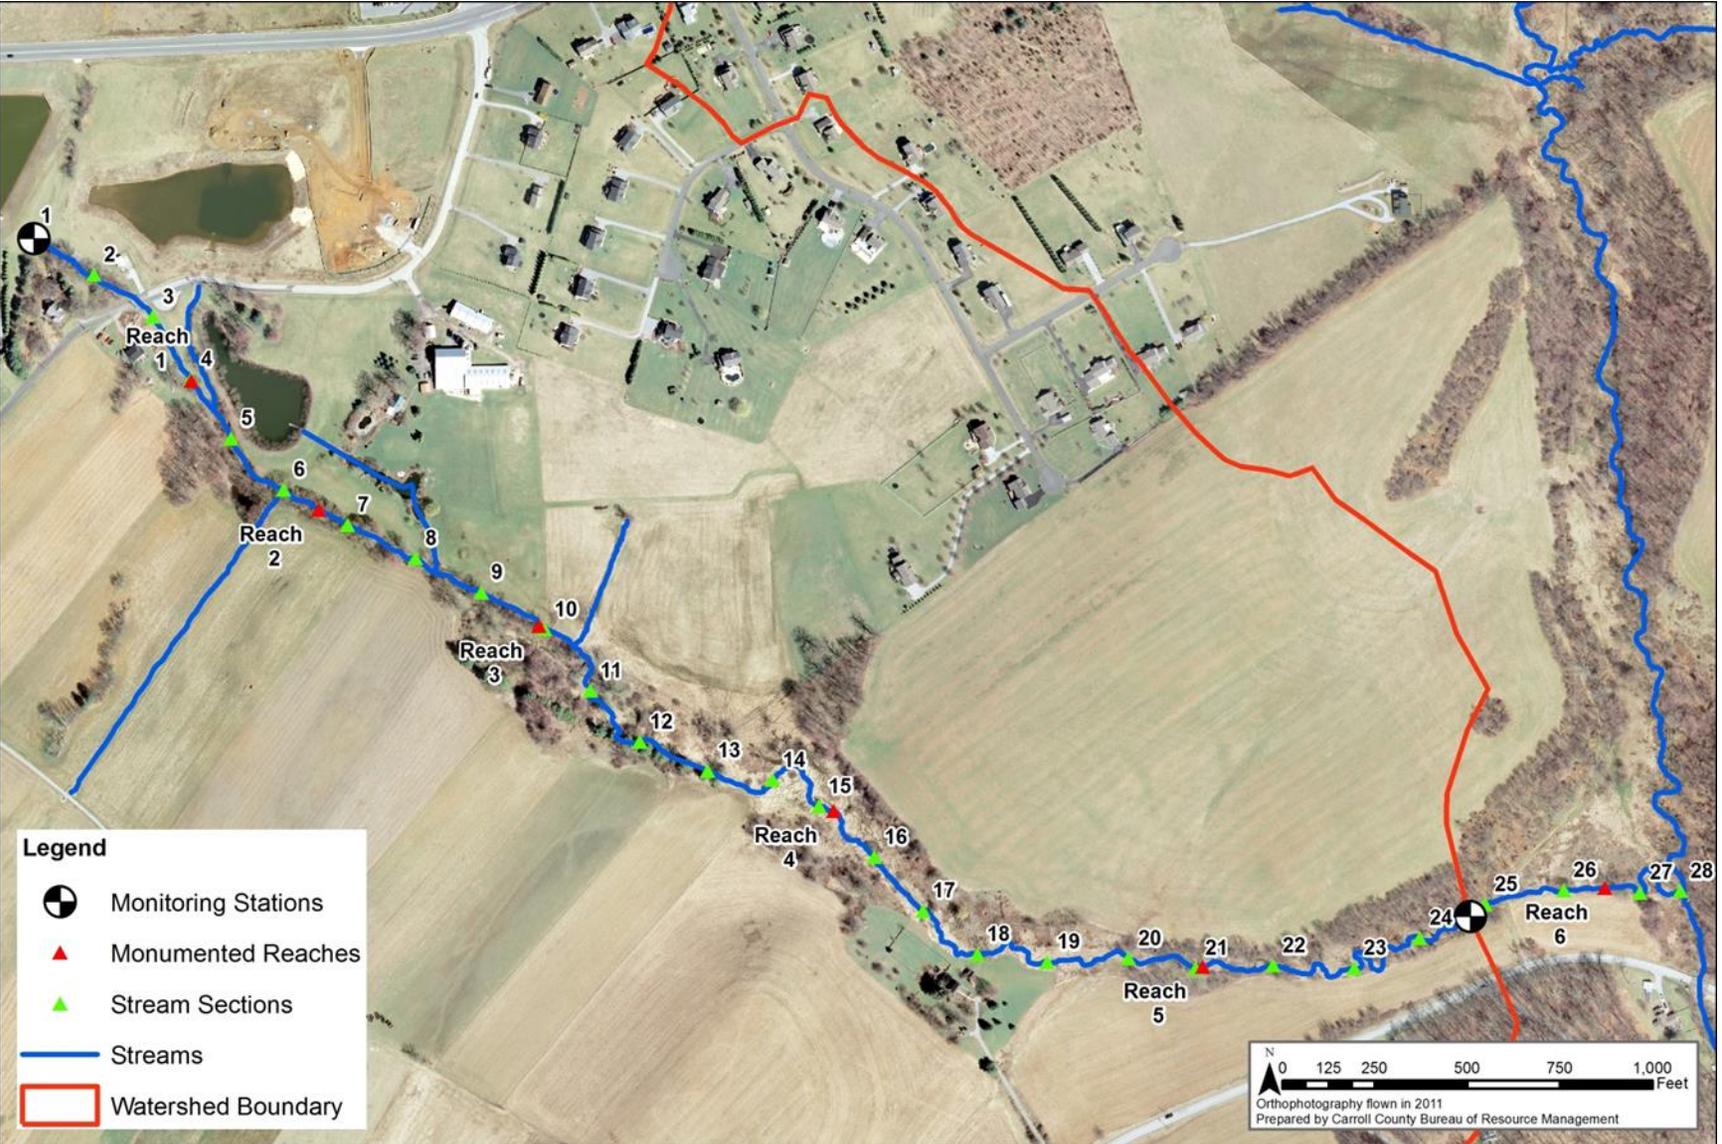
Figure 16: Physical Data Collection Stations

Consistent with past findings, analysis at monumented cross-section six indicates that the stream channel has widened by four feet since 2000, extending from a width of five feet to a width of nine feet. This width is unchanged during the past several years. This monumented cross-section is located approximately 200 feet upstream of the confluence on a straight reach of stream that precedes a series of bends. As is discussed below, this region of the stream has the steepest slope and corresponding highest energy for stream bank erosion. Bank soils in this area are of the Manor Series, which is characterized as highly erodible (USDA, 1969).

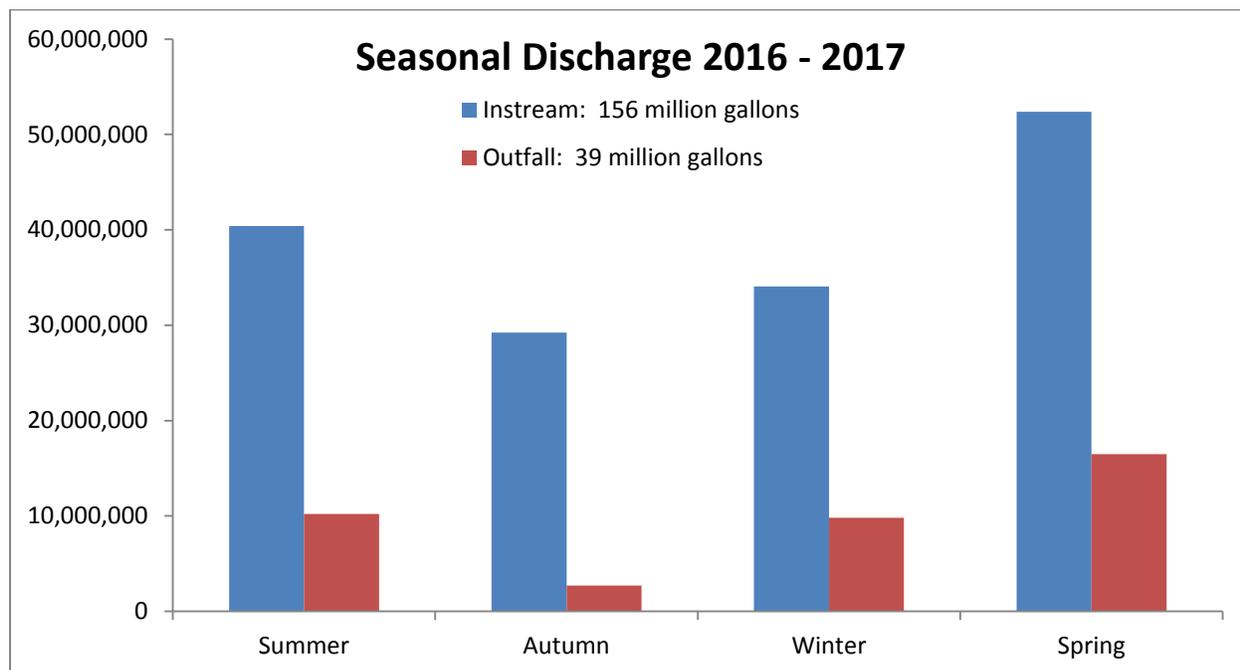
**Figure 21: Seasonal Discharge for the 2016 – 2017 Reporting Year**

percent of the TSS loading occurred in spring at the instream station and 43 percent of total outfall loading occurred during spring. As usual, spring was also the season with greatest loading of Phosphorus and TKN at the instream station with 64 percent and 44 percent of total loading, respectively. Nitrite/Nitrate loading at the instream station, however, was greatest in the summer with 32 percent of the total load occurring during that season. The outfall station relatively consistently correlates to values estimated for the instream station. Observed loadings for all of the metals and TPH were highest in the spring season.

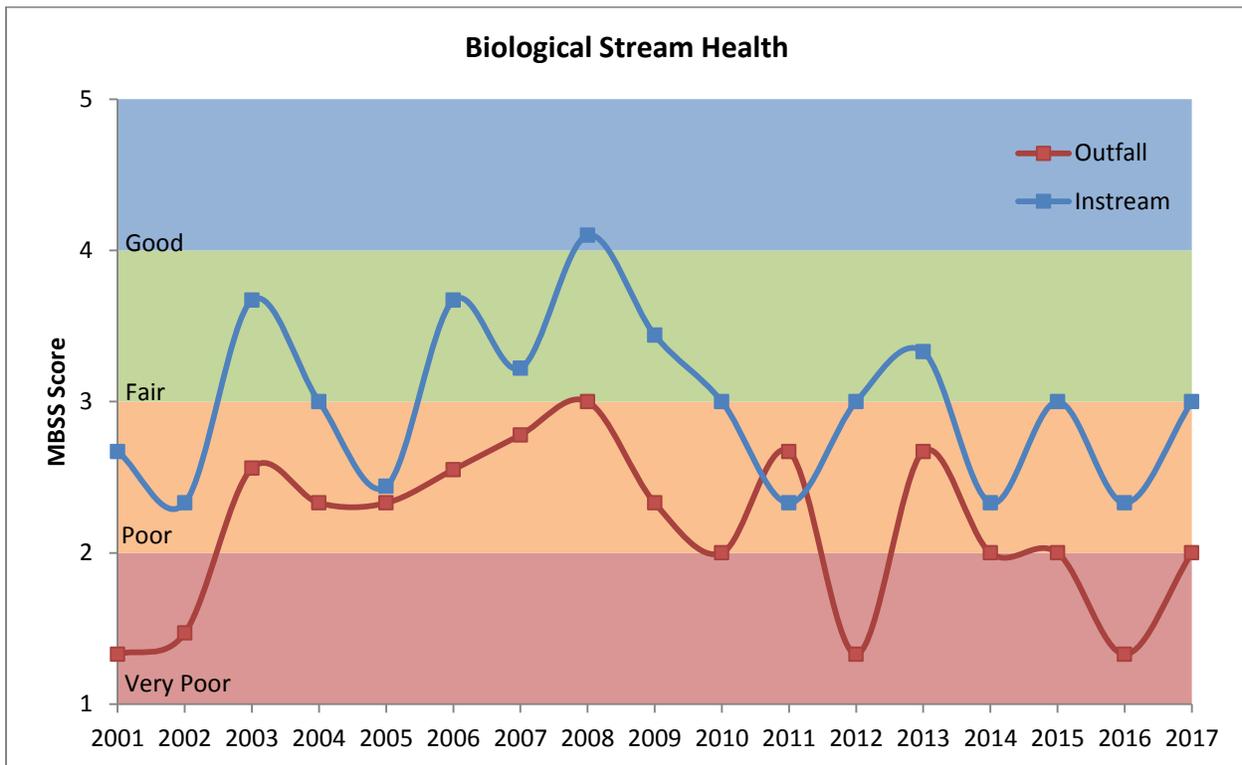
**Figure 22: Macro-Invertebrate IBI Analysis 2001 – 2017**

**Figure 22** presents these scores annually from 2001 through 2017. The trends of both stations appear to be correlative throughout this time period. On average, the score for the instream station remains 0.8 greater than that of the outfall station. The average score for the outfall station is 2.2, which is rated as poor biological health according to MBSS guidelines. The average score for the instream station is 3, which is on the boundary between poor and fair biological health according to MBSS guidelines. This year, the instream reach had a significantly higher number of taxa and individuals, along with a higher score in all but one scoring parameter. Percentage Chironomidae was the only scoring parameter that was the same for both reaches. The outfall station appears to still be relatively intolerable for most sensitive species as only 11 percent of the individuals recovered were considered sensitive with a large percentage of tolerant species present; no Ephemeroptera were observed.

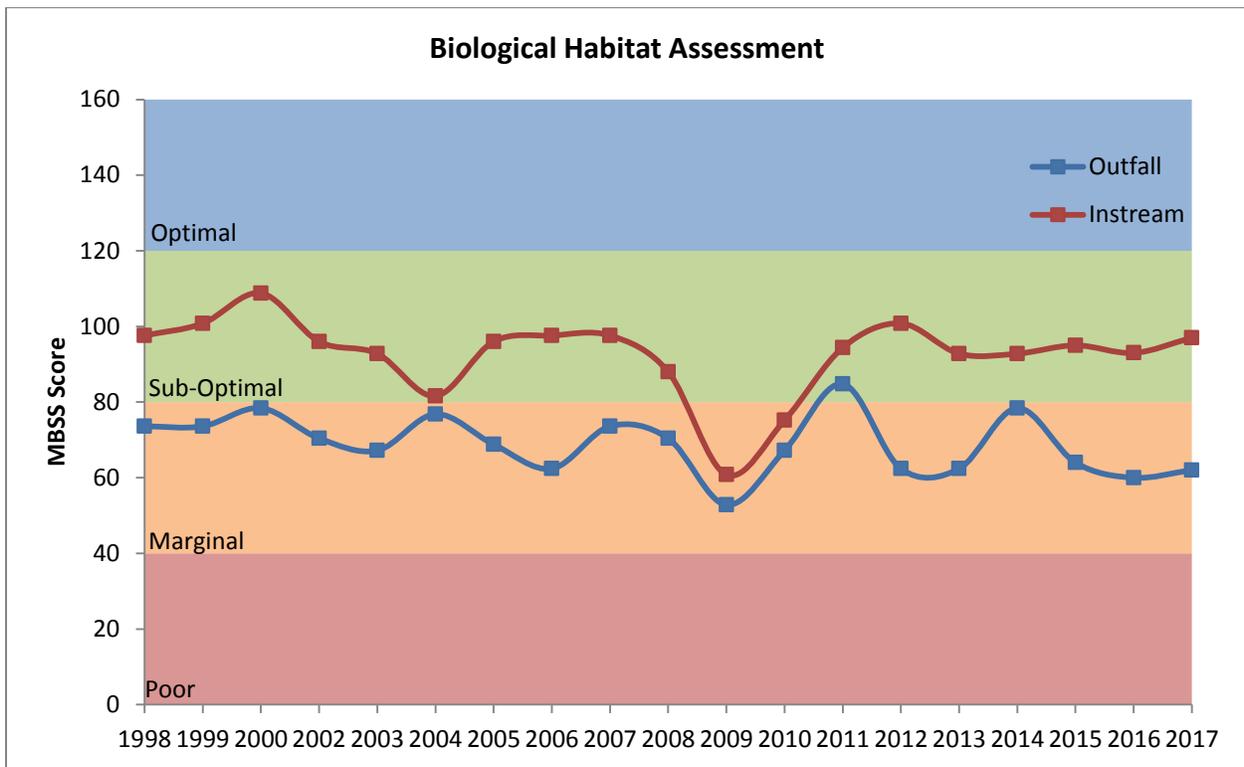
**Figure 23: Comparison of NPDES Station Habitat 1998 – 2017 (Excluding 2001)**

The biological habitat assessment results for each station are summarized in **Table 25**. The scores are of a maximum 160 points based on eight parameters as shown in **Table 16**. Overall, the quality of biological habitat at the instream station remains higher than the outfall station with overall habitat scores of 97 and 62, respectively. From 1998 through 2017 (excluding 2001), as shown in **Figure 23**, the stations have average habitat scores of 92 for the instream station and 69 for the outfall station. This was a fairly typical year for both stations with the instream scoring five points higher and the outfall scoring seven points below average. The weakest parameters for both stations are riffle/run quality, embeddedness, and shading. The outfall station also showed a loss of some stable habitat as it scored lower than the previous years.

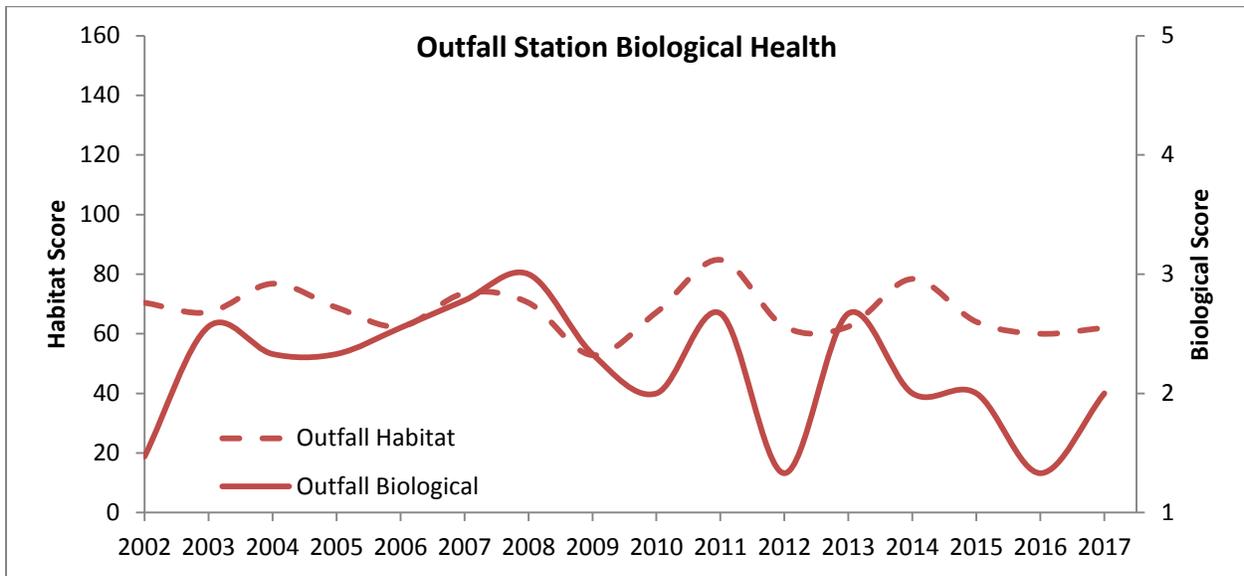
**Figure 24: Comparison of Outfall Station Habitat and Biological IBI Scores 2002 – 2017**

It should be noted that the habitat assessment is wholly subjective. Slight changes may be a result of inconsistencies in assessor(s) scoring methodology. To show a general relationship between the habitat and biological scores, these have been plotted for the outfall and instream stations in **Figures 24 and 25**, respectively. These are plotted on each assessments overall scoring range. Though not unexpected, it is evident that the lower the quality of habitat in this case, the lower the biological quality found in said habitat. Both stations appear to have a one to

two year period of latency between habitat and biological changes. The certainty of any evident relationship is low given the high degree of bias and chance that is probable in these assessments.
