**NATIONAL POLLUTANT DISCHARGE ELIMINATION SYSTEM
MUNICIPAL SEPARATE STORM SEWER SYSTEM
DISCHARGE PERMIT**

2018 ANNUAL REPORT

**CARROLL COUNTY, MARYLAND
NATIONAL POLLUTANT DISCHARGE ELIMINATION SYSTEM (NPDES)
MUNICIPAL SEPARATE STORM SEWER SYSTEM (MS4)
PERMIT**

This document summarizes Carroll County, Maryland's compliance efforts taken in response to conditions attached to the National Pollutant Discharge Elimination System Permit No. 11-DP-3319 (MD0068331) issued for the County's municipal storm sewer systems. Permit No. 11-DP-3319 is required under Section 1342 (p) of the Clean Water Act (ref.: USC, Title 33, Ch. 26, Sub. Ch. IV). It is in response to the specific requirements in 40 CFR122.42(c). This report provides documentation under Carroll County's fourth generation permit from July 1, 2017, through June 30, 2018.

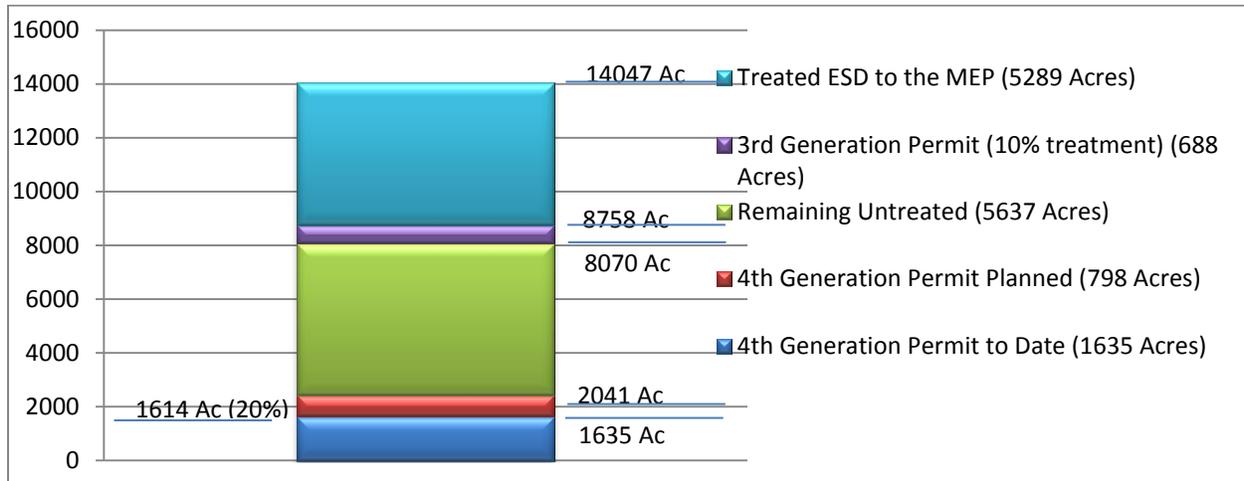
Figure 1: Carroll County Fourth Generation Permit Impervious Surface Analysis

Activities associated with treatment efforts which have been taken during this permit term are listed in **Table 11** "Listing of Watershed Restoration Efforts July 2018 NPDES". Impervious acres treated to date are 1,634.8. There are projects under construction or in design, scheduled for completion in 2019 and 2020 which will treat an additional 798.41 acres bringing the anticipated County total for this permit to 2,433.21 acres. During the next two (2) years, the County anticipates approximately 33 acres of Forested and Grassed Buffer credits through the development process. The County total would then be 2,466 which is 152.8% of the 20% permit requirement of 1,614 acres.

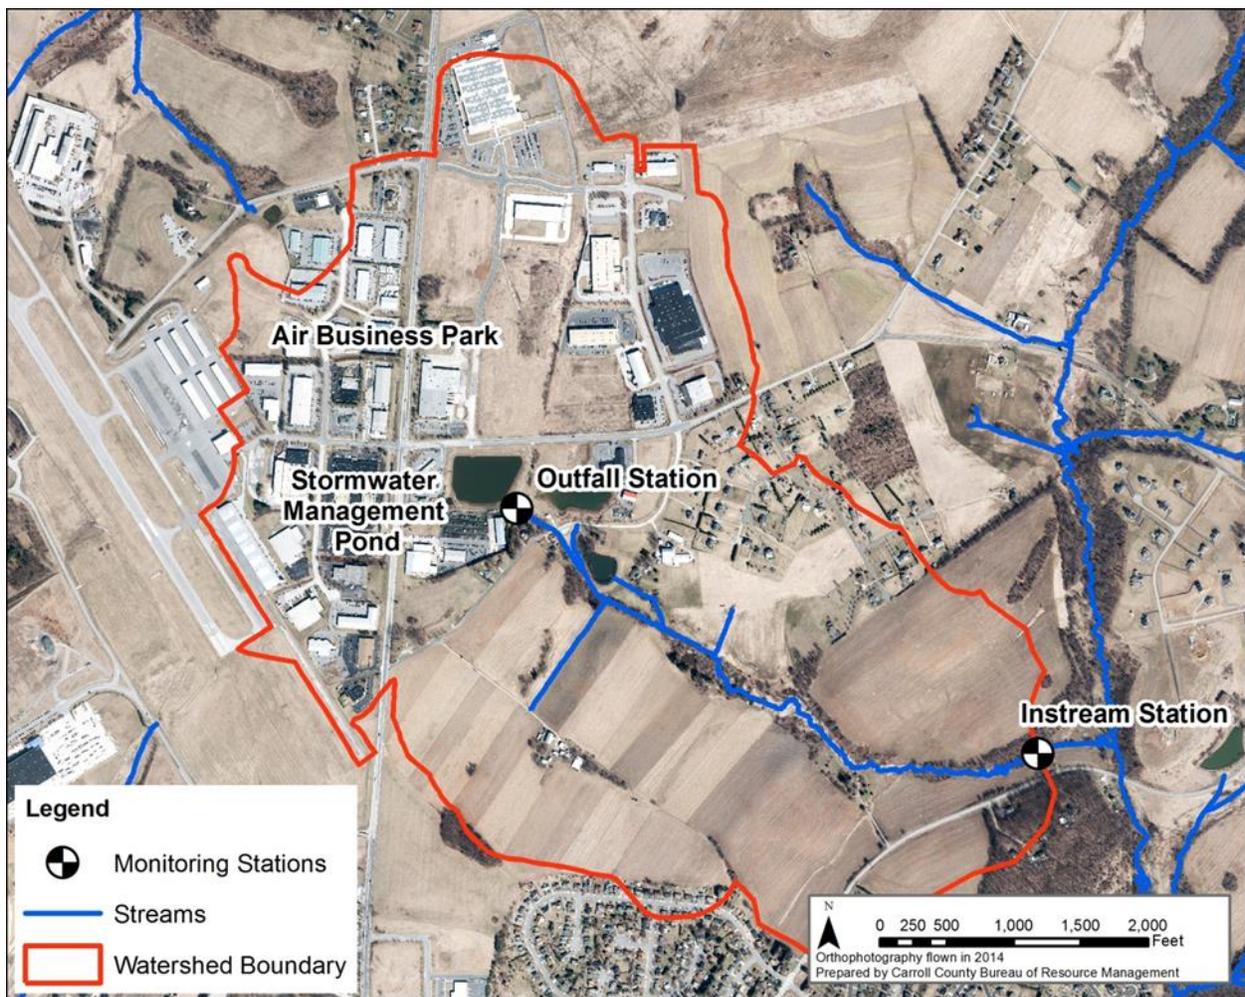
Figure 8: NPDES Discharge Characterization Watershed

The discharge characterization is completed in a first order stream that is a tributary to the West Branch of the North Branch Patapsco River. The location of the watershed where monitoring is conducted within the County is shown in **Figure 7**, while the location of the monitoring stations and other watershed features are shown in **Figure 8**. The study area is located near the topographic divide separating the eastern and western piedmont physiographic provinces. As shown in **Figure 7**, the unnamed tributary drains the upper-most extent of first order tributary and is located in the Liberty Reservoir watershed.

The Air Business Center regional stormwater management facility discharges via a constructed outfall to a small stream that travels southeast to the confluence with the West Branch. The stream receives the majority of water from the pond, with contribution from overland flow from the drainage basin during precipitation events. A new stormwater management pond at the West Branch Trade Center has been constructed adjacent to and east of the Air Business Center stormwater management facility. This facility drains to the stream, just downstream of the outfall station.

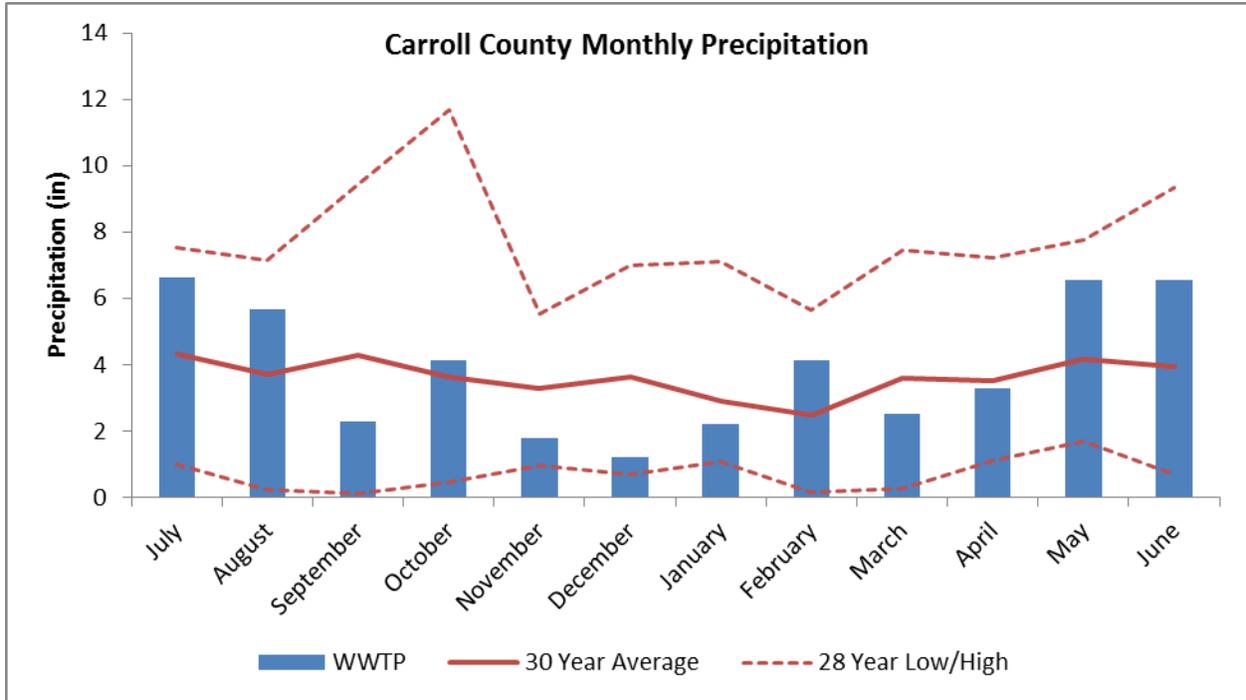
Figure 10: Monthly Precipitation Summary for the 2017 – 2018 Reporting Period

while December 2017 was the driest month with a deficit of 2.45 inches. This reporting year was the fifth wettest year for total precipitation since reporting began at this station in 2000.

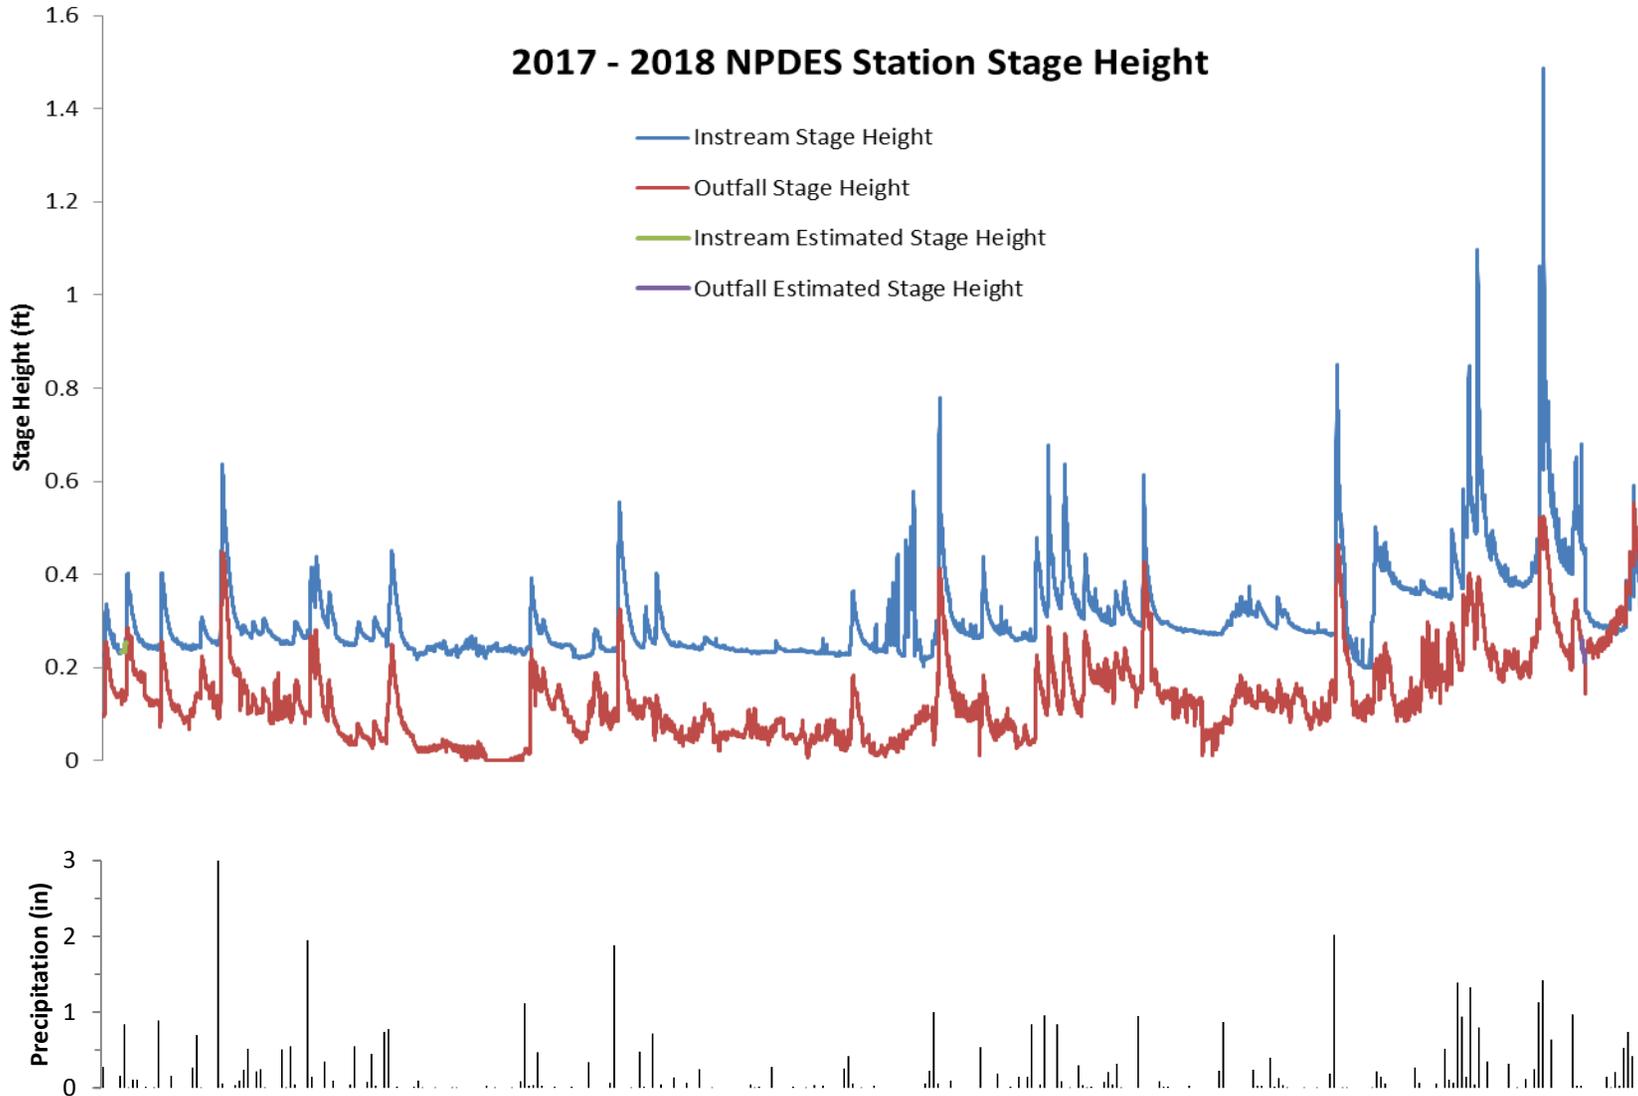
Figure 12: Stage Heights and Daily Precipitation for NPDES Monitoring Stations for the 2017 – 2018 Reporting Year

Storage by the stormwater facility results in peak stage heights less than 0.5 feet at the outfall station except for two storm events on June 2-3, 2018 when 2.55 inches of precipitation was recorded, and June 22-24, 2018 when 1.24 inches of precipitation was recorded during three successive intense storms. The stage reached peak height at close to 0.55 feet with a maximum discharge of 2,026 gallons per minute (gpm). Baseflow at the outfall monitoring station was marginal, typically with a stage height of 0.12 feet. The resulting baseflow discharge was approximately 76 gpm. In general, the storm events were more frequent and slightly more intense than previous years with a higher than normal baseflow.

Typical stage heights observed for the instream monitoring station were approximately 0.28 feet, or 230 gpm. During the June 2-3 storm event, stage height reached the peak for the reporting year at 1.49 feet. The resulting discharge was 17,130 gpm. There was only one other storm event during this time where stage heights above 1 foot (7,833 gpm) were observed. This occurred on May 19, 2018, with peak discharges of 9,451 gpm.

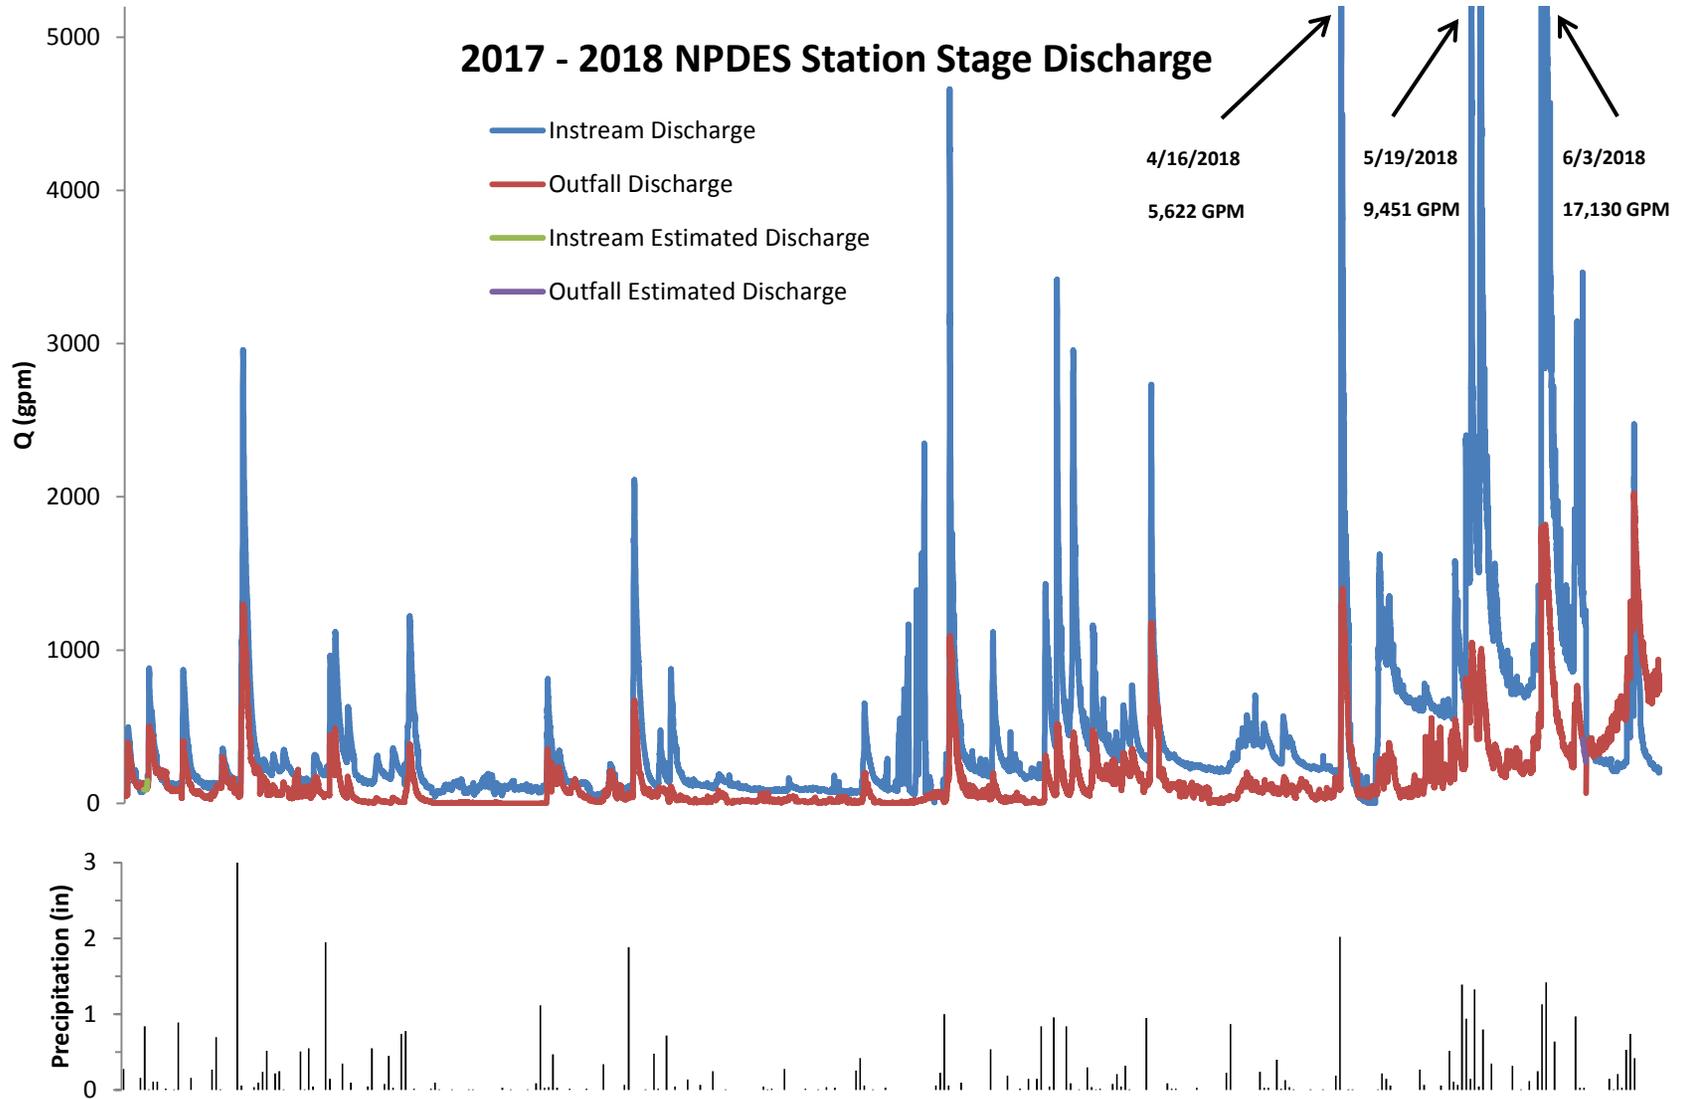
Figure 13: Discharge and Daily Precipitation for NPDES Monitoring Stations for the 2017 – 2018 Reporting Year

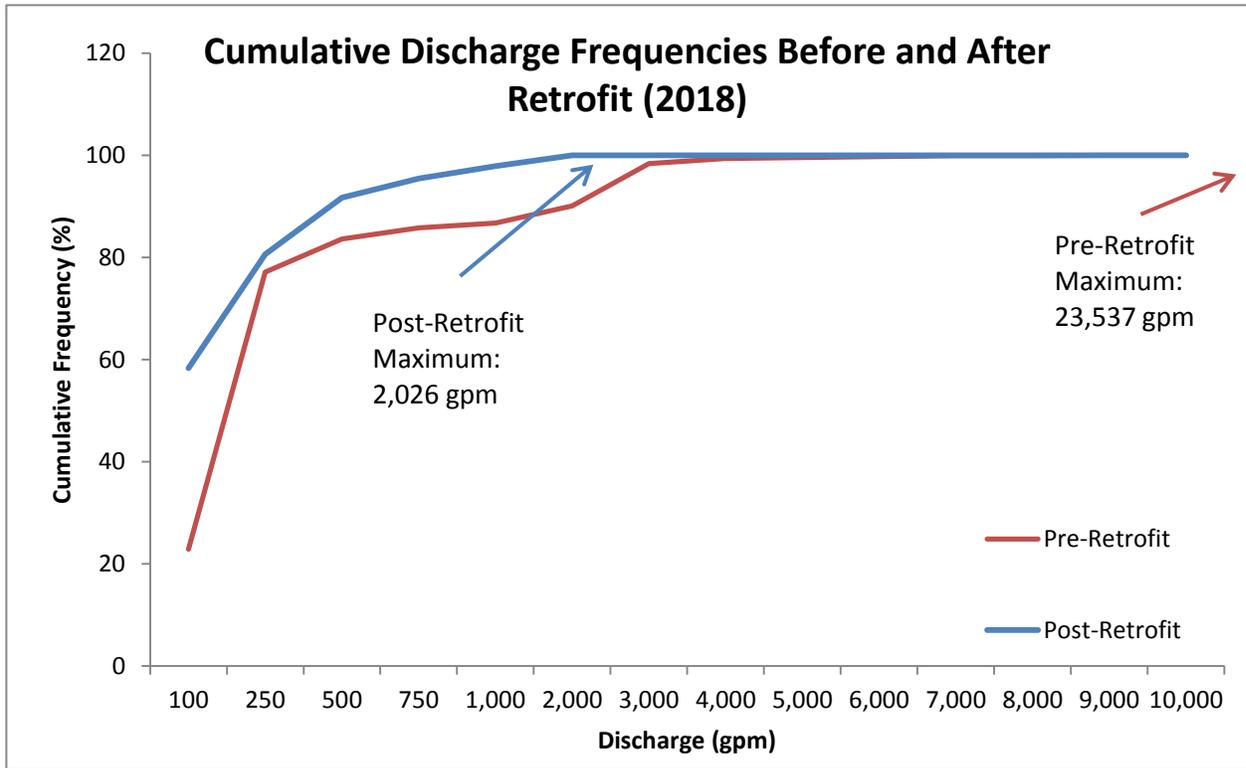
Figure 14: Outfall Discharge Frequencies for 2007 and 2018

To compare pre and post pond retrofit hydrology, cumulative discharge frequency was plotted in **Figure 14**. This figure compares the discharge frequencies from the outfall monitoring station for the 2006 – 2007 and 2017 – 2018 reporting years. The maximum discharge during the pre-retrofit period (2007) was an order of magnitude higher than the post-retrofit period (2018). The maximum discharge in 2007 was 23,537 gpm while the maximum in 2018 was only 2,026 gpm. Additionally, the frequency and magnitude of high discharge events was greater during the pre-retrofit period. 58% of all discharge measurements were below or equal to 100 gpm. This contrasts with the pre-retrofit measurements where only 23% of measurements were below 100 gpm. 10% of all measurements in 2007 were greater than 2,000 gallons per minute, which are greater in magnitude than most of the highest discharges from 2018. Only 1.25 hours during one storm event did the outfall discharge exceed 2,000 gallons per minute in the 2018 reporting year.

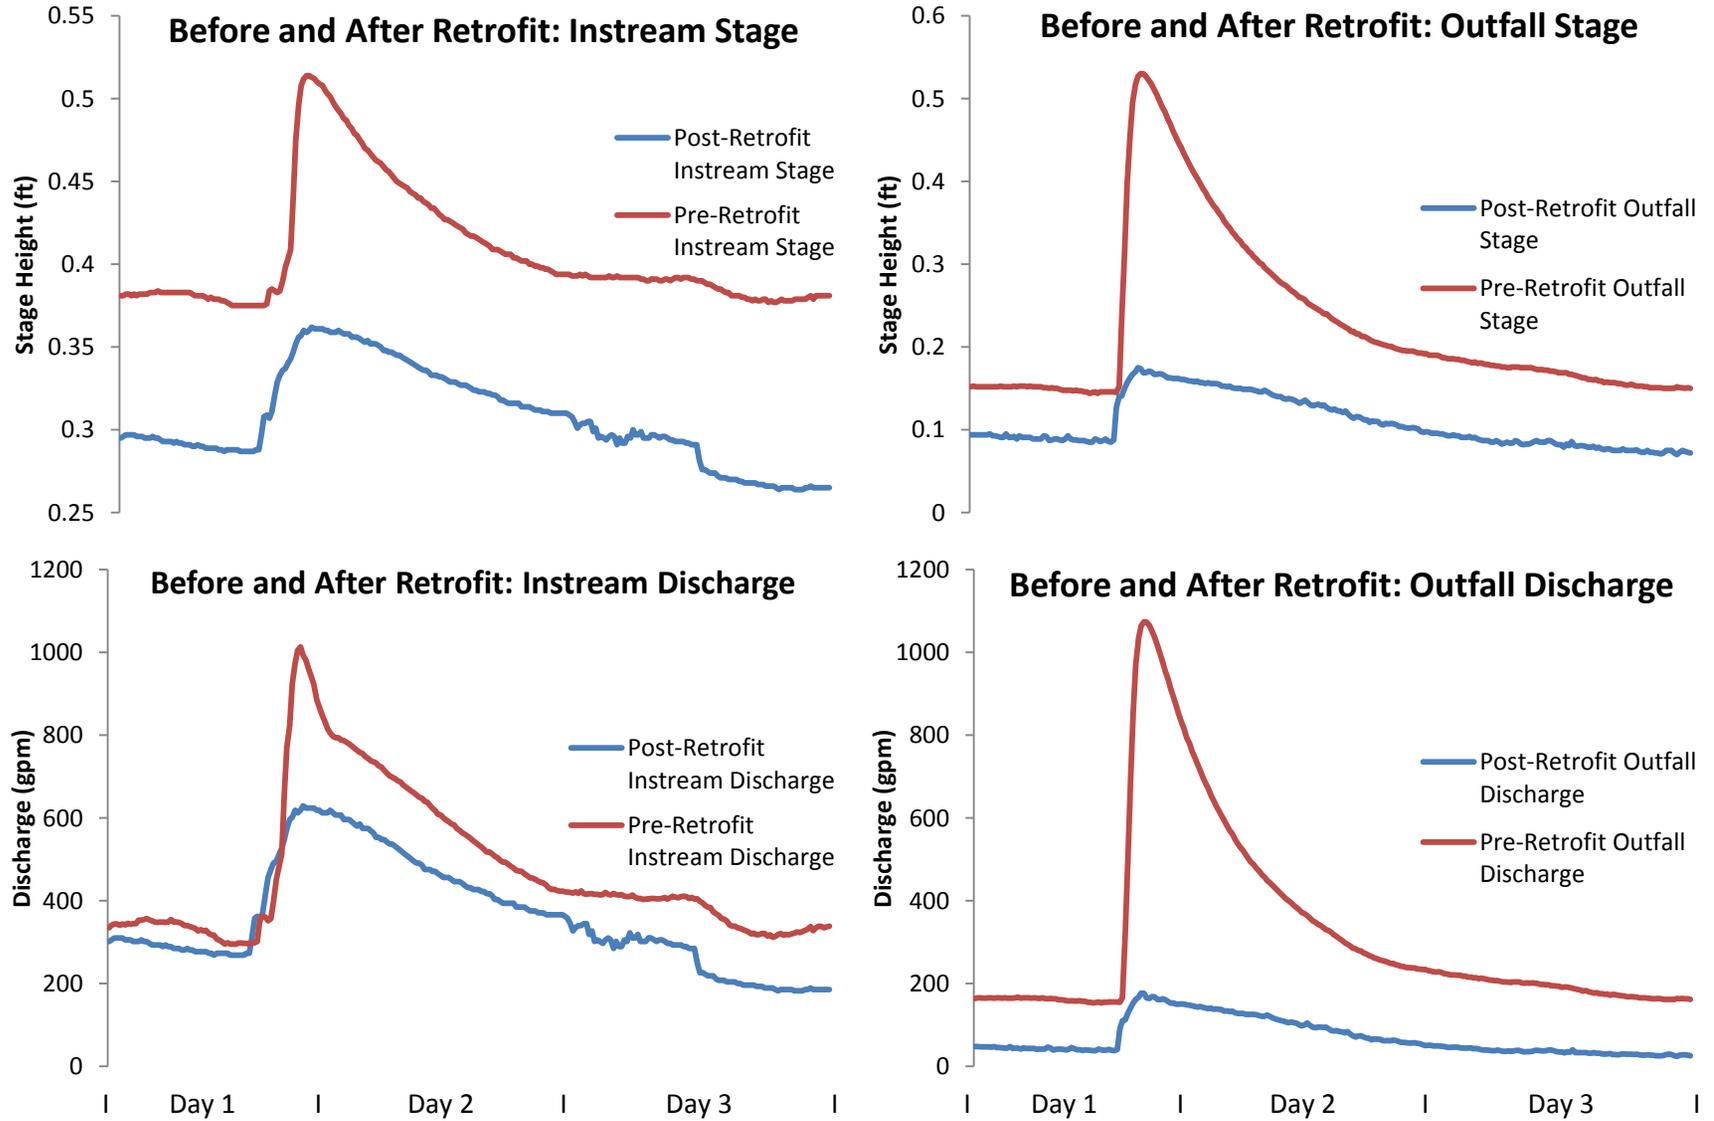
Figure 15: Characteristics of Analogous Storms Pre-Retrofit (7/23/2006, 0.39") and Post-Retrofit (8/22/2017, 0.35")

Looking at individual components of the hydrograph allows one to observe the distinct mechanism behind any changes in cumulative frequencies throughout the year. **Figure 15** represents two analogous storm events, one before and one after the stormwater retrofit, and a hydrological comparison therein. This figure contains hydrographs before and after retrofit for instream and outfall stage heights and discharges. Unlike previous years which compared storm events with nearly identical precipitation totals, this comparison is of a larger storm event to the same pre-retrofit storm. The pre-retrofit event had 0.39 inches of precipitation observed while the post-retrofit event had 0.35 inches of precipitation observed. The post-retrofit storm was a higher intensity event despite having a lower precipitation total. Despite the higher precipitation intensity, the ascending limb for the post-retrofit outfall station still had a lower slope and peak discharge than the hydrograph of the pre-retrofit outfall station. The outfall to instream station discharge ratio for the post-retrofit storm event averaged a ~17% contribution, peaking at 35% as was roughly the case for the overall discharge and separated stormflow for the reporting period. During the pre-retrofit storm however, the outfall station contributed ~70% of the total instream discharge. The lesser contribution during the post-retrofit storm event is evident in the instream station hydrographs. The post-retrofit storm event at the instream station has a lower volume discharged compared to the pre-retrofit storm. The storm hydrographs look similar apart from the lesser volume. The period of baseflow recession after the storm event was similar to the pre-retrofit storm as well. Overall, longer baseflow recessions and lower peak discharges were observed with the current stormwater configuration.

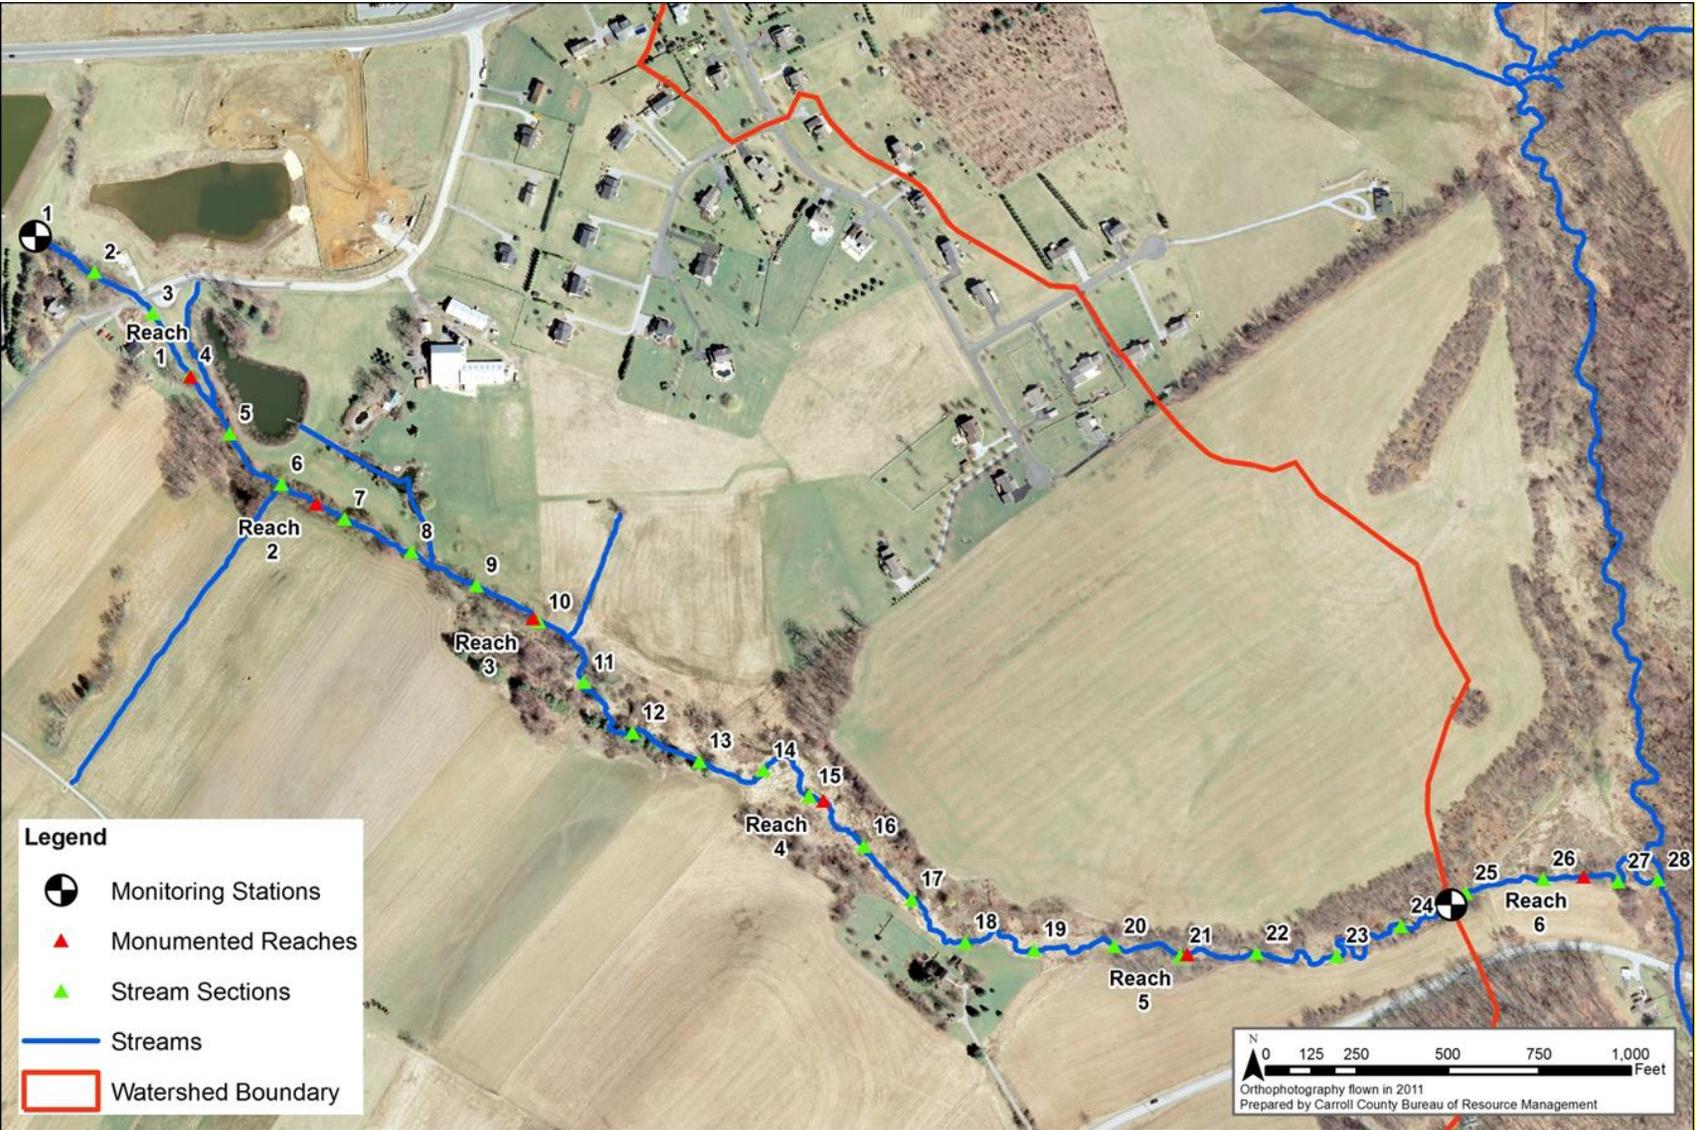
Figure 16: Physical Data Collection Stations

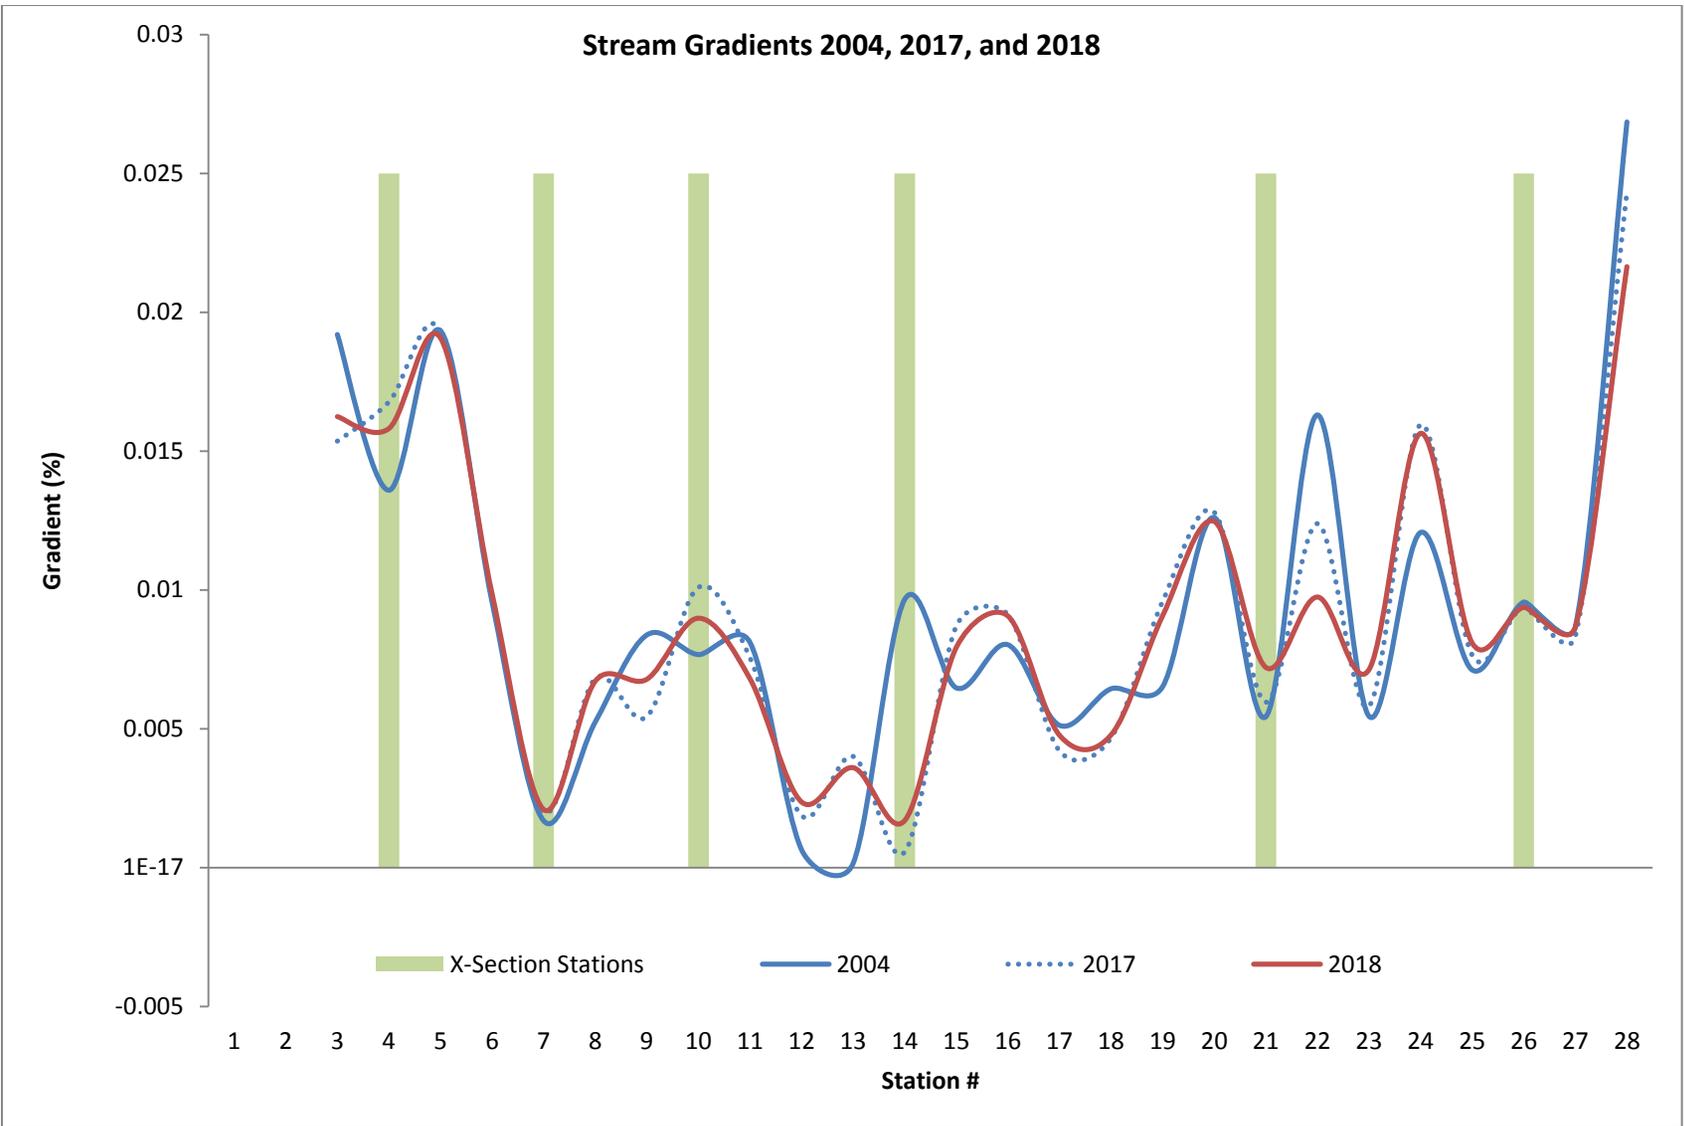
Figure 17: Stream Gradient Change from 2004 – 2018

Table 18 displays thalweg elevation and section gradient for selected years from 2004 through 2018. One notable observation from the table is the low gradients found in the center section of the tributary. This observation coincides with the section four stream survey which discovered locally significant sediment deposition from year to year, which one would expect to find in an area with low gradients. **Figure 17** displays stream gradients from the current reporting year (2018), 2017, and 2004 as a longitudinal profile along with the locations of the six monumented stream reaches. The overall average gradient has remained unchanged over this period and has remained a gentle slope with only one section above a two percent gradient, but some individual sections have changed significantly. In general, increases in gradient between stations are indicative of higher energy and potential for increased channel scour. The first third of the stream profile has remained relatively unchanged during this period, but the gradient is generally higher than that of the final two thirds of the tributary. This can be seen in the survey of monumented section one where the stream channel has moved laterally approximately two to three feet over this period. The gradient has changed significantly over the second third of the stream profile and ranges from 0.02% to 1.26%. These ever-changing low gradients can explain why there is so much deposition at monumented section four which has roughly a flat gradient. The final third of the stream profile changes gradient a number of times, but slopes are relatively similar for 2018 and 2004; the slope at station 22 has a decreasing gradient while station 24 has an increasing gradient over time. **Figure 18** displays the longitudinal stream profile for elevation and depth of deposition or incision at each of the 28 sections along the profile. Included are the six monumented reaches for reference. The profile shows the low gradients in the center section of the stream and that the areas with lowest gradient have moved down stream, the cause of elevated deposition at monumented reach four. Aggradation and degradation is most significant in the center section of the stream. For the first time in ten years, one station (22) has exceeded one foot elevation change for this reporting year, but most stations are significantly less. Since the stream has two small tributaries, varying bends and straight segments, as well as a number of soils series represented along the channel, it is important to monitor the physical characteristics of the stream channel over time.

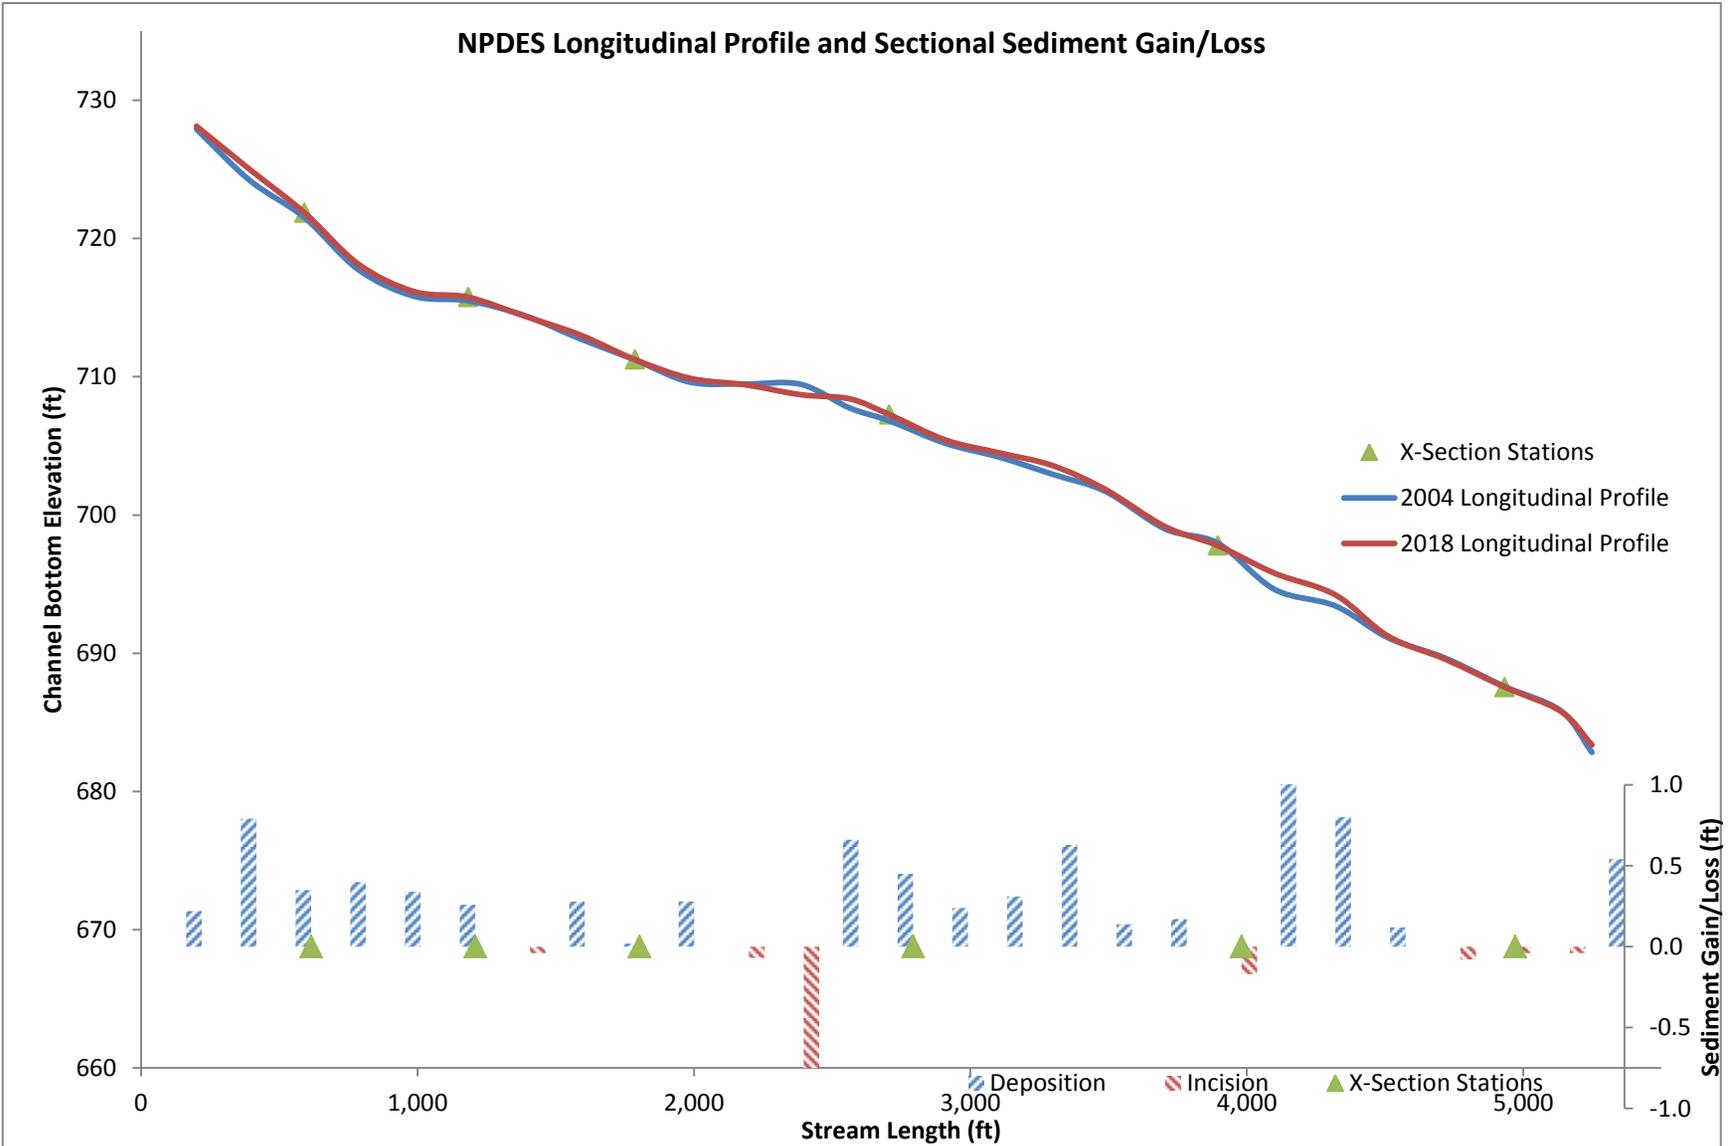
Figure 18: Comparison of Longitudinal Profile and Sectional Deposition/Incision from 2004 - 2018

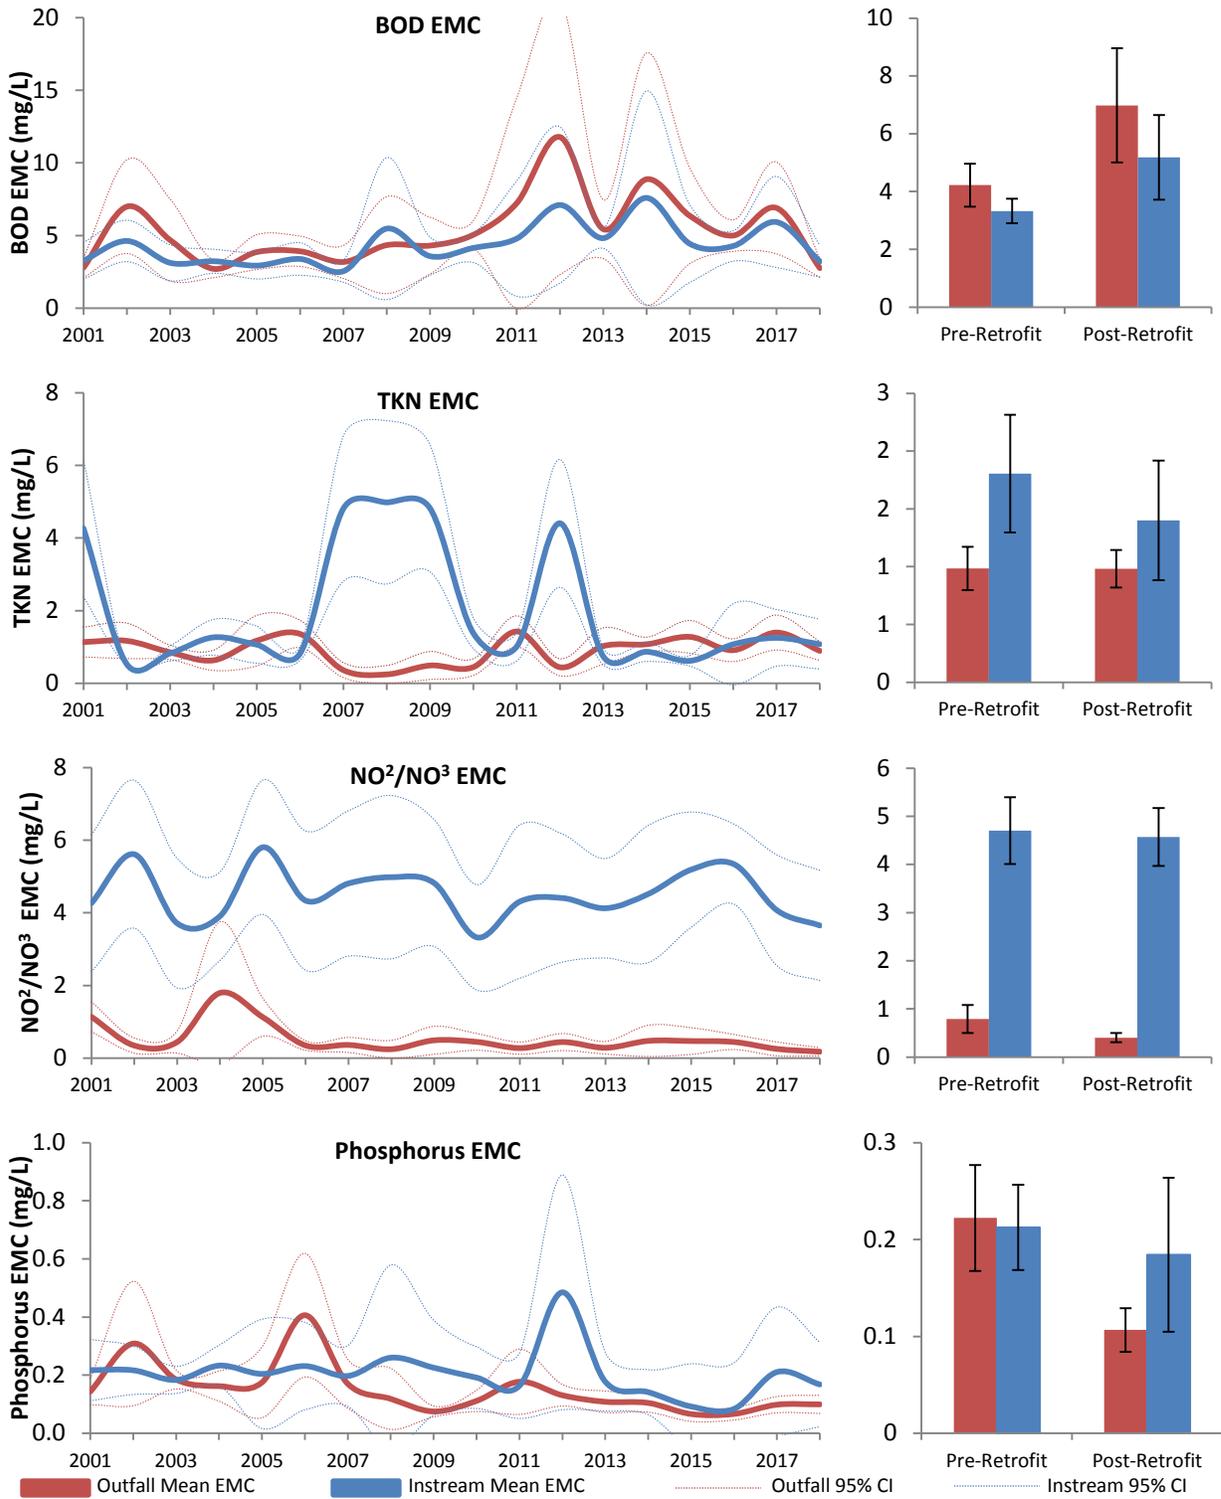
Figure 19: EMC Values from 2001 – 2018 for BOD, TKN, NO²/NO³, and Phosphorus

Figures 19 and 20 present annual mean EMC values for eight analytes from the 2001 through 2018 reporting years. Also presented are mean EMC values before and after the stormwater retrofit. The only analyte with a significant observed difference between the outfall and instream stations consistently from 2001 – 2018 was Nitrites/Nitrates; the pre and post retrofit graph reinforces this difference. Though not all mean EMC values were significantly different for the three metals at the instream station, all EMC values for Copper, Lead, and Zinc decreased at the outfall station after the retrofit. This is not unexpected given the increased residence within the stormwater facility. Please note that a single outlying measurement in July 2014 caused a large increase in average Zinc for that reporting year.

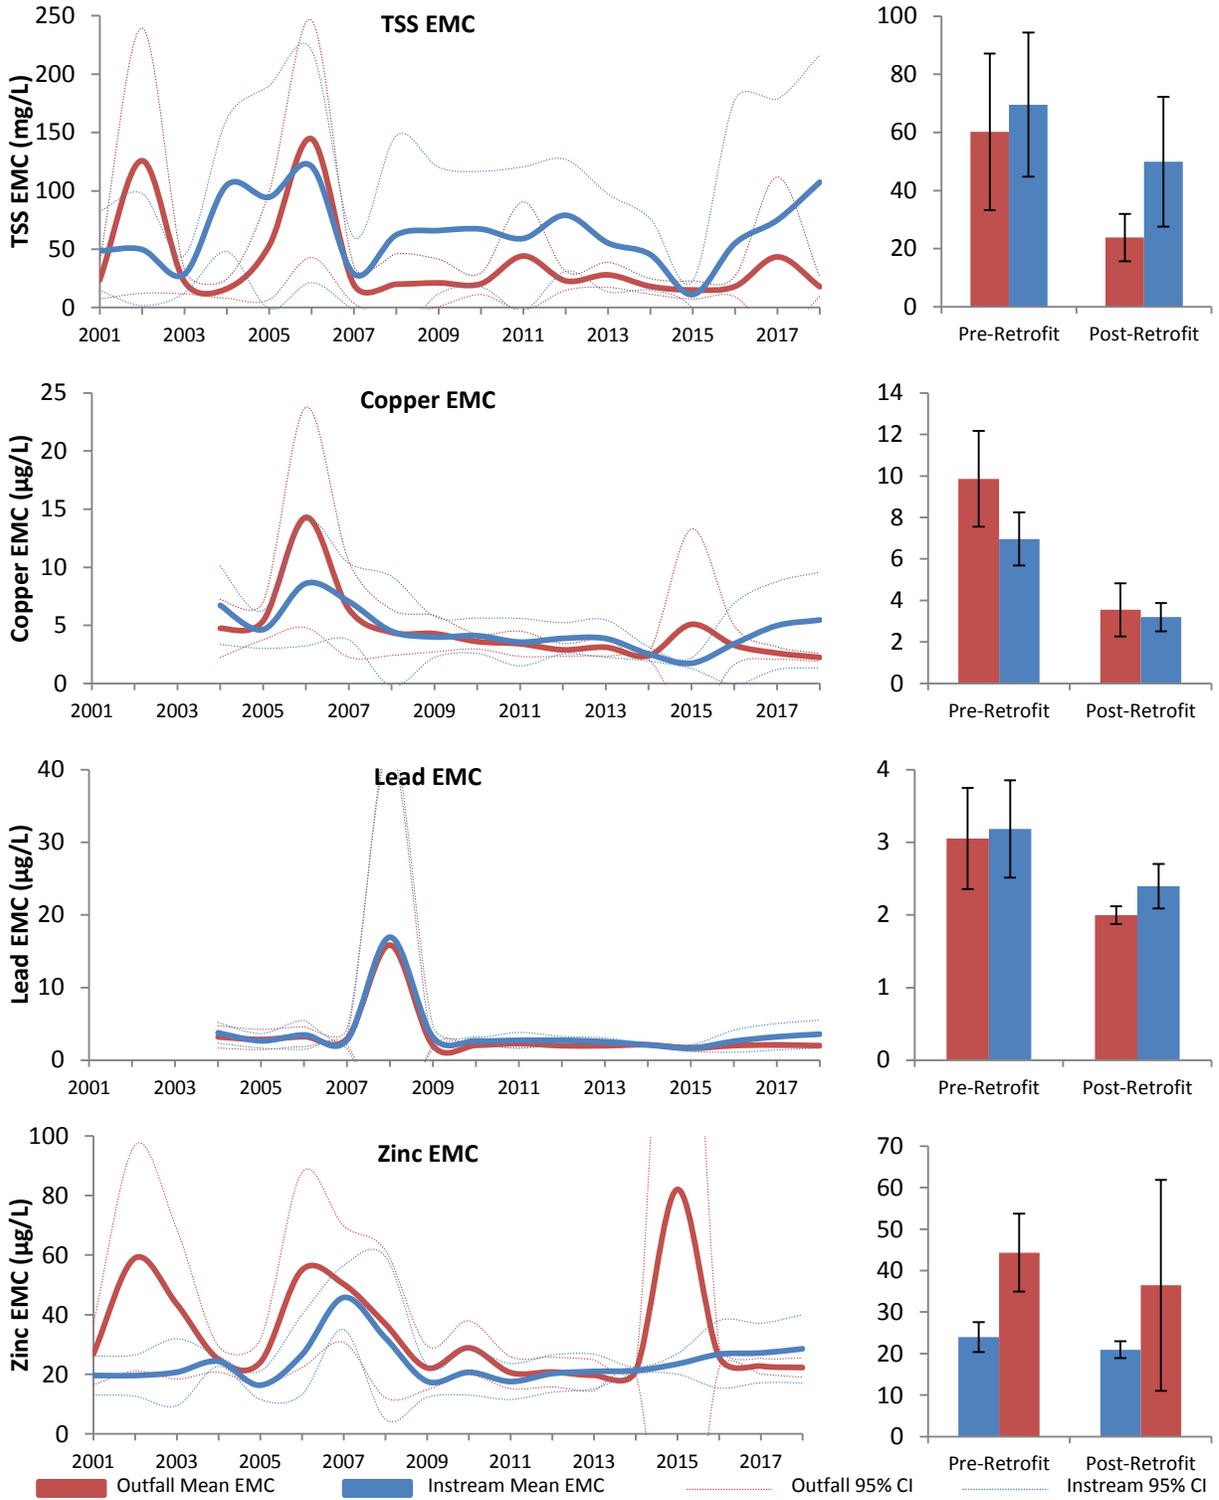
Figure 20: EMC Values from 2001 – 2018 for TSS, Copper, Lead, and Zinc

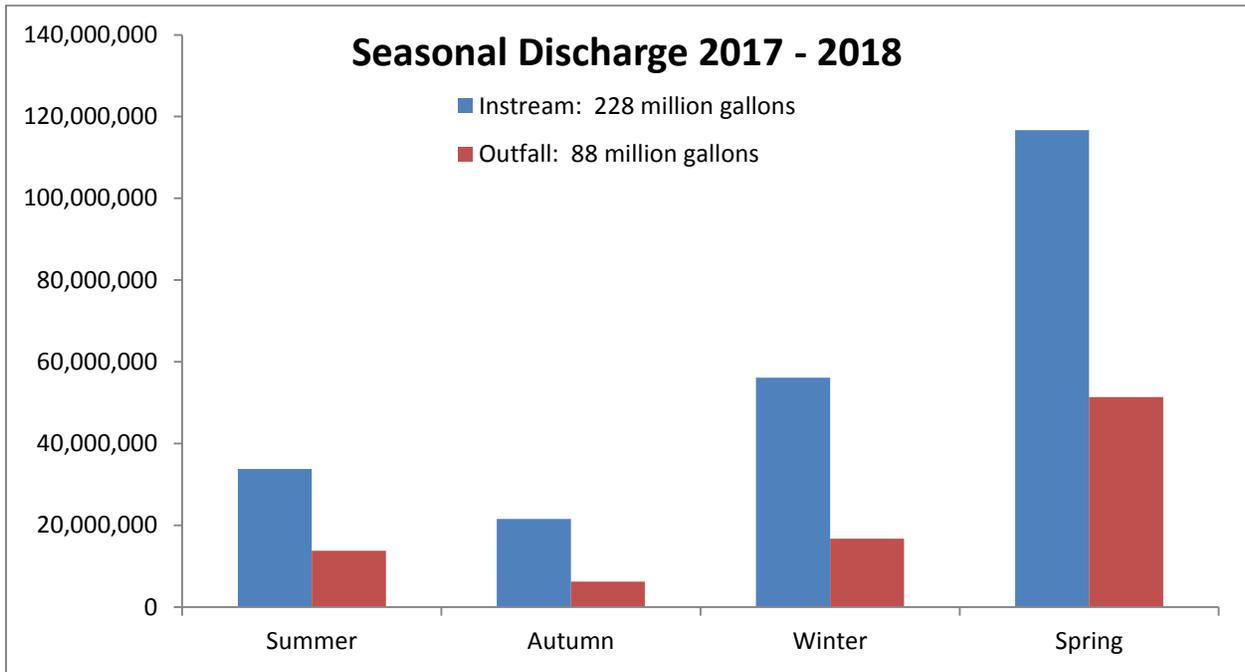
Figure 21: Seasonal Discharge for the 2017 – 2018 Reporting Year

instream station. Phosphorus, TSS, and Copper had a range of 81% to 85% of total chemical loading occur during the spring season. Loading during autumn was the lowest for all but one analyte due to lack of precipitation, while summer and winter loadings were mixed. Average loadings during autumn were generally 6% with loadings during summer and winter averaging around 15% of total yearly loading. The outfall station relatively consistently correlates to values estimated for the instream station. Observed loadings for TPH were highest in the spring season. It should be noted that for loading calculation, the detection limit concentrations were used instead of zero values with samples below detection. Therefore, actual loadings are likely less than values displayed below. All TPH samples were below detection during the reporting year so any differences are due to differences in flow volume.
