**NATIONAL POLLUTANT DISCHARGE ELIMINATION SYSTEM
MUNICIPAL SEPARATE STORM SEWER SYSTEM
DISCHARGE PERMIT**

2018 ANNUAL REPORT

**CARROLL COUNTY, MARYLAND
NATIONAL POLLUTANT DISCHARGE ELIMINATION SYSTEM (NPDES)
MUNICIPAL SEPARATE STORM SEWER SYSTEM (MS4)
PERMIT**

This document summarizes Carroll County, Maryland's compliance efforts taken in response to conditions attached to the National Pollutant Discharge Elimination System Permit No. 11-DP-3319 (MD0068331) issued for the County's municipal storm sewer systems. Permit No. 11-DP-3319 is required under Section 1342 (p) of the Clean Water Act (ref.: USC, Title 33, Ch. 26, Sub. Ch. IV). It is in response to the specific requirements in 40 CFR122.42(c). This report provides documentation under Carroll County's fourth generation permit from July 1, 2017, through June 30, 2018.

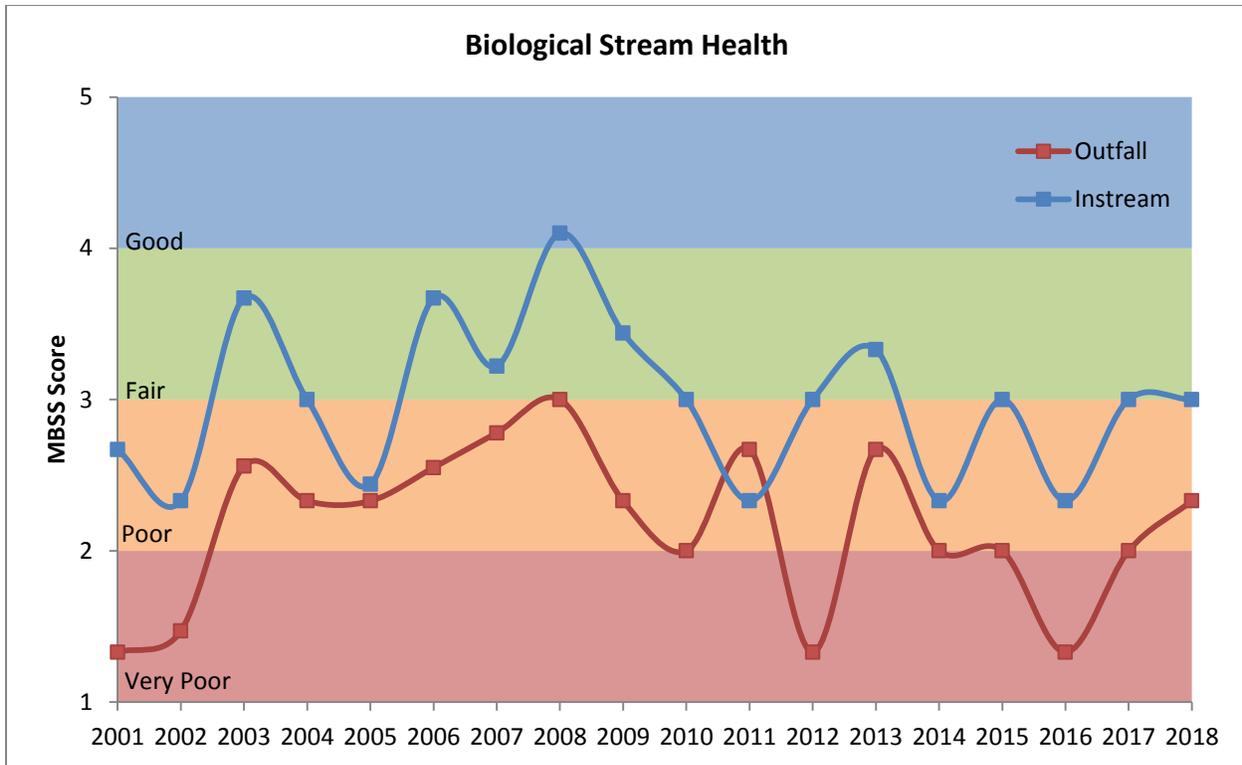
Figure 22: Macro-Invertebrate IBI Analysis 2001 – 2018

Figure 22 presents these scores annually from 2001 through 2018. The trends of both stations appear to be correlative throughout this time period. On average, the score for the instream station remains 0.8 greater than that of the outfall station. The average score for the outfall station is 2.2, which is rated as poor biological health according to MBSS guidelines. The average score for the instream station is 3, which is on the boundary between poor and fair biological health according to MBSS guidelines. The outfall reach had a similar score as the previous year; the only metric that changed was the number of taxa, which increased the score from 3 to 5. The instream reach score remained the same as the previous year. While the number of taxa was fewer than the previous year, the % of clingers in the sample increased. Both stations appear to be relatively intolerable for sensitive species, particularly within the outfall reach where no sensitive species were observed.

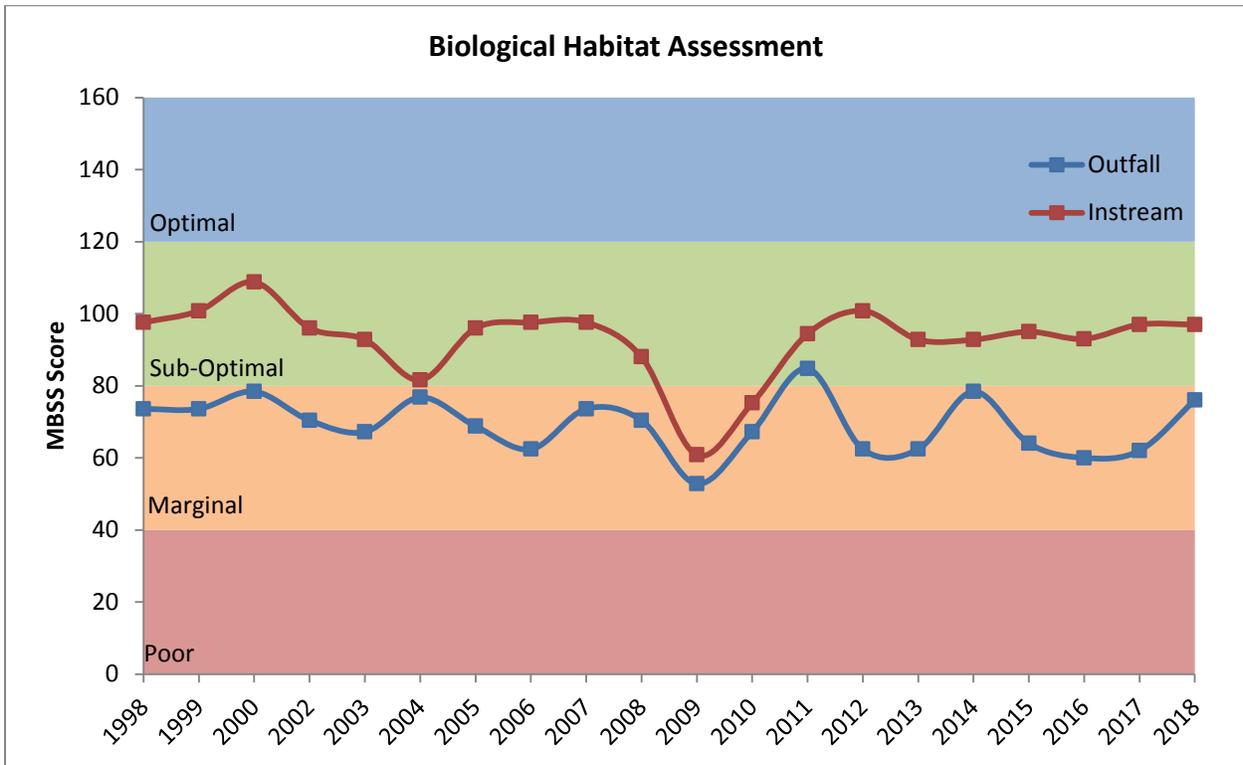
Figure 23: Comparison of NPDES Station Habitat 1998 – 2018 (Excluding 2001)

It should be noted that the habitat assessment is wholly subjective. Slight changes may be a result of inconsistencies in assessor(s) scoring methodology. To show a general relationship between the habitat and biological scores, these have been plotted for the outfall and instream stations in **Figures 24 and 25**, respectively. These are plotted on each assessments overall scoring range. Though not unexpected, it is evident that the lower the quality of habitat in this

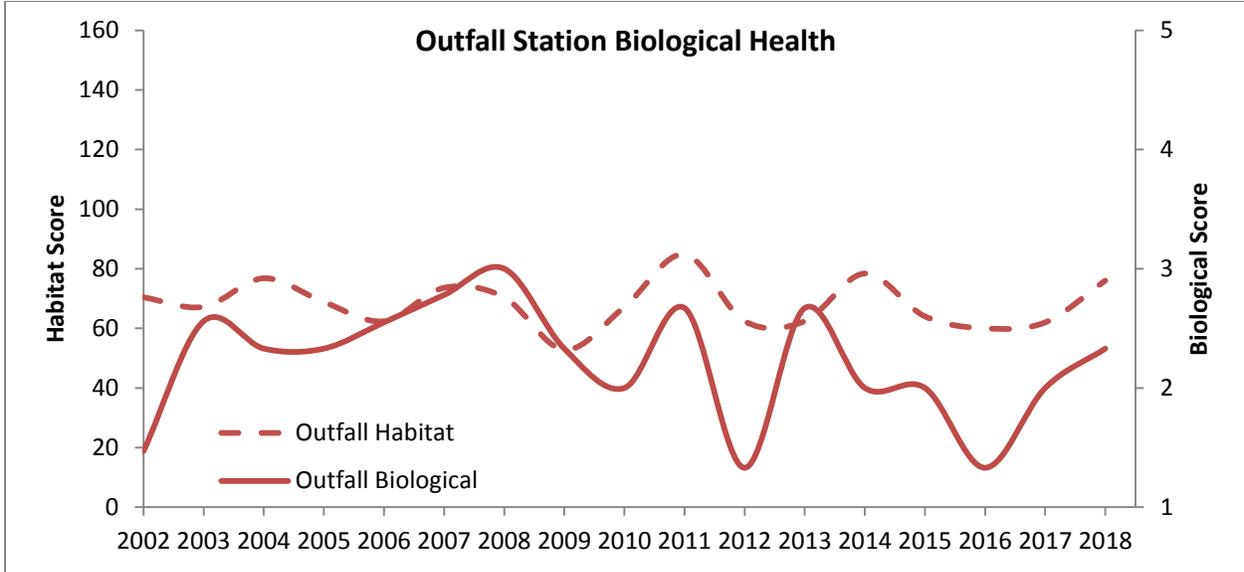
Figure 24: Comparison of Outfall Station Habitat and Biological IBI Scores 2002 – 2018

case, the lower the biological quality found in said habitat. Both stations appear to have a one to two year period of latency between habitat and biological changes. The certainty of any evident relationship is low given the high degree of bias and chance that is probable in these assessments.

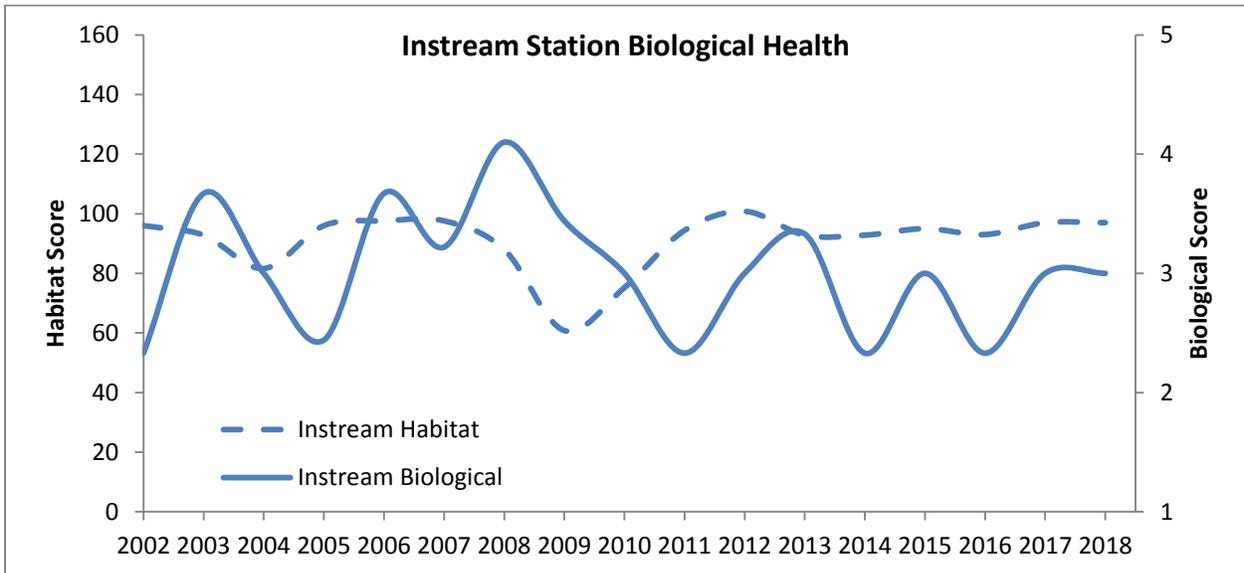
Figure 25: Comparison of Instream Station Habitat and Biological IBI Scores 2002 – 2018

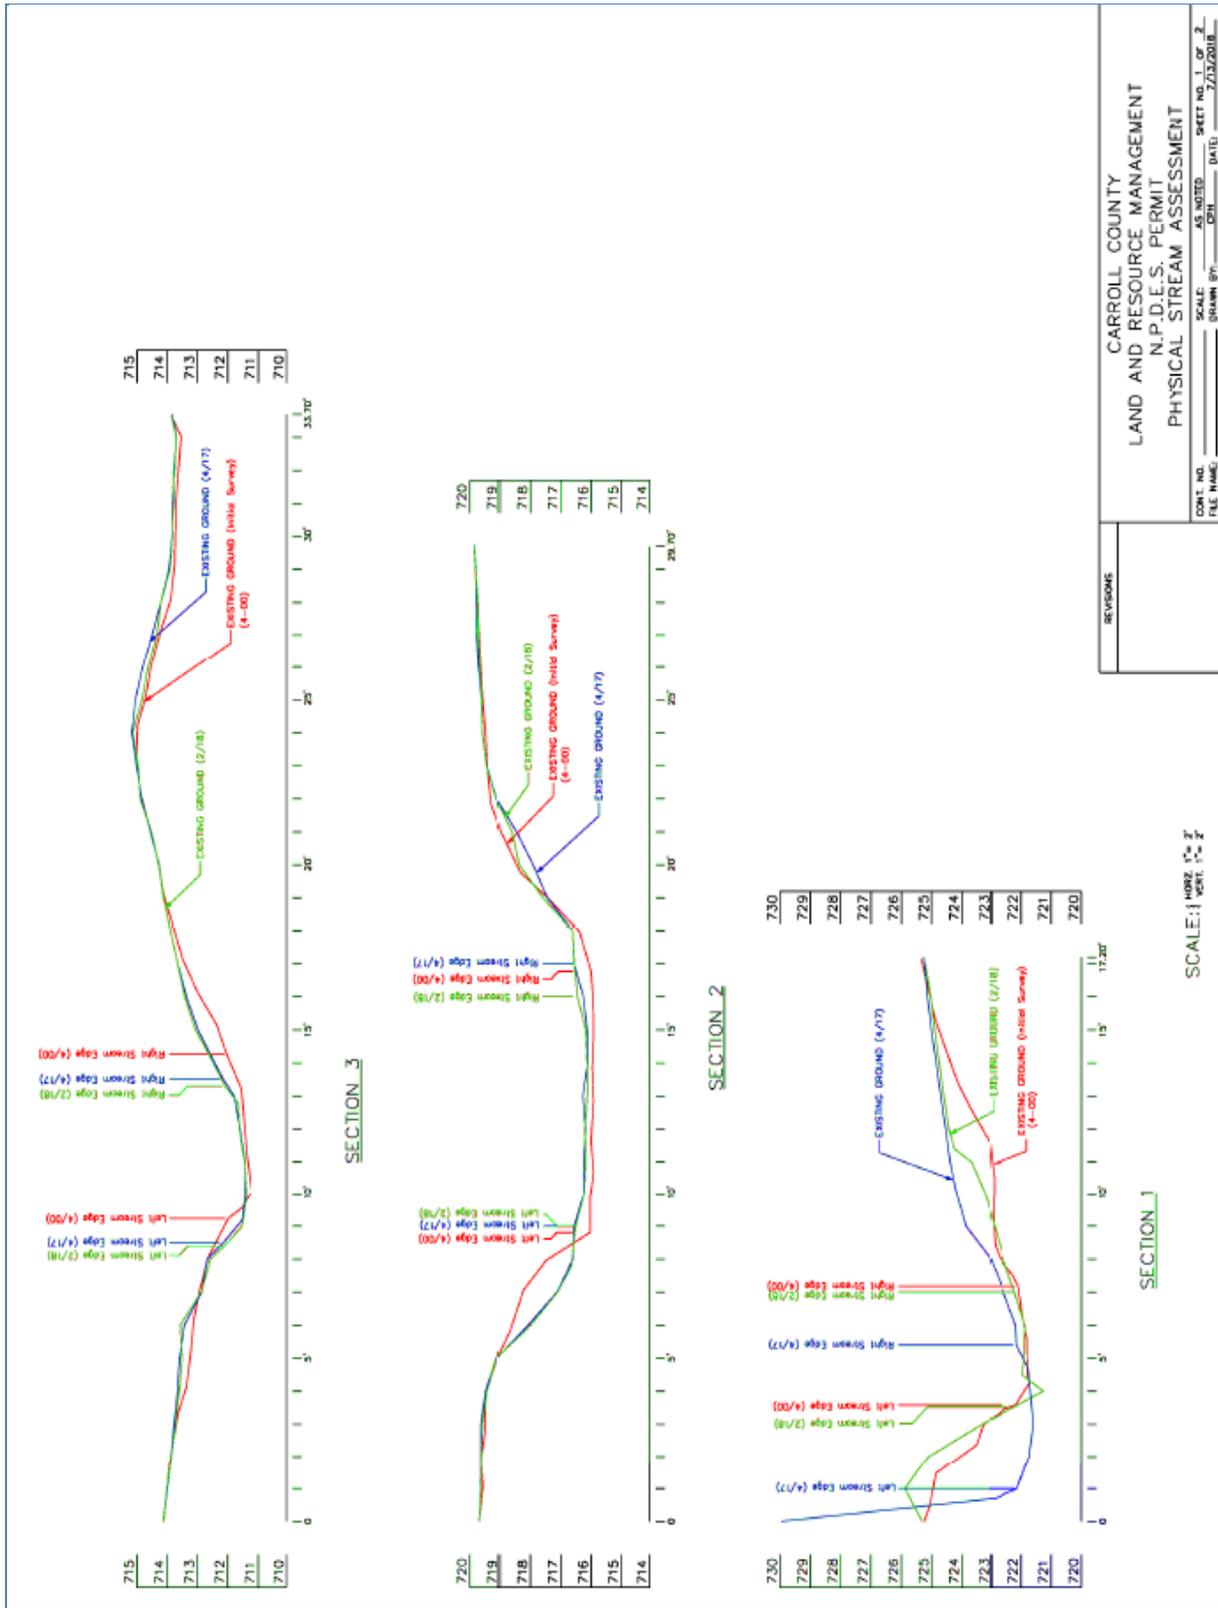
- **Physical Stream Assessment, Sections 1-6 (graphs)**

REVISIONS	CARROLL COUNTY LAND AND RESOURCE MANAGEMENT N.P.D.E.S. PERMIT PHYSICAL STREAM ASSESSMENT
CONF. NO.	AS NOTED
FILE NAME	DATE: 7/13/2018
DRAWN BY	SCALE

Cross-sections two and three are still generally unchanged since 2000, with only minor changes in stream channel shape. Located approximately 65 feet downstream of a series of bends and two draws, section four has shown relatively significant aggradation and narrowing of the channel since 2000. The channel bottom and associated floodplain have been elevated by almost one foot since 2000. In the past year, the channel bottom has moved slightly, cutting and steepening the left bank. This aggradation explains the reduction of stream gradient from approximately 1% to 0% over the previous 11 years. Section five is essentially unchanged since 2000; however, the channel has widened and moved slightly west over the last 18 years. Over the past year, some aggradation occurred along the east bank, narrowing the channel slightly.

Consistent with past findings, analysis at monumented cross-section six indicates that the stream channel has widened by four feet since 2000, extending from a width of five feet to a width of nine feet. This width is unchanged during the past several years. This monumented cross-section is located approximately 200 feet upstream of the confluence on a straight reach of stream that precedes a series of bends. As is discussed below, this region of the stream has the steepest slope and corresponding highest energy for stream bank erosion. Bank soils in this area are of the Manor Series, which is characterized as highly erodible (USDA, 1969).
