NATIONAL POLLUTANT DISCHARGE ELIMINATION SYSTEM MUNICIPAL SEPARATE STORM SEWER SYSTEM DISCHARGE PERMIT

2019 ANNUAL REPORT

**CARROLL COUNTY, MARYLAND
NATIONAL POLLUTANT DISCHARGE ELIMINATION SYSTEM (NPDES)
MUNICIPAL SEPARATE STORM SEWER SYSTEM (MS4)
PERMIT**

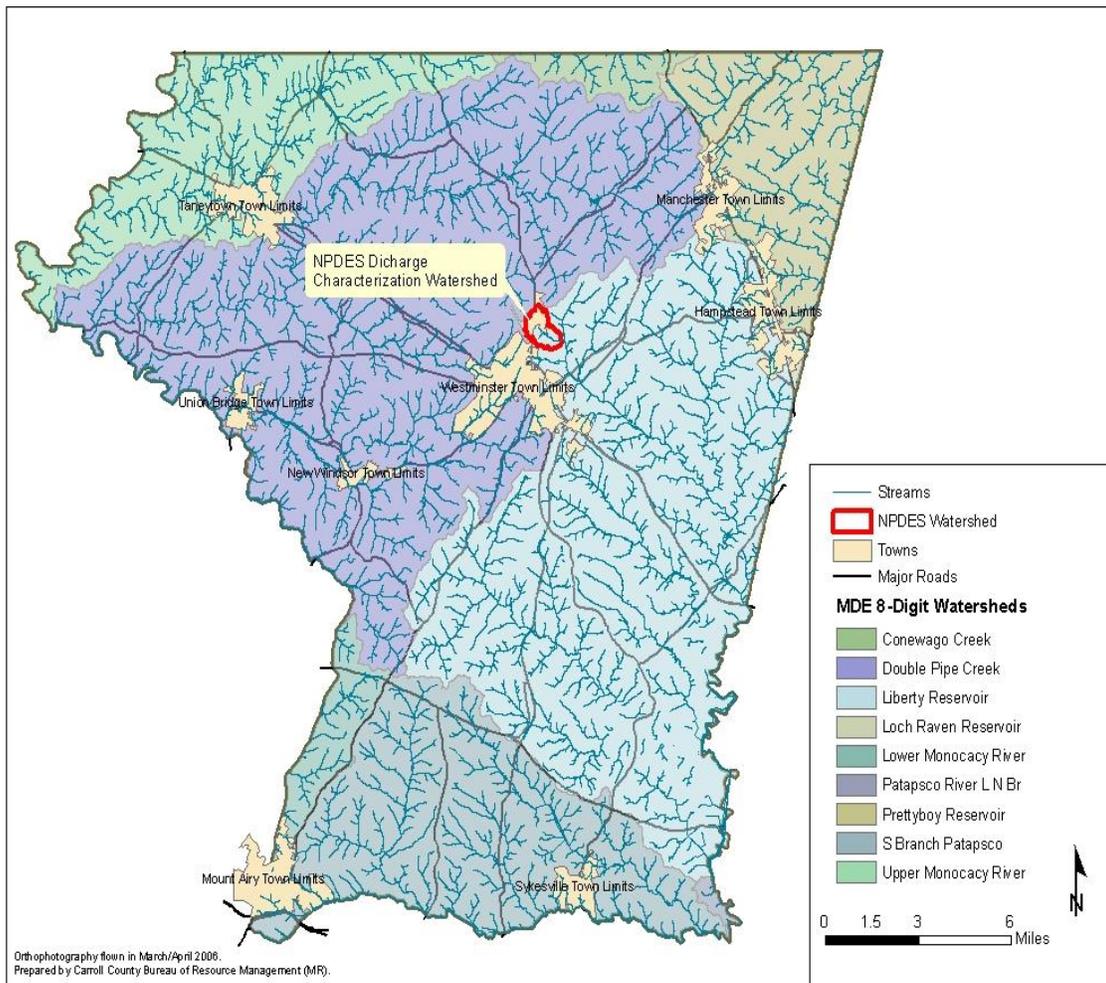
Figure 7: Carroll County NPDES Discharge Characterization Location

The Air Business Center regional stormwater management facility discharges via a constructed outfall to a small stream that travels southeast to the confluence with the West Branch. The stream receives the majority of its flow from the pond's outfall, with contribution from overland flow from the drainage basin during precipitation events. A new stormwater management pond at the West Branch Trade Center has been constructed adjacent to and east of the Air Business

Center stormwater management facility. This facility also drains to the stream, just downstream of the outfall station.

The discharge characterization is completed in a first order stream that is a tributary to the West Branch of the North Branch Patapsco River. The location of the watershed where monitoring is conducted within the County is shown in **Figure 7**, while the location of the monitoring stations and other watershed features are shown in **Figure 8**. The study area is located near the topographic divide separating the eastern and western piedmont physiographic provinces. As shown in **Figure 7**, the unnamed tributary drains the upper-most extent of the first order tributary and is located in the Liberty Reservoir watershed.

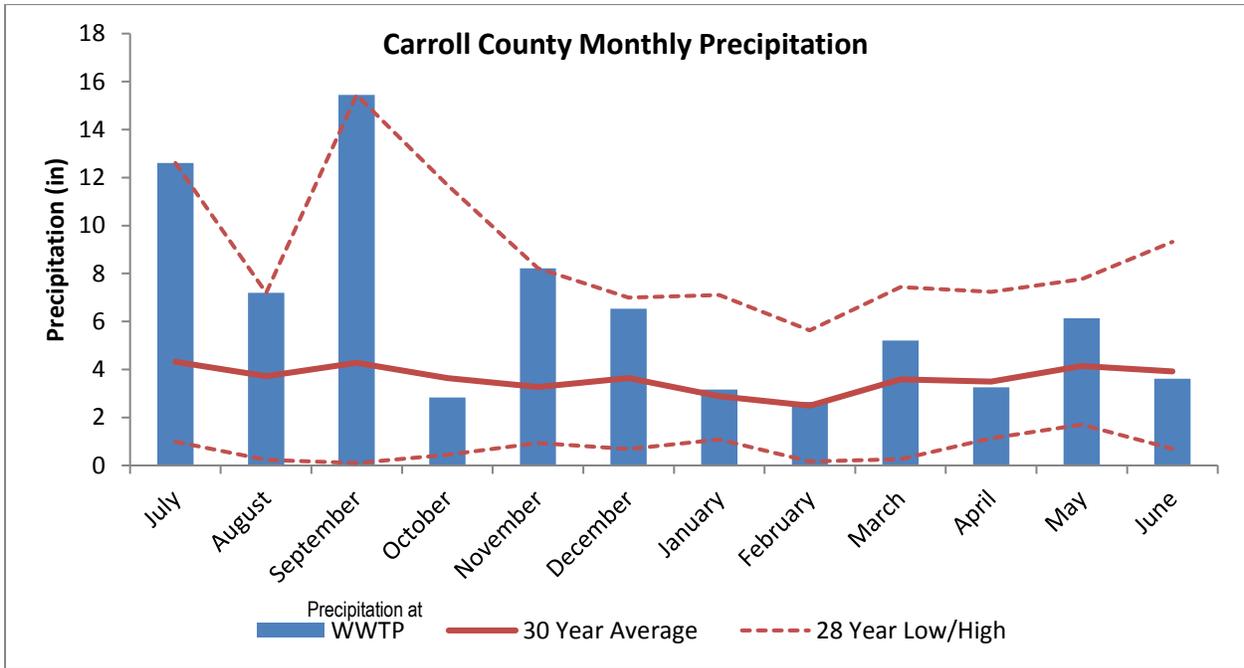
Figure 10: Monthly Precipitation Summary for the 2018 – 2019 Reporting Period

inches, while October 2018 was the driest month with a deficit of 0.81 inches. This reporting year was the wettest year for total precipitation since reporting began at this station in 2000.

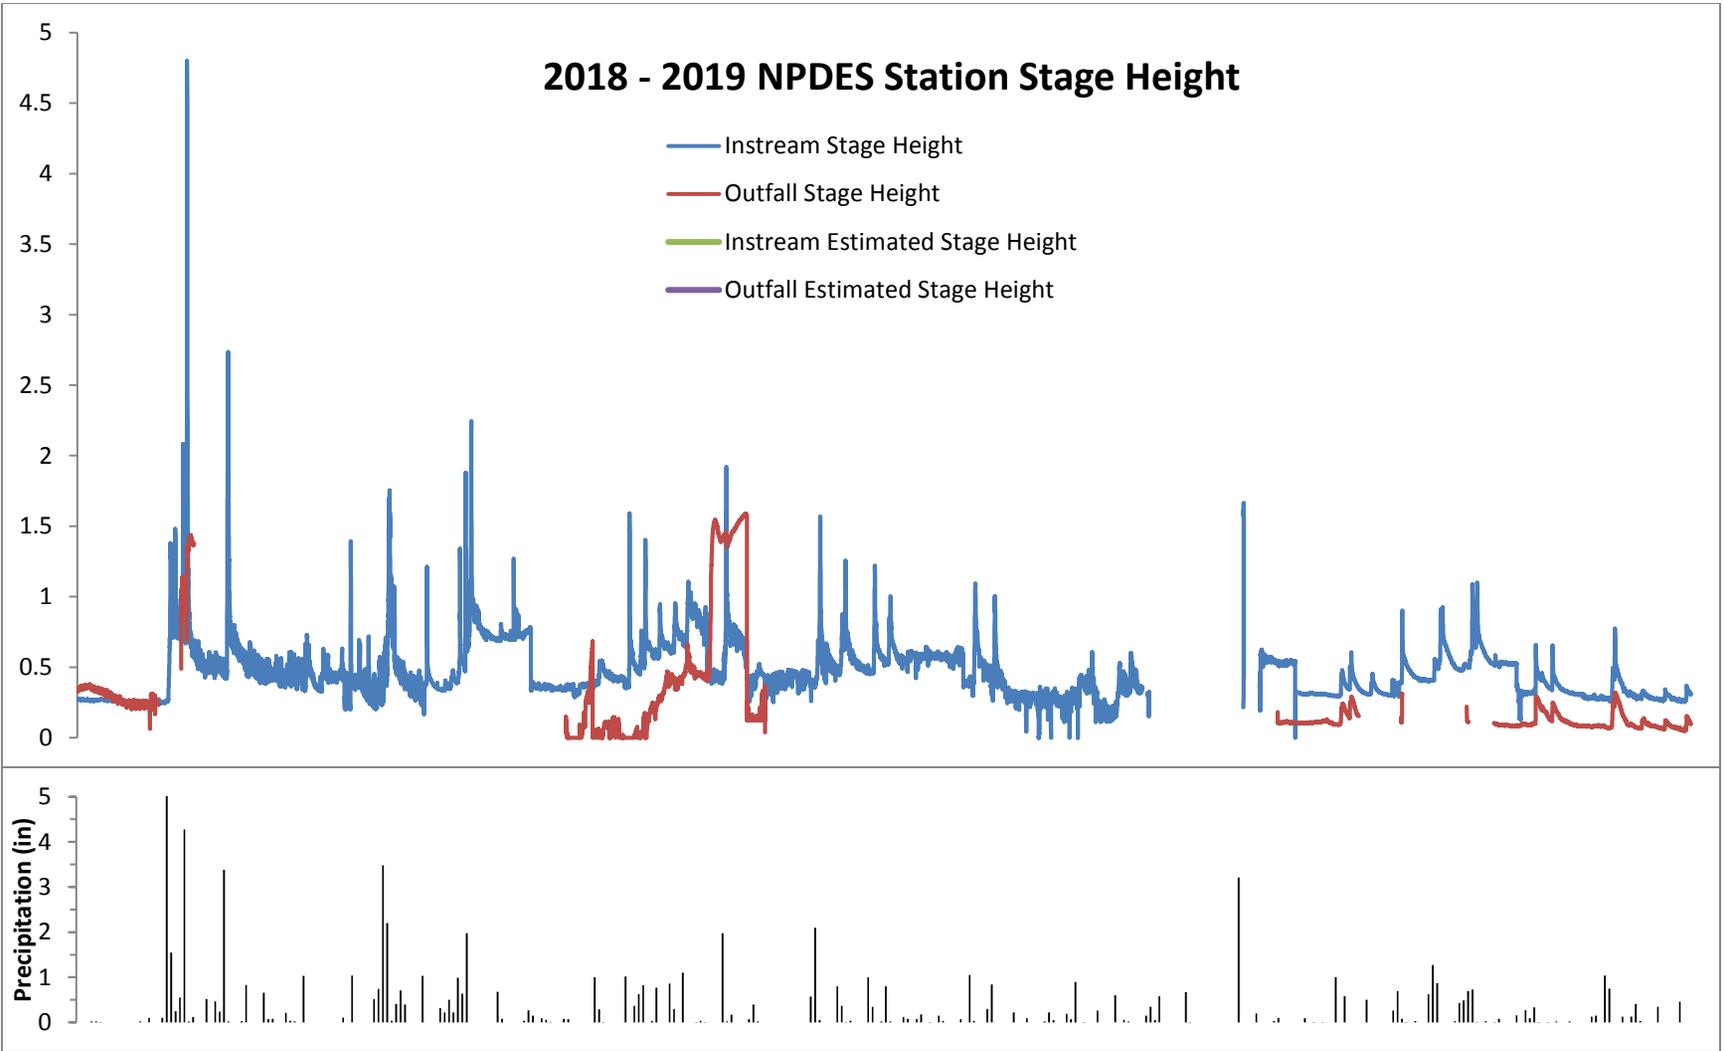
Figure 12: Stage Heights and Daily Precipitation for NPDES Monitoring Stations for the 2018 – 2019 Reporting Year

Typical stage heights observed for the instream monitoring station were approximately 0.42 feet, or 1,025 gpm. During the July 21-25 storm event, stage height reached the peak for the reporting year at 4.8 feet. The resulting discharge was 2,485,062 gpm, though this value is highly inaccurate as the stage height was well above the weir walls. During the reporting period, there were 15 other storm events with peak stage heights of over 1 foot (7,833 gpm), primarily during summer and autumn 2018.

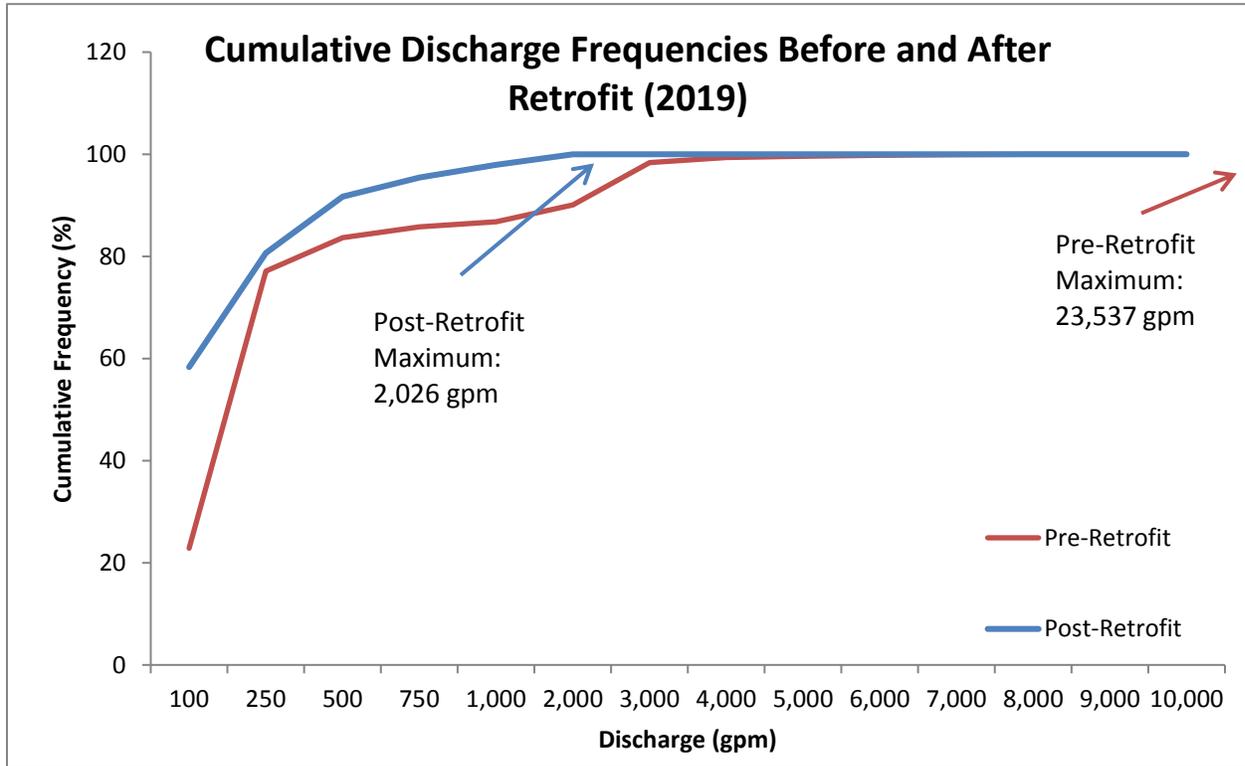
Figure 14: Outfall Discharge Frequencies for 2007 and 2019

below or equal to 100 gpm. This contrasts with the pre-retrofit measurements where only 23 percent of measurements were below 100 gpm. Ten percent of all measurements in 2007 were greater than 2,000 gallons per minute, which are greater in magnitude than most of the highest discharges from most post-retrofit years. Many of the higher discharge measurements were observed during the record storm event on July 21-25, 2018. It should also be noted that only a third of the yearly discharge measurements were recorded due to the previously stated equipment problems at the outfall station. Despite the record the record storm event, the peak discharge at the outfall station was over 10,000 fewer gallons per minute than during the pre-retrofit period.

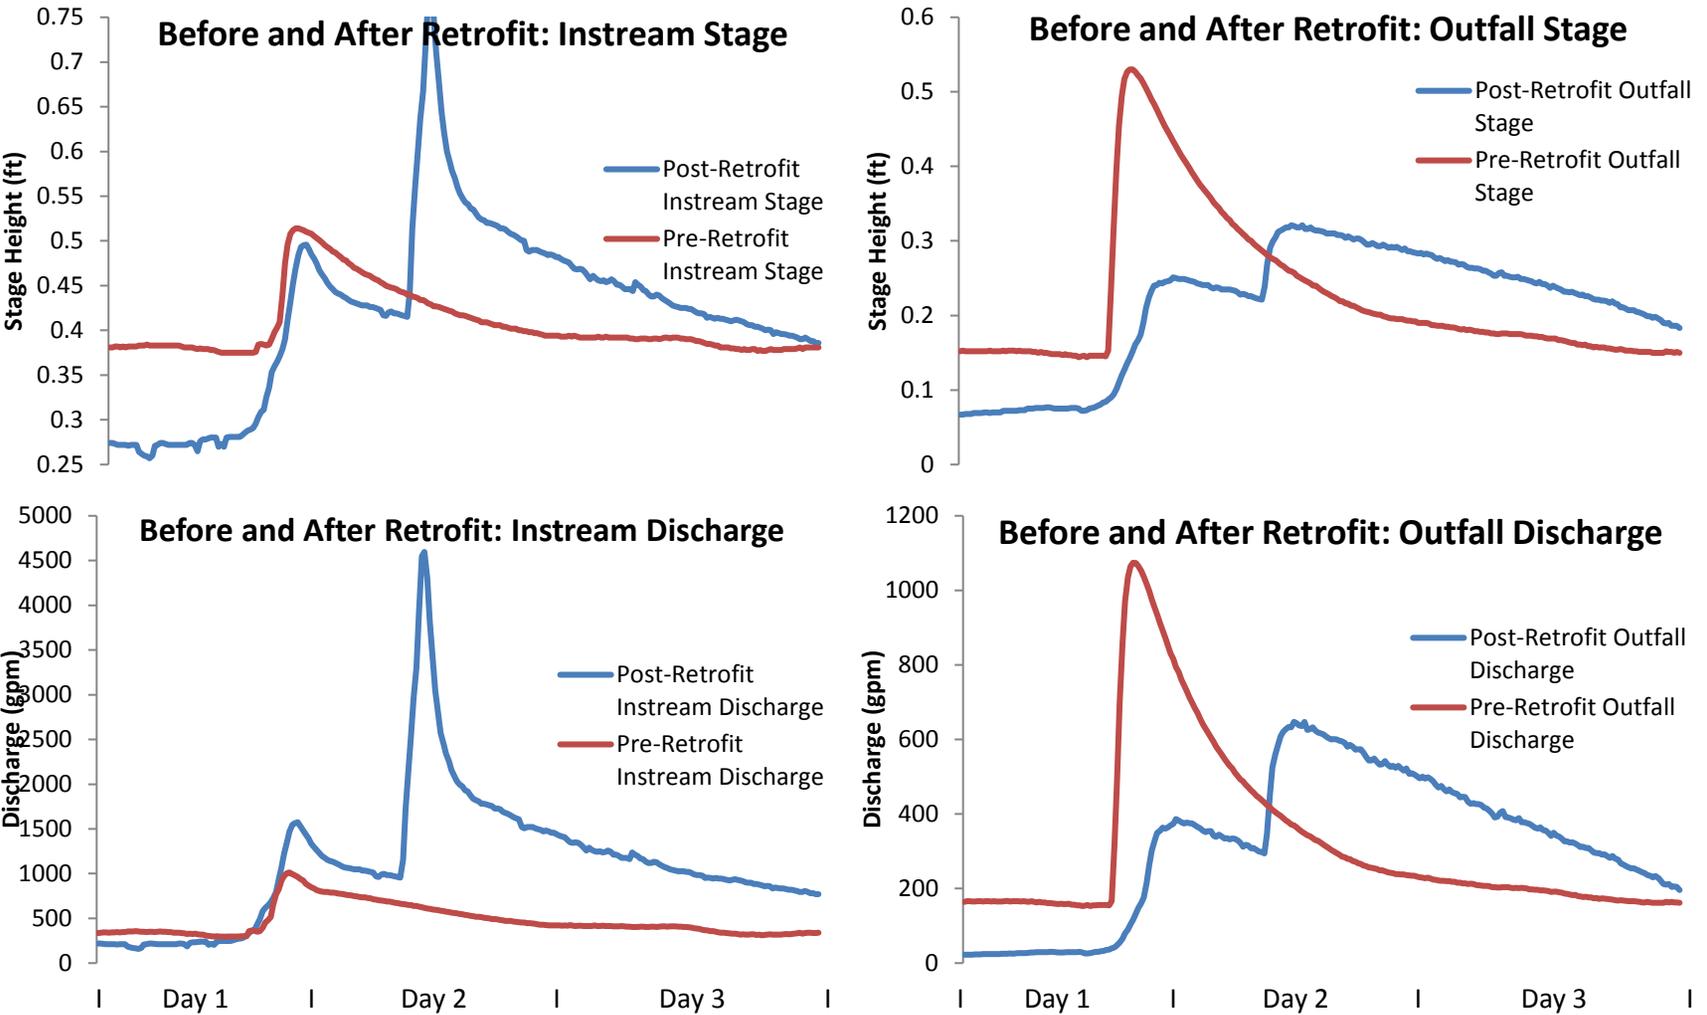
Figure 15: Characteristics of Analogous Storms Pre-Retrofit (7/23/2006, 0.39") and Post-Retrofit (6/13/2019, 1.73")

Looking at individual components of the hydrograph allows one to observe the distinct mechanism behind any changes in cumulative frequencies throughout the year. **Figure 15** represents two analogous storm events, one before and one after the stormwater retrofit, and a hydrological comparison therein. This figure contains hydrographs before and after retrofit for instream and outfall stage heights and discharges. Unlike previous years which compared storm events with nearly identical precipitation totals, this comparison is of a larger storm event to the same pre-retrofit storm. The pre-retrofit event had 0.39 inches of precipitation observed while the post-retrofit event had 1.73 inches of precipitation observed. Despite the higher precipitation intensity, the ascending limb for the post-retrofit outfall station still had a lower slope and peak discharge than the hydrograph of the pre-retrofit outfall station. The outfall to instream station discharge ratio for the post-retrofit storm event averaged a ~26 percent contribution, peaking at 37 percent as was roughly the case for the overall discharge and separated stormflow for the reporting period. During the pre-retrofit storm, however, the outfall station contributed ~70

percent of the total instream discharge. The lesser contribution during the post-retrofit storm event is evident in the instream station hydrographs despite more than four times greater precipitation. Overall, longer baseflow recessions and lower peak discharges were observed with the current stormwater configuration.

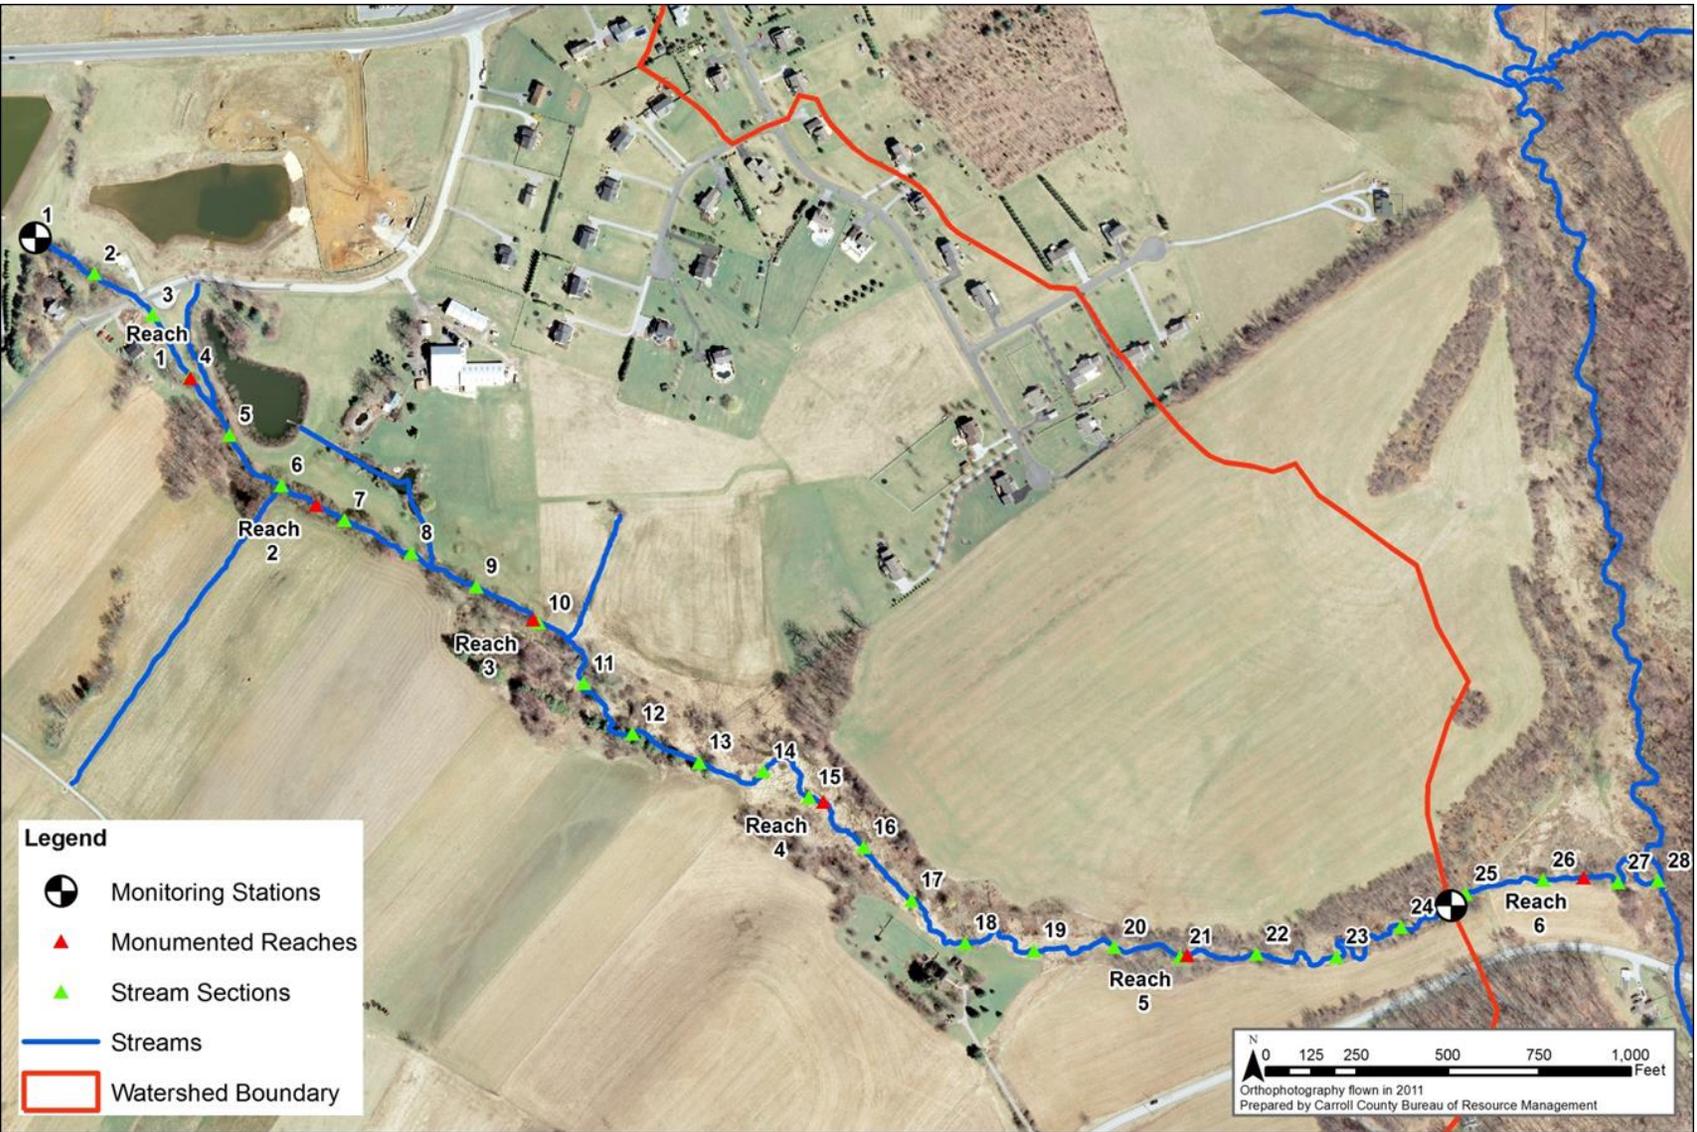
Figure 16: Physical Data Collection Stations

Consistent with past findings, analysis at monumented cross-section 6 indicates that the stream channel has widened by 4 feet since 2000, extending from a width of 5 feet to a width of 9 feet. This width is unchanged during the past several years. This monumented cross-section is located approximately 200 feet upstream of the confluence on a straight reach of stream that precedes a series of bends. As is discussed below, this region of the stream has the steepest slope and corresponding highest energy for stream bank erosion. Bank soils in this area are of the Manor Series, which is characterized as highly erodible (USDA, 1969).

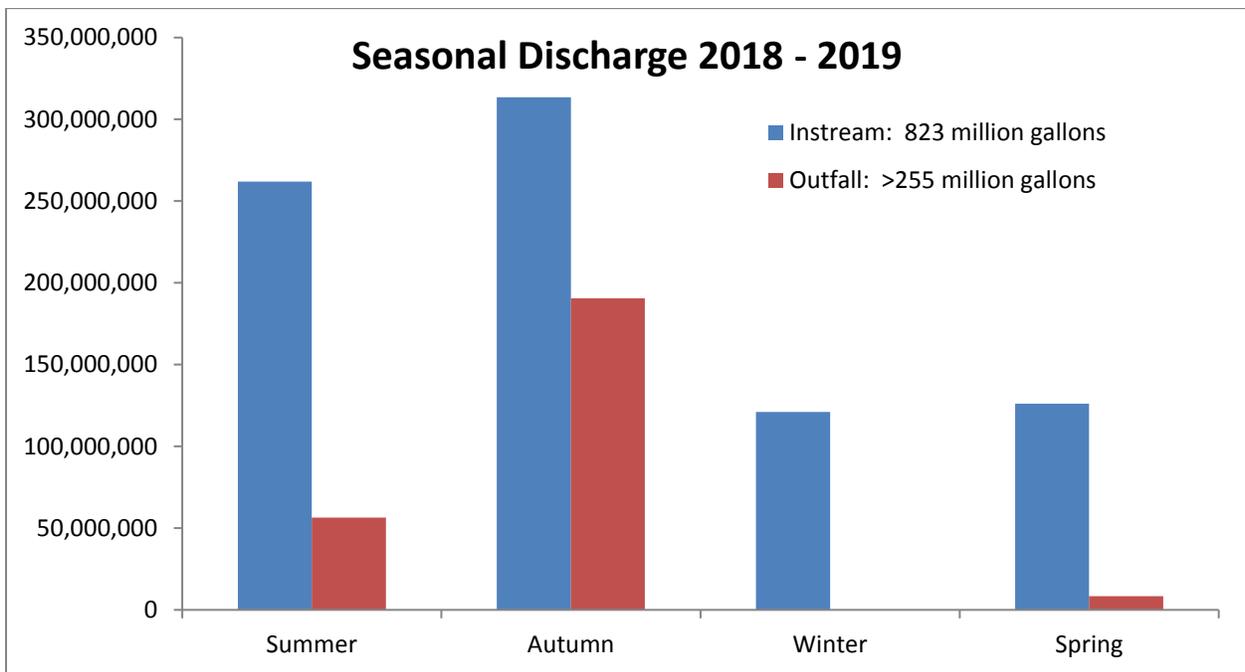
Figure 21: Seasonal Discharge for the 2017 – 2019 Reporting Year

All analytes had the greatest loadings in the autumn season. This is not surprising considering the autumn season had the greatest total discharge of the reporting period. While many analytes had only slightly greater loading in autumn relative to summer, TKN, TP, and TSS all had greater than half of the total annual estimated loadings, ranging from 54 percent to TP with 75 percent. Typically, the outfall station relatively consistently correlates to values estimated for the instream station. It should be noted that for loading calculation, the detection limit concentrations were used instead of 0 values with samples below detection. Therefore, actual loadings are likely less than values displayed below. Almost all TPH samples were below detection during the reporting year so any differences are due to differences in flow volume.

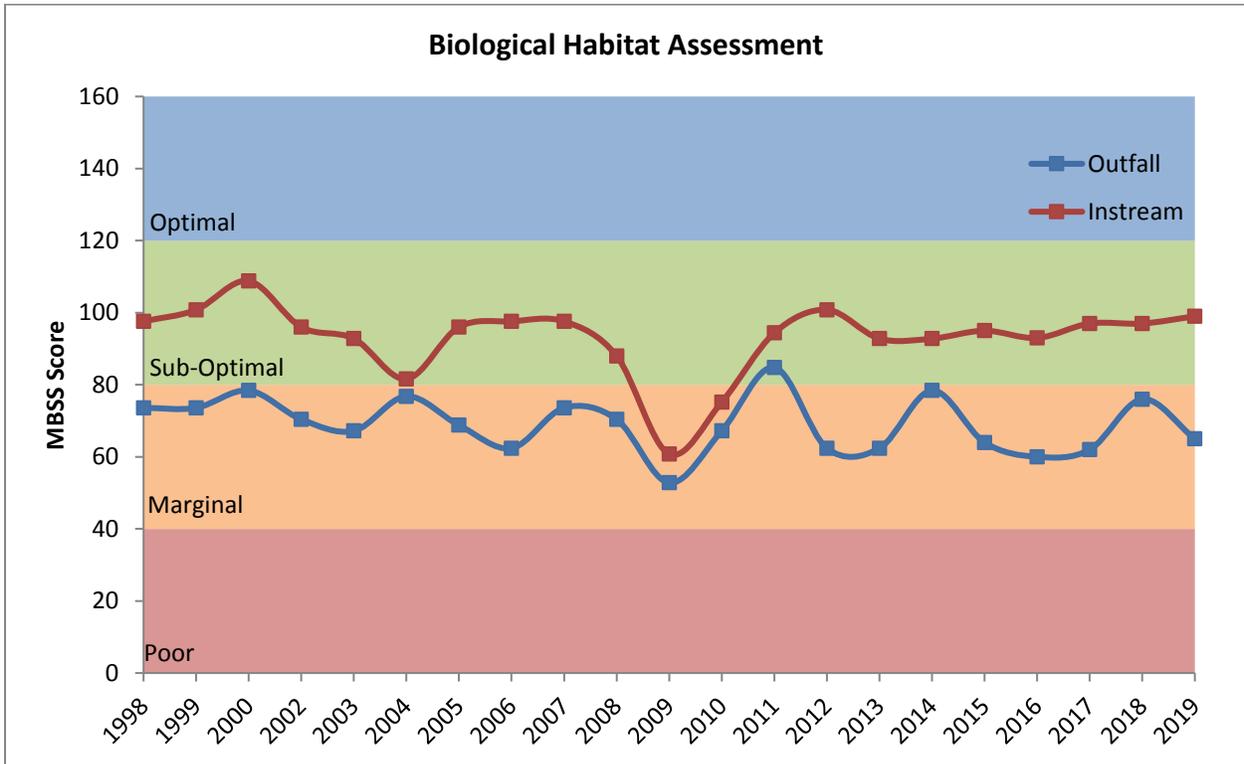
Figure 23: Comparison of NPDES Station Habitat 1998 – 2019 (Excluding 2001)

The biological habitat assessment results for each station are summarized in **Table 23**. The scores are of a maximum 160 points based on 8 parameters as shown in **Table 15**. Overall, the quality of biological habitat at the instream station remains higher than the outfall station with overall habitat scores of 99 and 65, respectively. From 1998 through 2019 (excluding 2001), as shown in **Figure 23**, the stations have average habitat scores of 93 for the instream station and 69 for the outfall station. This was a fairly typical year for both stations, with the instream scoring 2 points higher but the outfall station scoring 4 points below average, with considerable decrease in the instream habitat category. The weakest parameters for both stations are riffle/run quality, embeddedness, and shading.

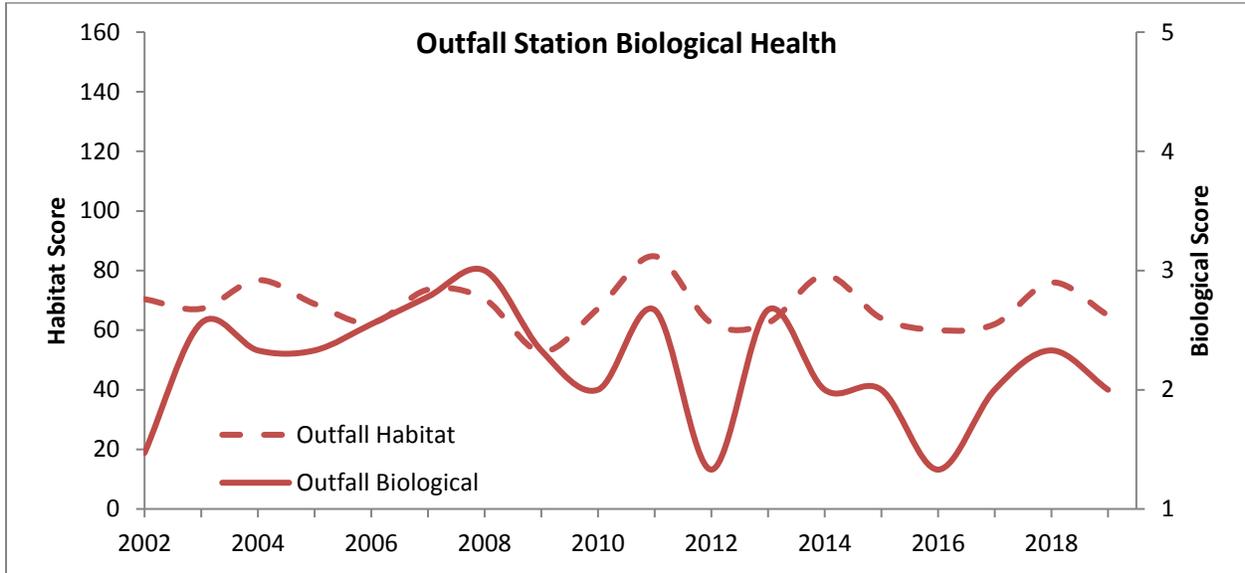
Figure 24: Comparison of Outfall Station Habitat and Biological IBI Scores 2002 – 2019

It should be noted that the habitat assessment is wholly subjective. Slight changes may be a result of inconsistencies in assessor(s) scoring methodology. To show a general relationship between the habitat and biological scores, these have been plotted for the outfall and instream stations in **Figures 24 and 25**, respectively. These are plotted on each assessment’s overall scoring range. Though not unexpected, it is evident that the lower the quality of habitat in this case, the lower the biological quality found in said habitat. Both stations appear to have a 1- to 2-year period of latency between habitat and biological changes. The certainty of any evident

relationship is low given the high degree of bias and chance that is probable in these assessments.

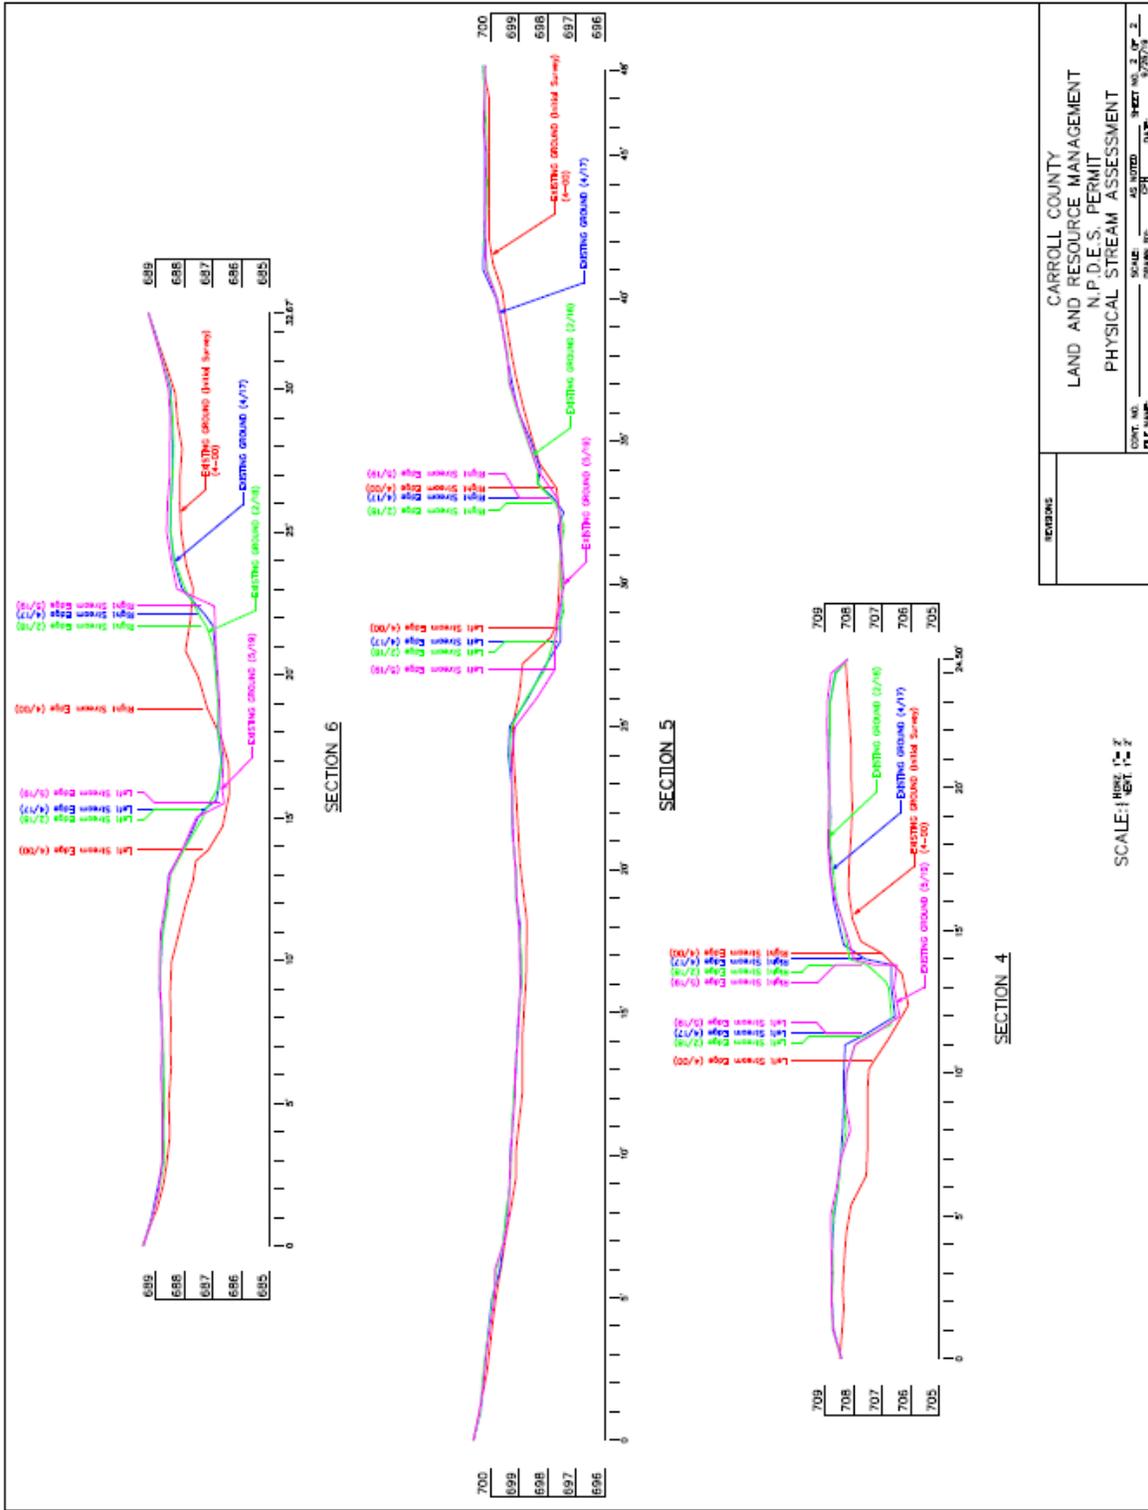
CARROLL COUNTY
 LAND AND RESOURCE MANAGEMENT
 N.P.D.E.S. PERMIT
 PHYSICAL STREAM ASSESSMENT

SCALE: HORIZ. 1" = 2'
