APPENDIX C

- Wetlands Investigation Memorandum
- Agency Coordination Regarding the Jurisdictional Determination
 - Draft Joint Permit Application

From: Mark Metzler <mmezler@rettew.com>
Sent: Monday, October 24, 2016 12:21 PM
To: Mary Ashburn Pearson
Cc: Mark Metzler
Subject: FW: Carroll County Regional Airport (CCRA; Carroll County, MD) - Summary of Areas Viewed During JD Field Visit (9/23/2016) (UNCLASSIFIED)

Subject: [EXTERNAL] Carroll County Regional Airport (CCRA; Carroll County, MD) - Summary of Areas Viewed During JD Field Visit (9/23/2016)

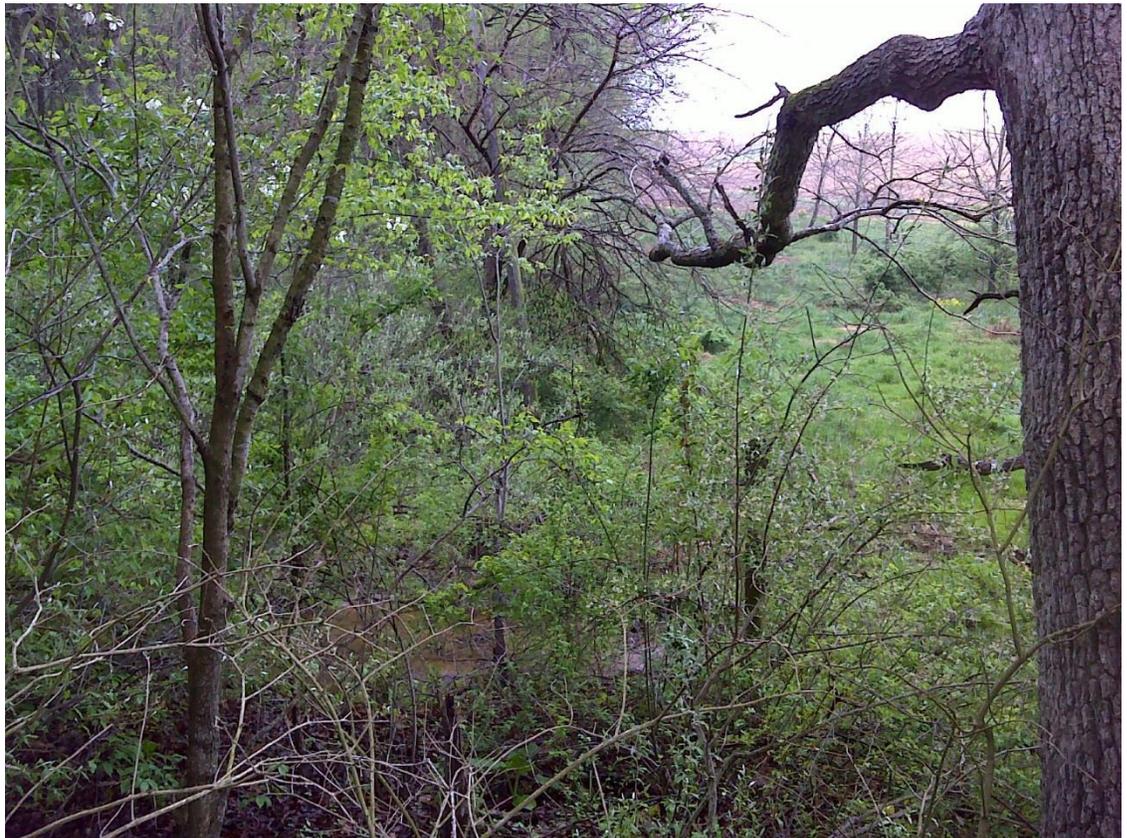
Photo 1

Comments:
View generally
northwest along the
north limit of the
Tansill Property.
(DSC08704-P07-NW
Tansill Prop)

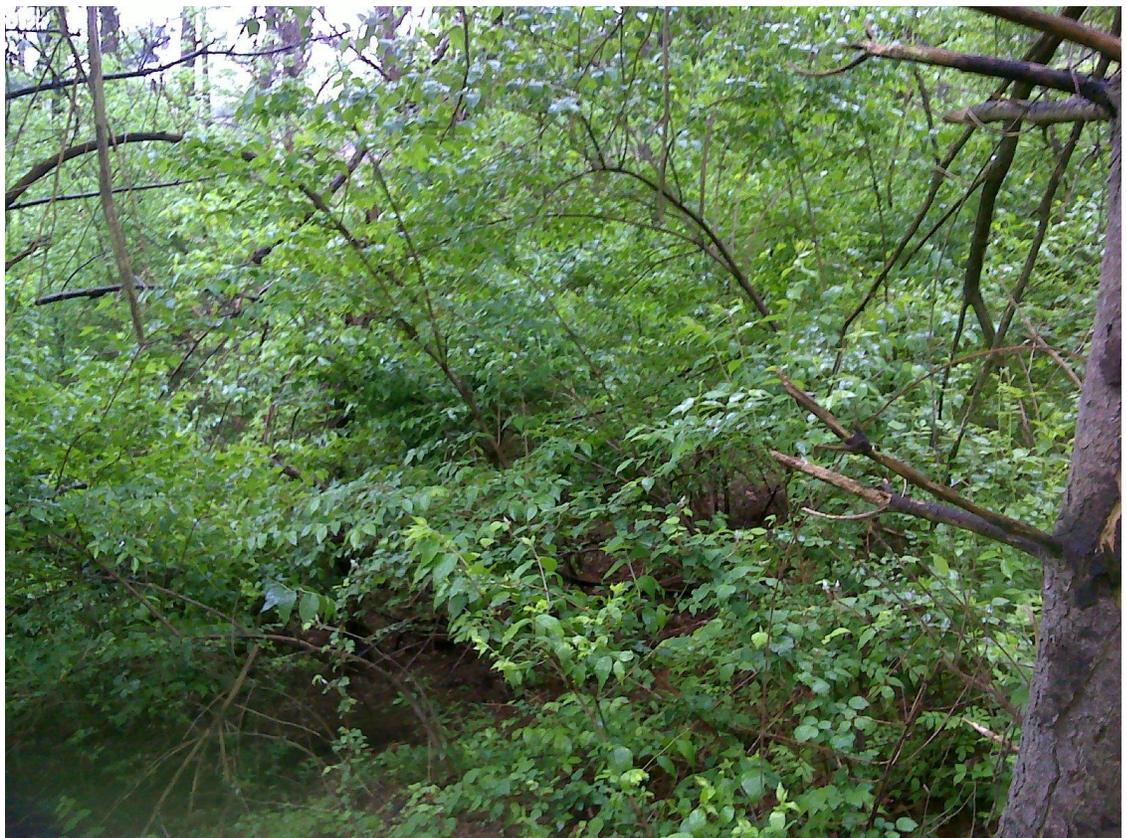
Photo 2

Comments:
A view of the
forested portion of
the Tansill Property.
(DSC08707-P07-SW
Tansill Prop)

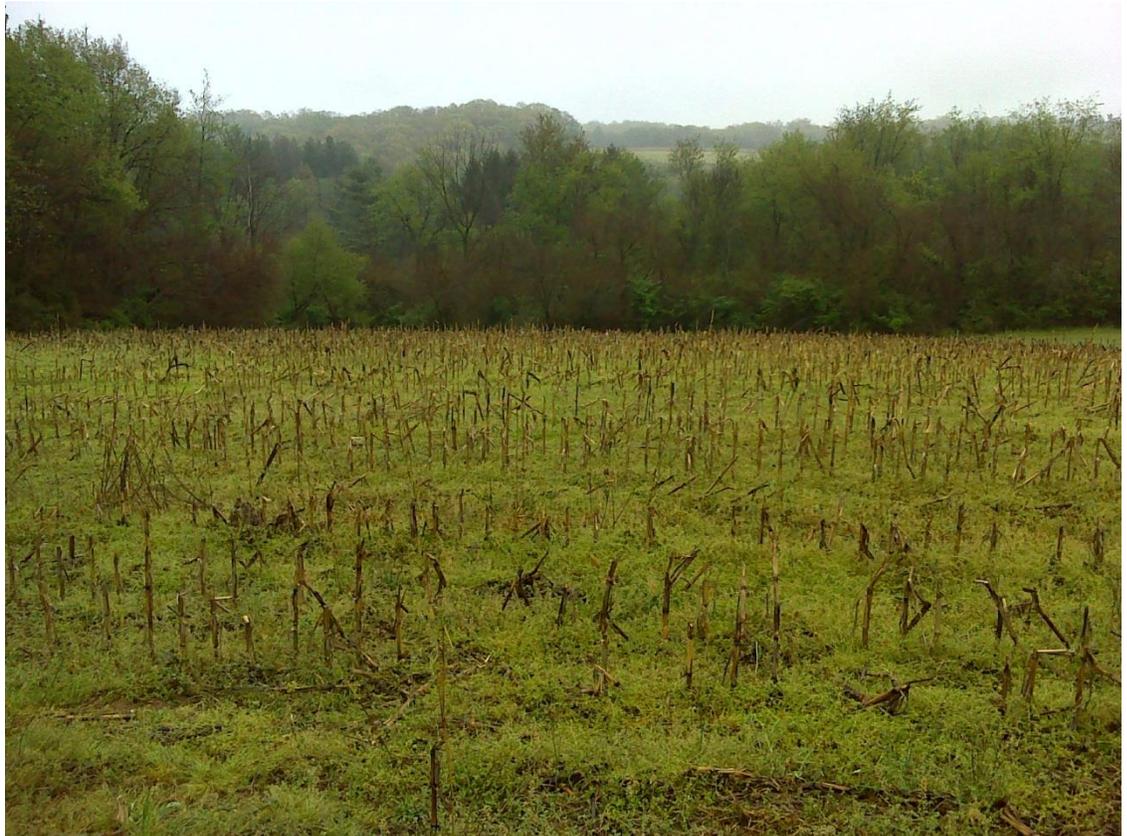
Comments:
A no-till agricultural
field on the Tansill
Property. (DSC08711-
PO7-E
Tansill Prop)

NOTE: Many of the
no-till agriculture
fields depicted in this
document were
recently treated with
herbicides and/or
pesticides.

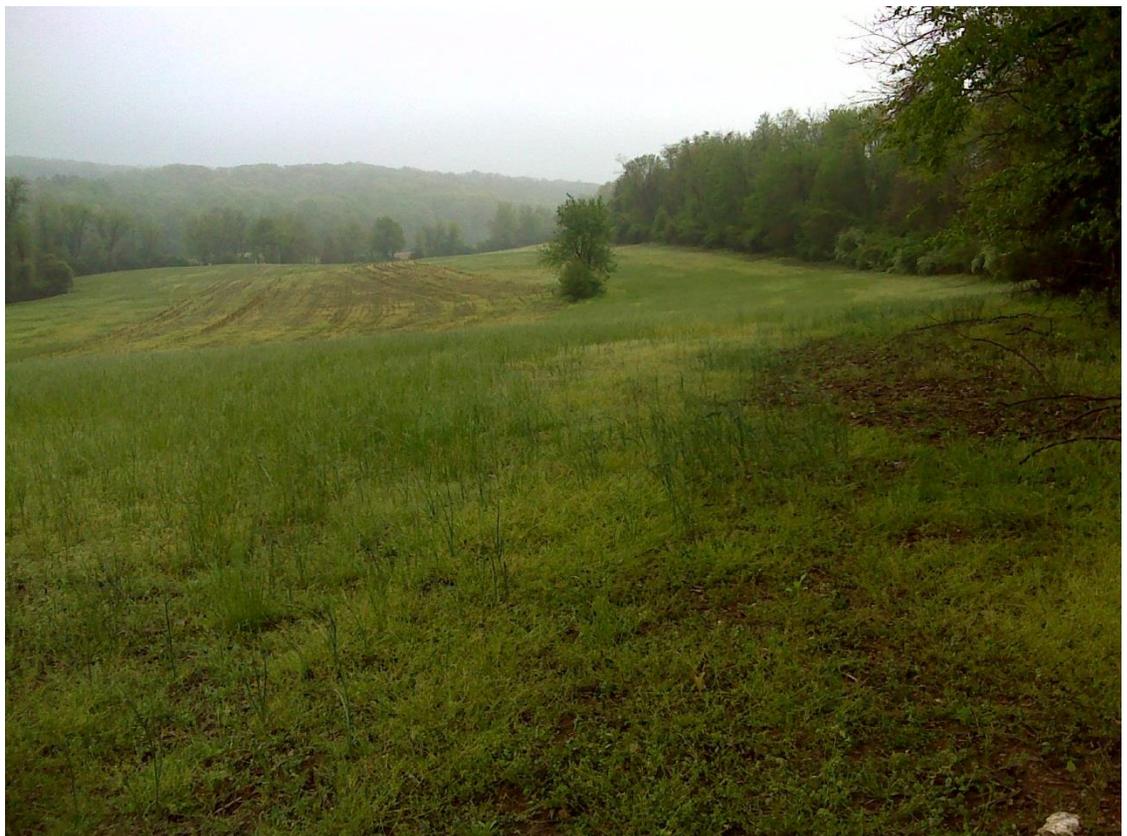
Photo 4

Comments:
An agricultural field
on the Tansill
Property. (DSC08712-
P07-S
Tansill Prop)

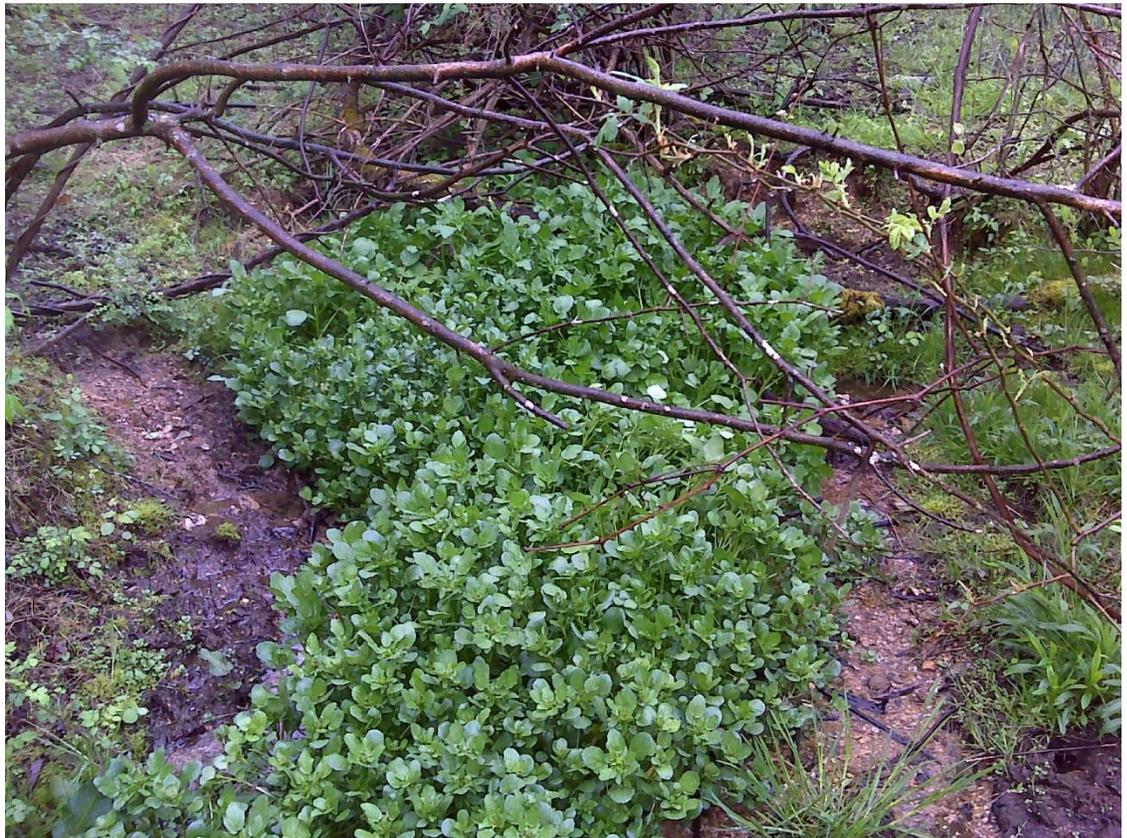
Photo 6

Comments:
An image of
W160429-1300.
(DSC08718-P07-NW
Tansill Prop)

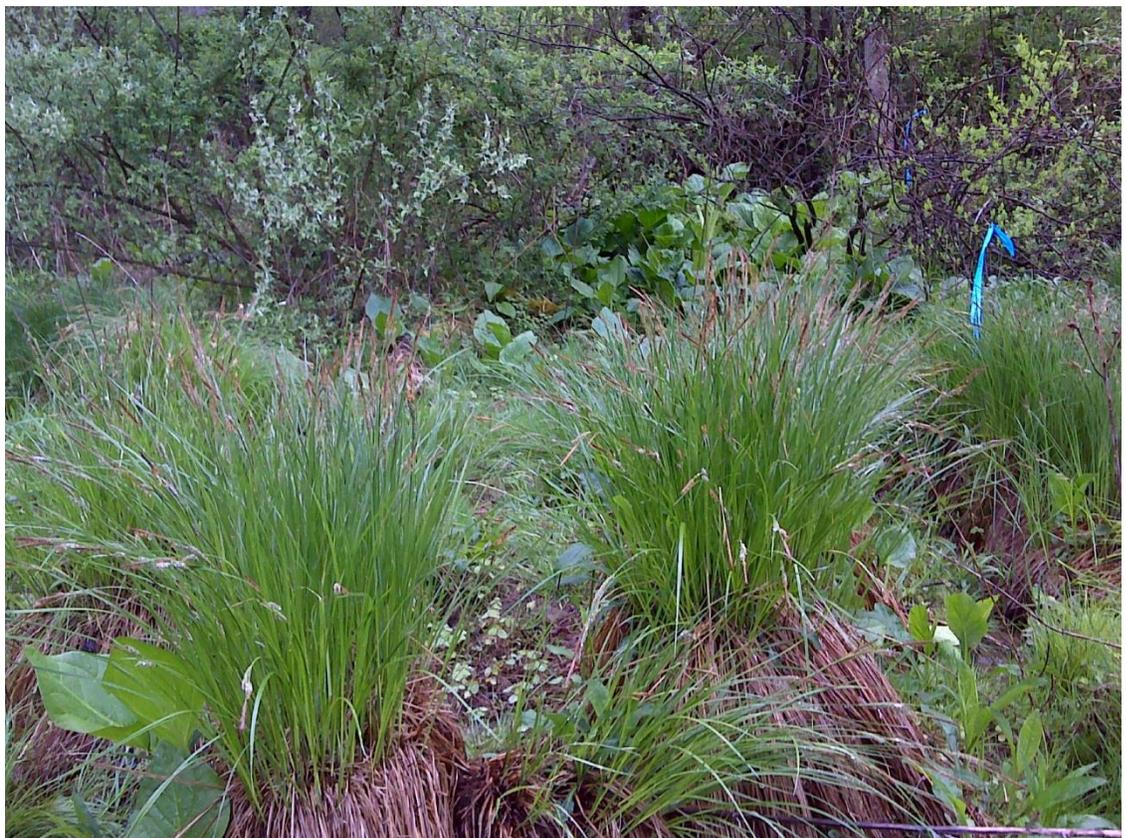
View of W160505-1250 and S160429-1345. According to a relative of the property owner, this area was formerly a man-made pond. The eroding earthen embankment (that forms the pond) has caused a drop in water levels. The sediment throughout this area creates an unsafe condition. (DSC08738 Tansill Prop)

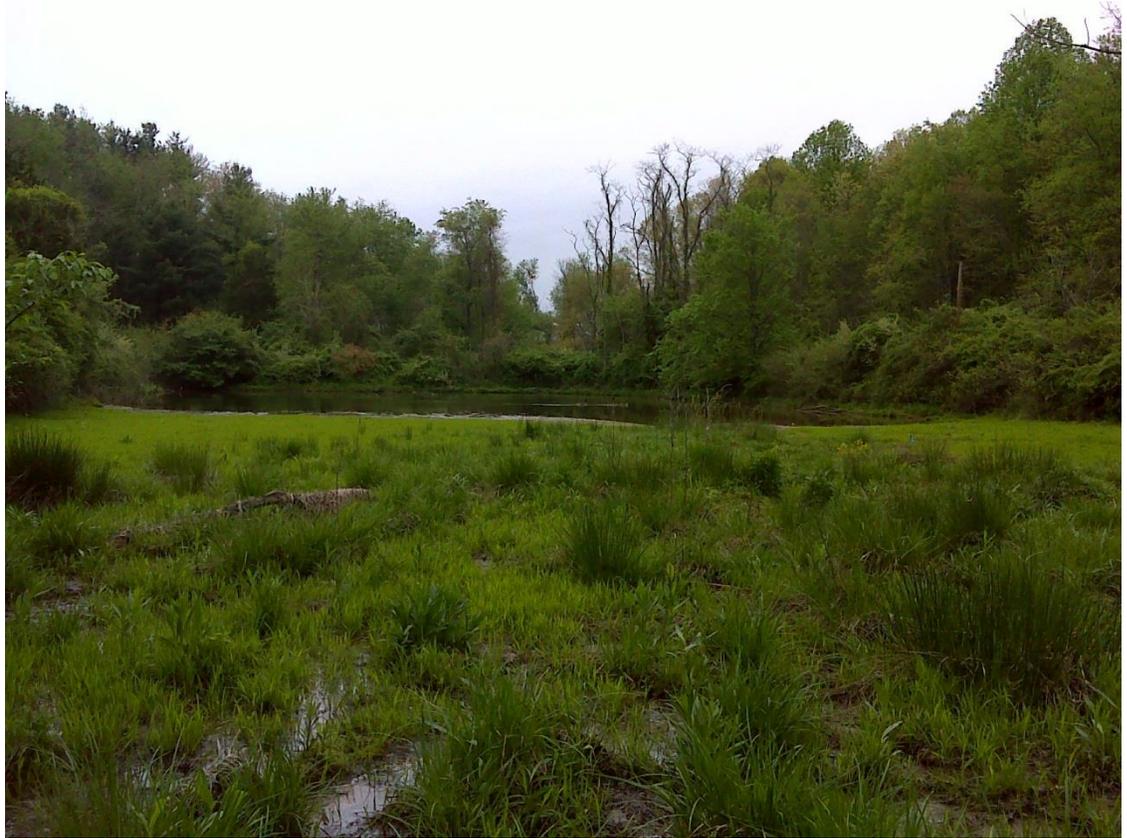
Photo 8

Image of W160505-1420 and STR 160429. (DSC08743 Tansill Prop)

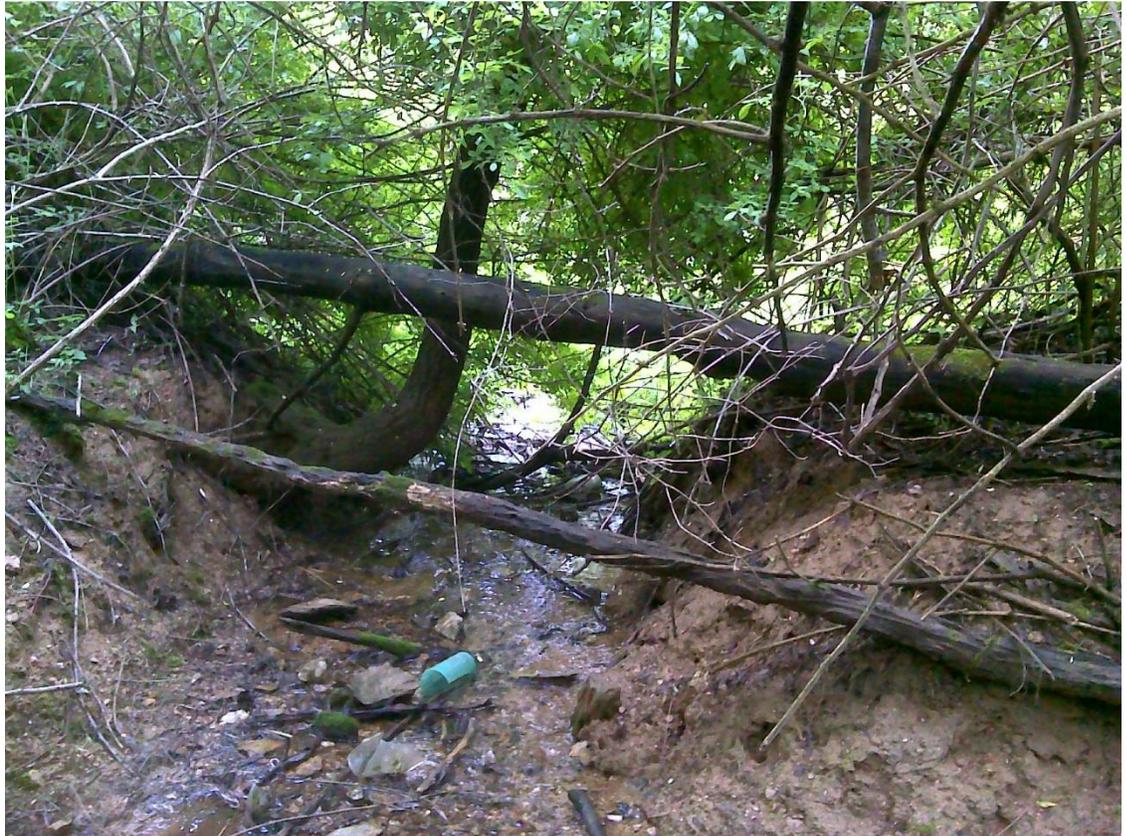
Photo 10

Comments:
W160505-1515 , a
PEM on the Tansill
Property. This
wetland, like others
nearby, is strongly
influenced by
groundwater. (08755
Tansill Prop)

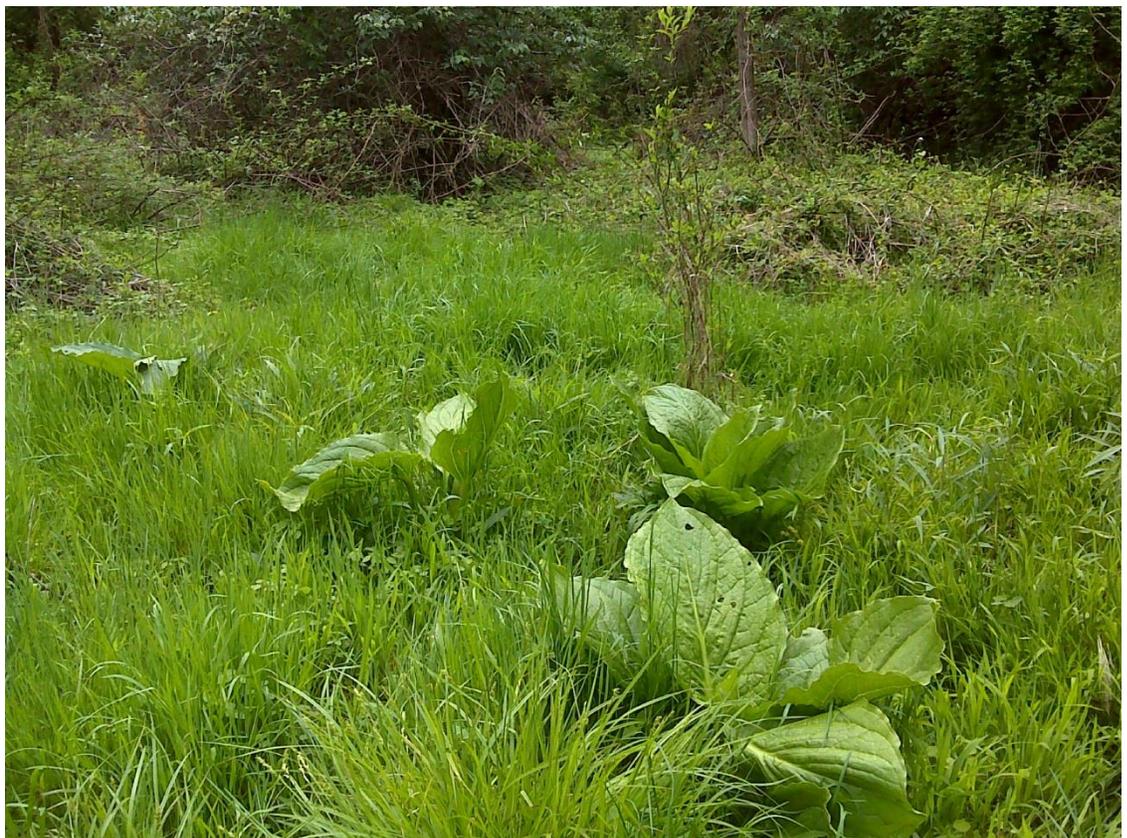
Comments:
An image of Wetland
12J (W12J), originally
identified and
delineated in 2008.
Such wetlands were
field-checked during
this delineation
effort. (DSC08511-
P08-E
Carroll Co P08)

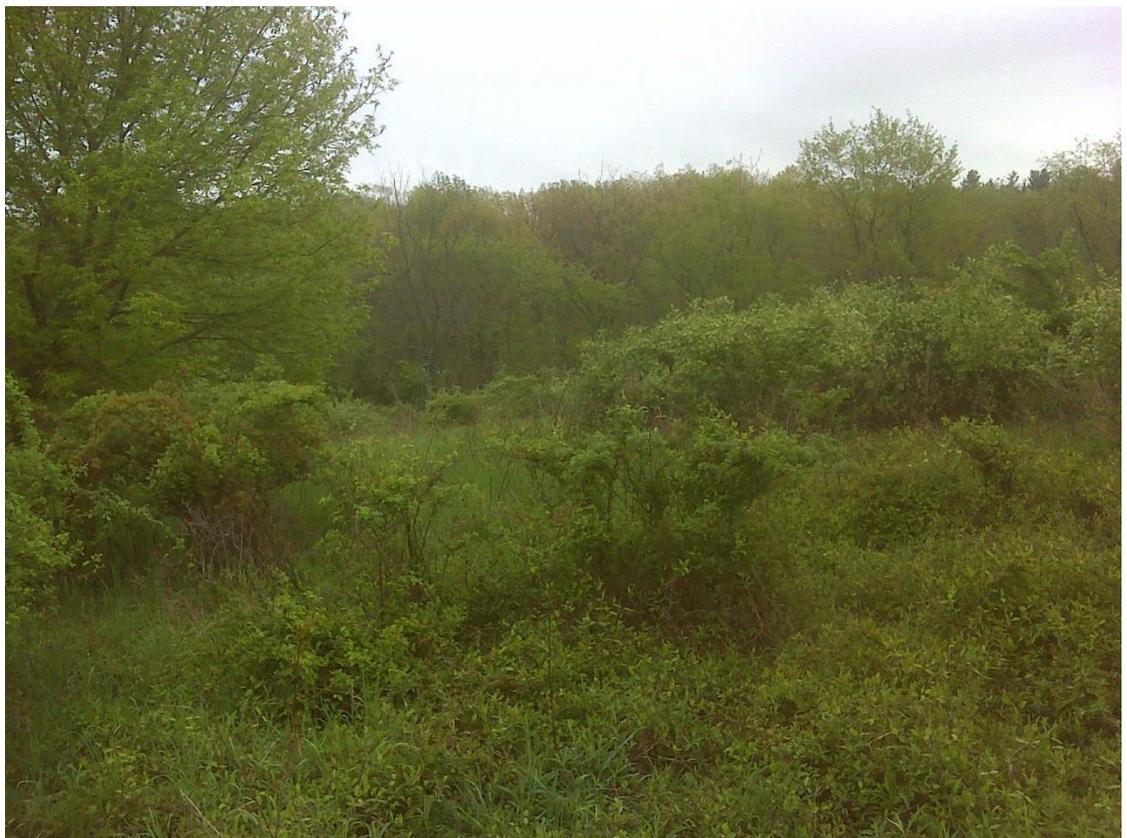
Photo 12

Comments:
A typical upland area,
depicting an area
composed primarily
of scrub/shrub
vegetation species in
the foreground and a
mixed upland
hardwood stand in
the background (on a
more steeply sloping
area). (DSC08625-
P08-E
Carroll Co P08)

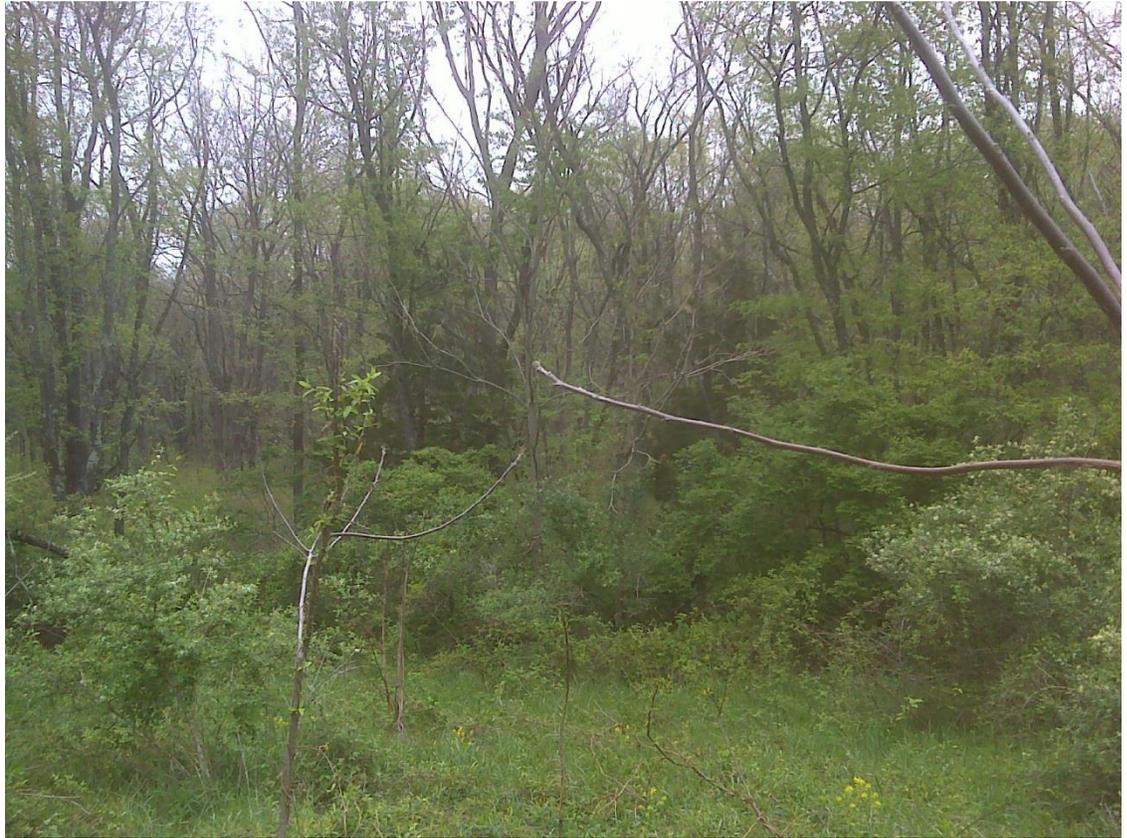
Photo 14

Comments:
A portion of wetland
W160422-1120.
(DSC08566-P10)

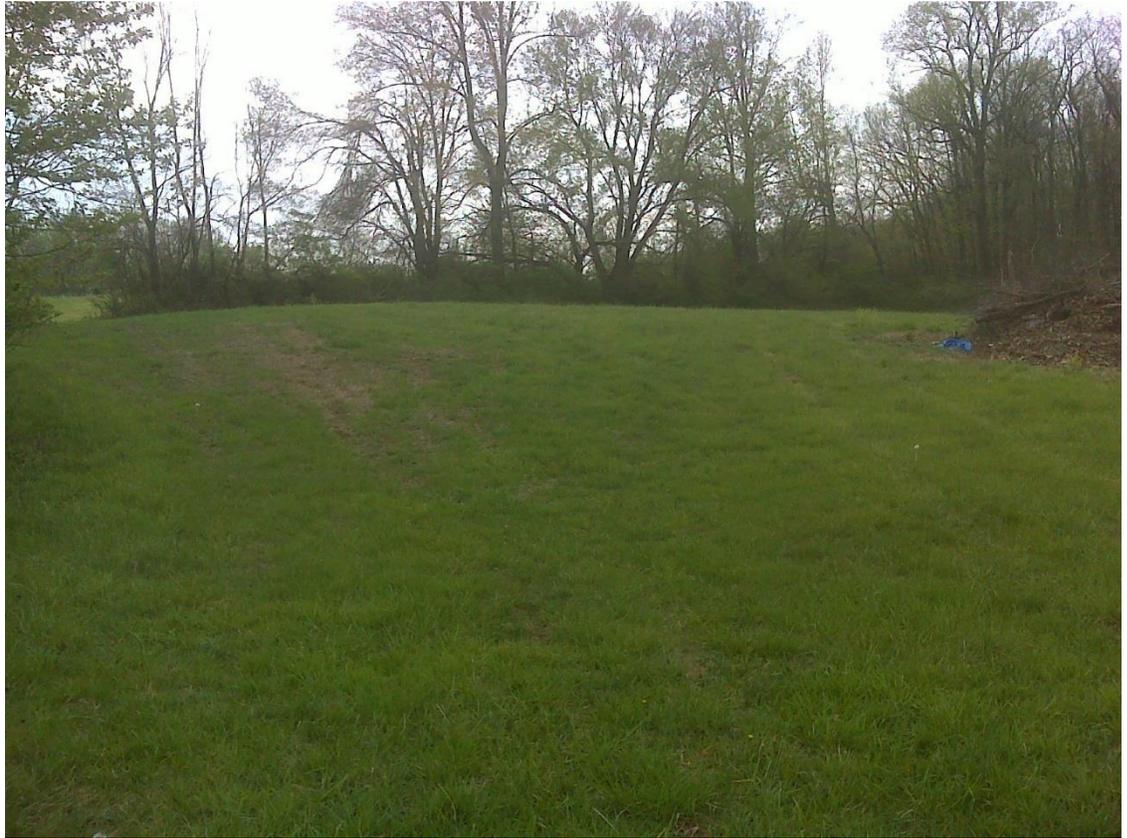
Photo 16

Comments:
An image of the area
near Wetland #9
(originally delineated
in 2008) and the
origin of Stream #7.
(DSC08544-P10-N
Carroll Co P10)

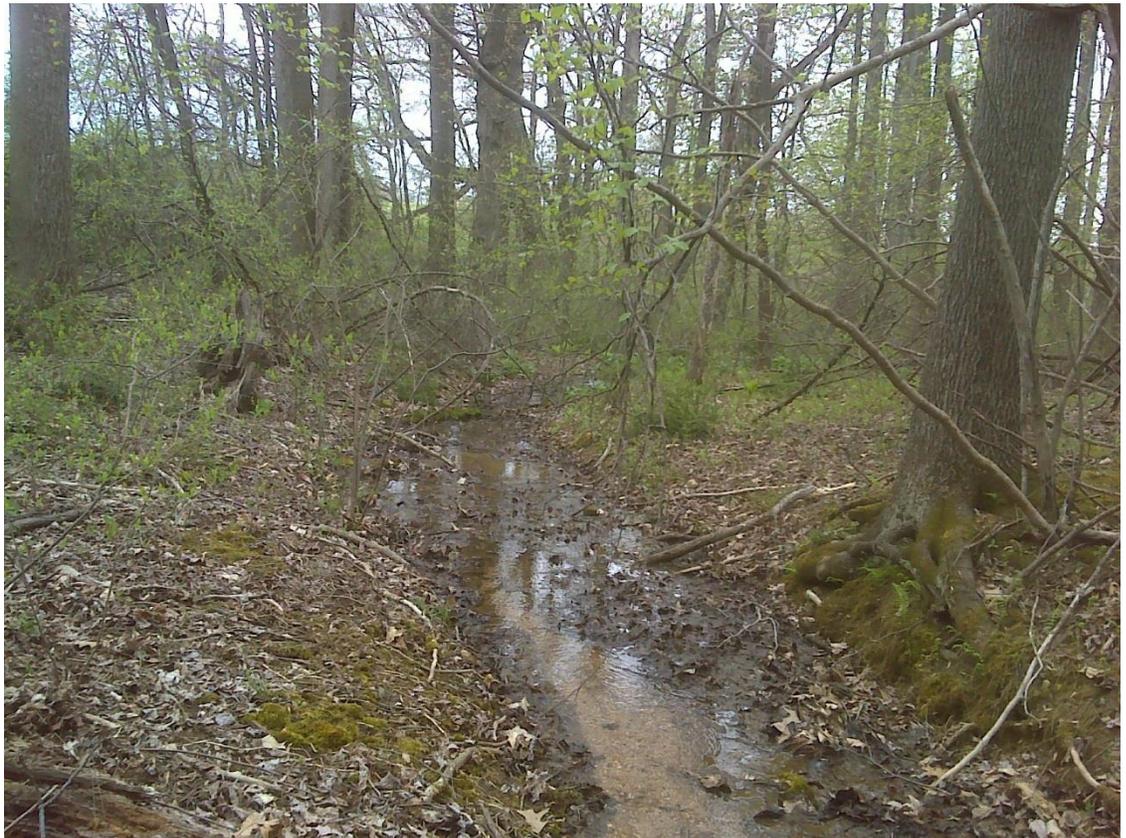
Photo 18

Comments:
W160422-0930 and
adjoining upland
area. (DSC08564-
P10-E
Carroll Co P10)

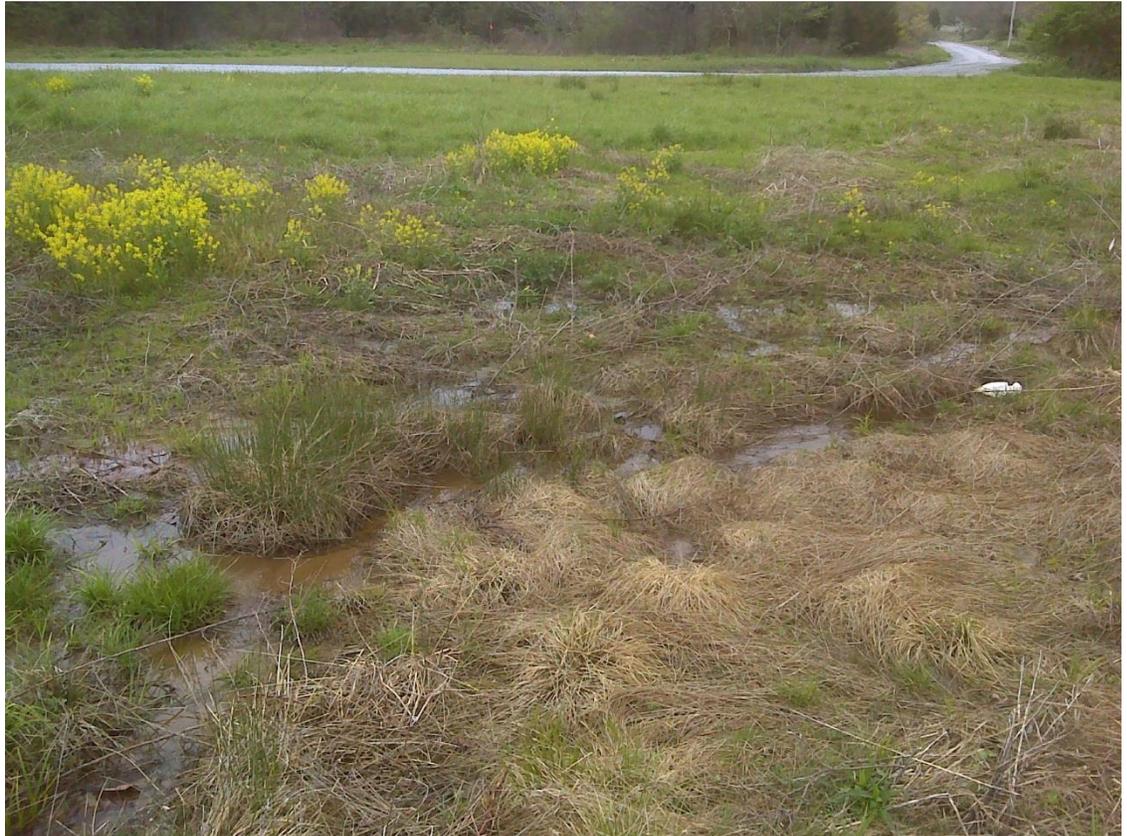
Photo 20

Comments:
An image of the
existing agricultural
crossing of
STR160422-0930.
(DSC08571-P10-S
Carroll Co P10)

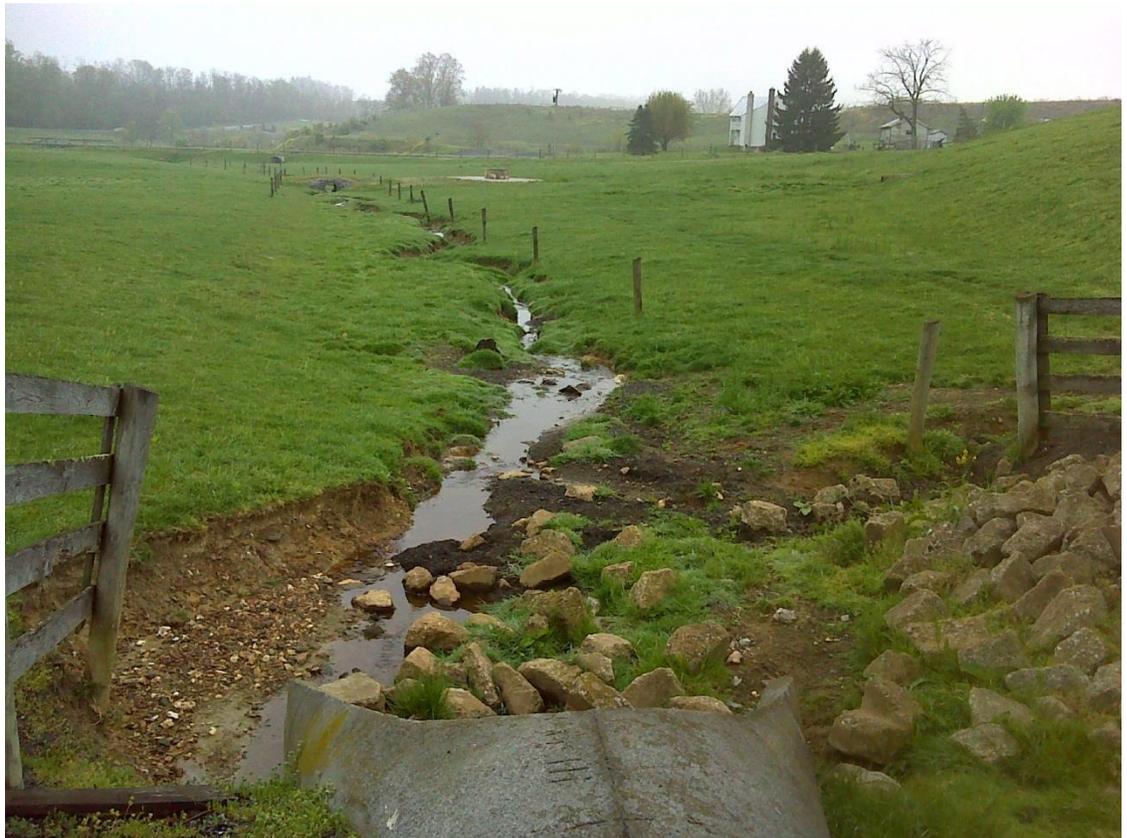
Comments:
Image of STR160429-
0730, which flows
through a pasture.
(DSC08698-P14-S
JRP Vision)

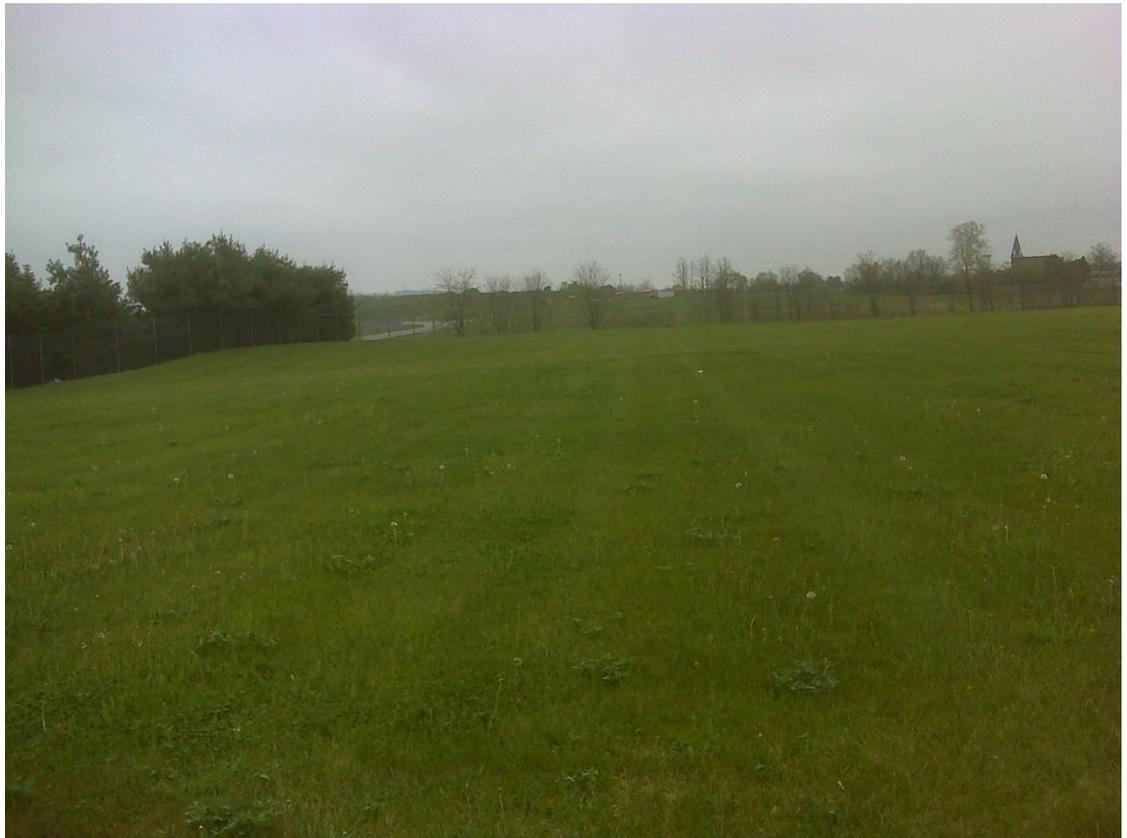
Photo 36

Comments:
An image of wetland W#14, originally delineated in 2008. (DSC08617-P19-SE DLH)

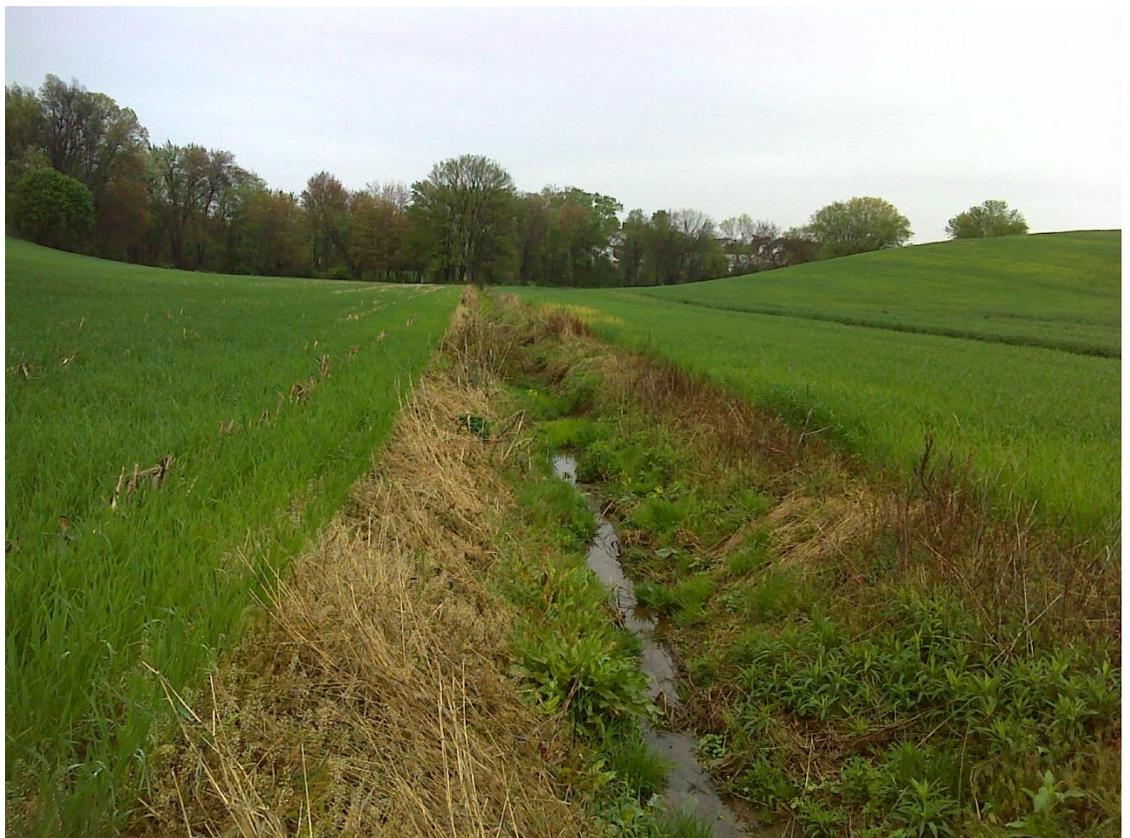
Comments:
View of Stream
160428-1310, an
unnamed tributary to
West Branch North
Branch Patapsco
River. (STR
DSC08662-P38-
NW.jpg
BISH)

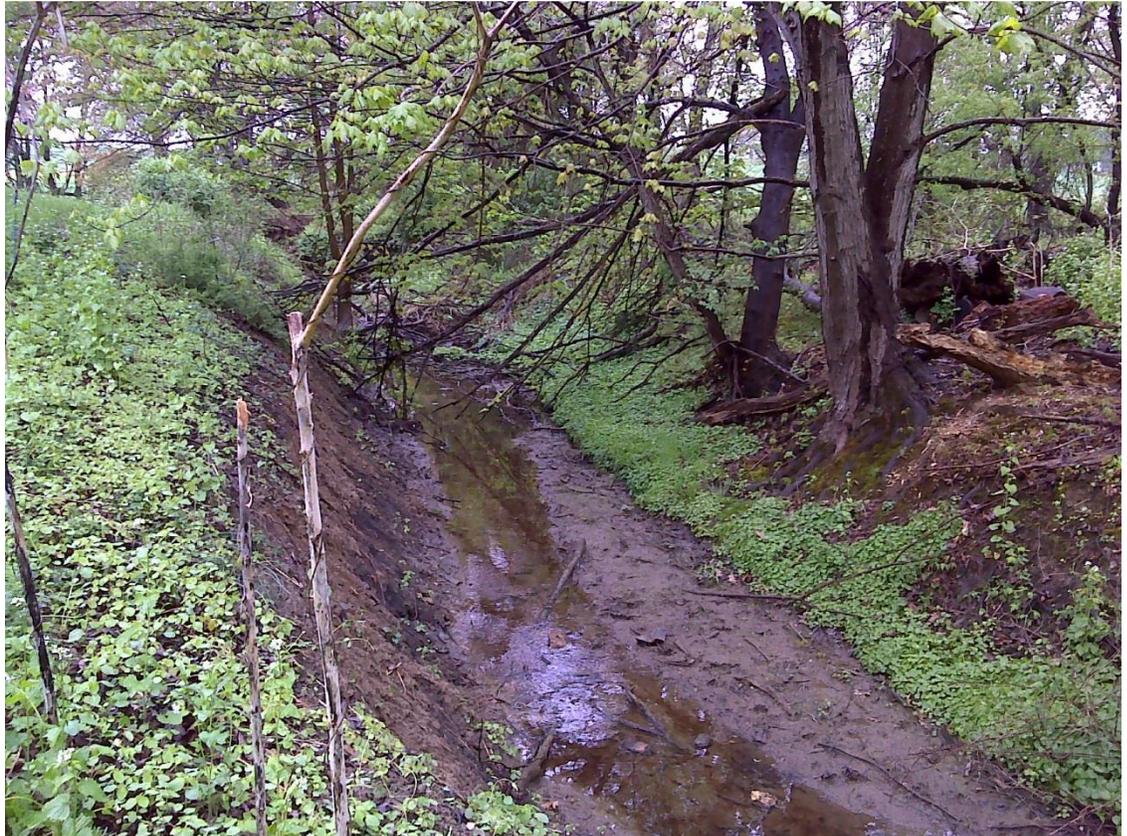
Photo 44

Comments:
View of wetland
160428-1250 (PUB).
Visible in the
foreground of the
image is a small part
of wetland 160428-
1245 (PEM). This is
an old farm pond.
(DSC08663-P38.jpg
BISH)

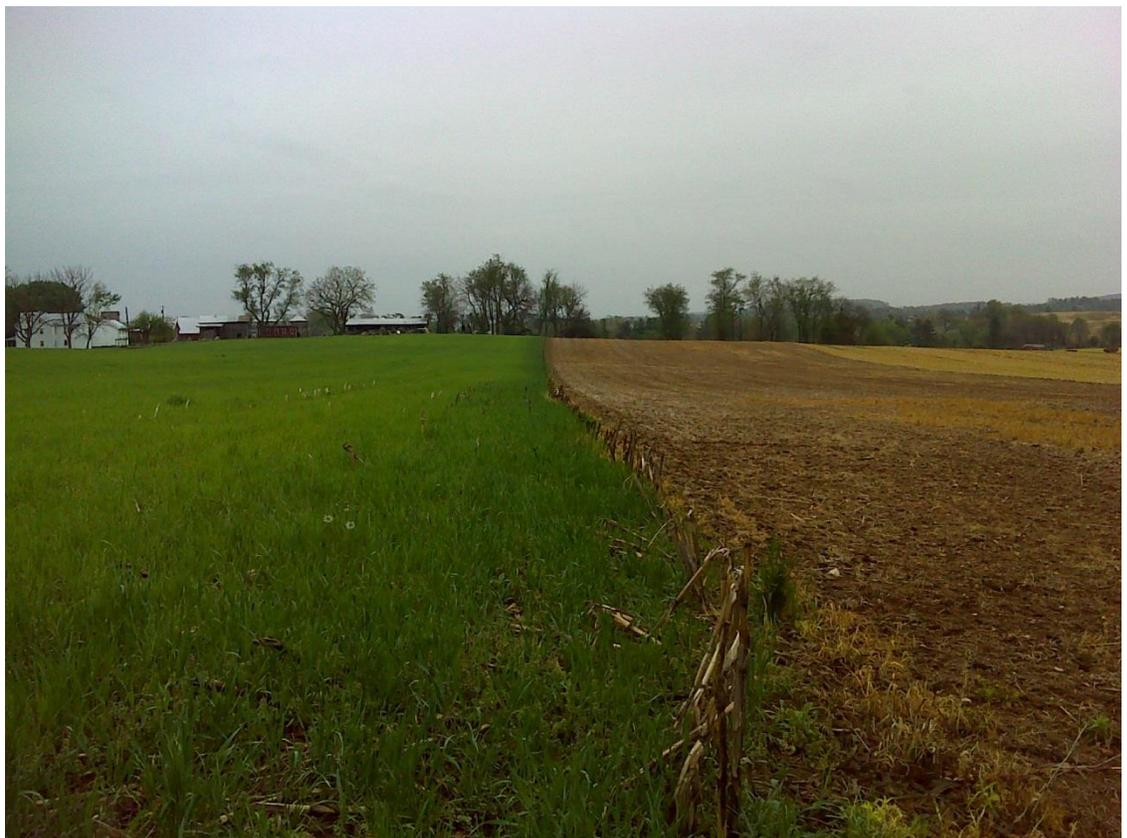
Comments:
An image of wetland
W160428-1425. This
large wetland
complex is adjacent
to an unnamed
tributary to West
Branch North Branch
Patapsco River,
identified as STR
#160428-1300.
(DSC08688-P38-N.jpg
BISH)

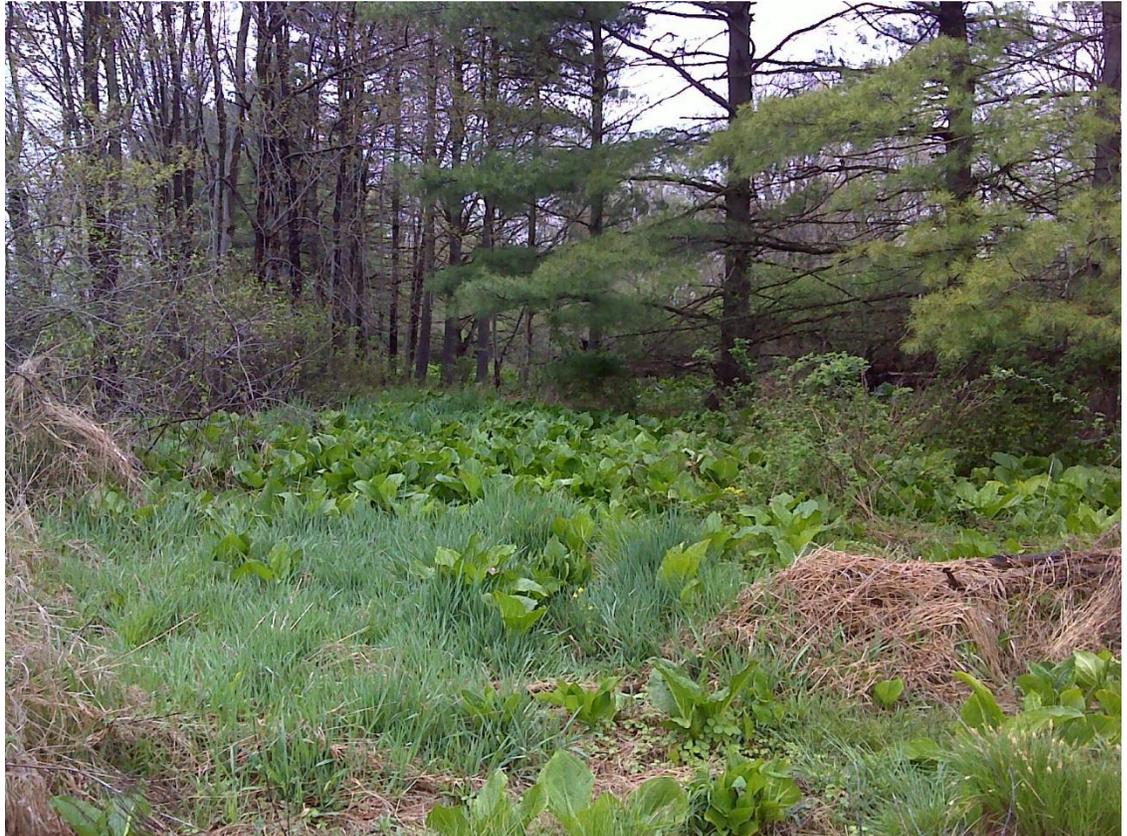
Photo 48

Comments:
Another view of
W160428-1425,
taken from SP-
160428-1425.
(DSC08693-P38.jpg
BISH)

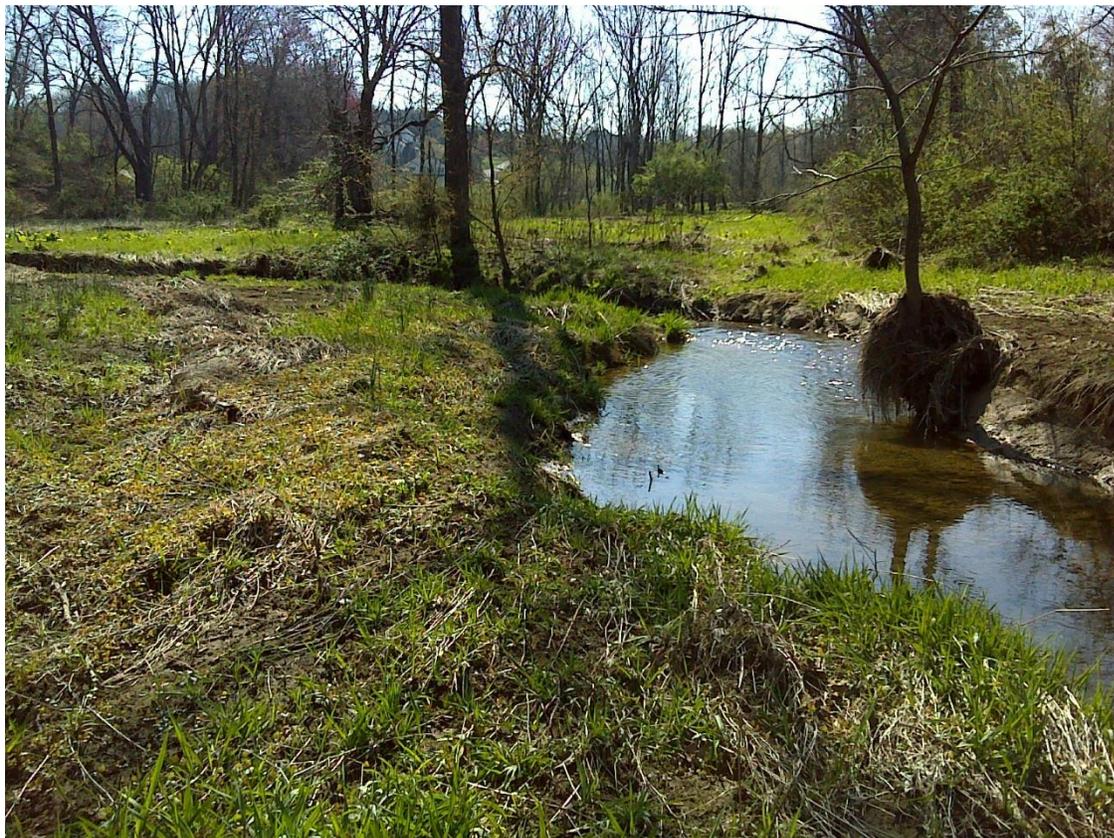
Comments:
Bear Branch,
identified as STR
160420-1540. This
stream flows through
an area that is
designated to be
placed in an avigation
easement.
(DSC08487.jpg
Osborne)

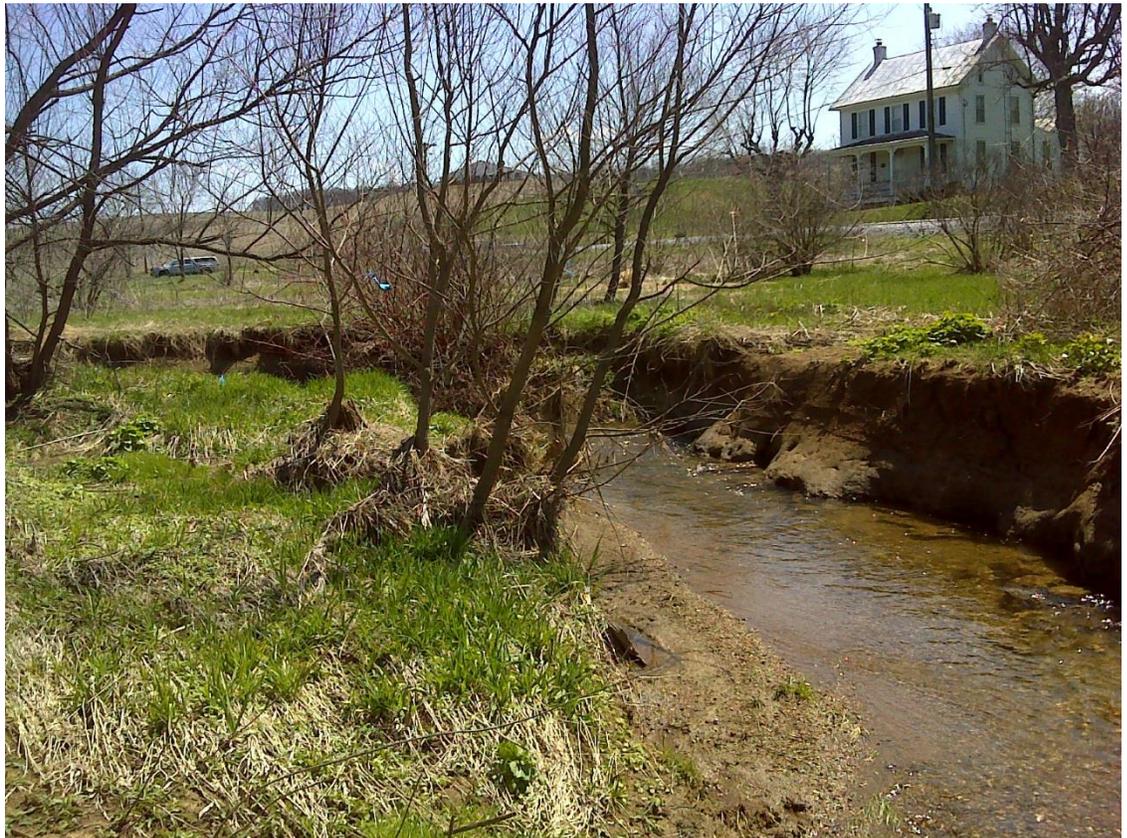
Photo 56

Comments:
Image of W160413-
1130, a
predominantly
herbaceous wetland
in the floodplain of
Bear Branch.
(DSC08465.jpg
Osborne)
