APPENDIX C

- Wetlands Investigation Memorandum
- Agency Coordination Regarding the Jurisdictional Determination
 - Draft Joint Permit Application

From: Mark Metzler <mmezler@rettew.com>
Sent: Monday, October 24, 2016 12:21 PM
To: Mary Ashburn Pearson
Cc: Mark Metzler
Subject: FW: Carroll County Regional Airport (CCRA; Carroll County, MD) - Summary of Areas Viewed During JD Field Visit (9/23/2016) (UNCLASSIFIED)

Subject: [EXTERNAL] Carroll County Regional Airport (CCRA; Carroll County, MD) - Summary of Areas Viewed During JD Field Visit (9/23/2016)

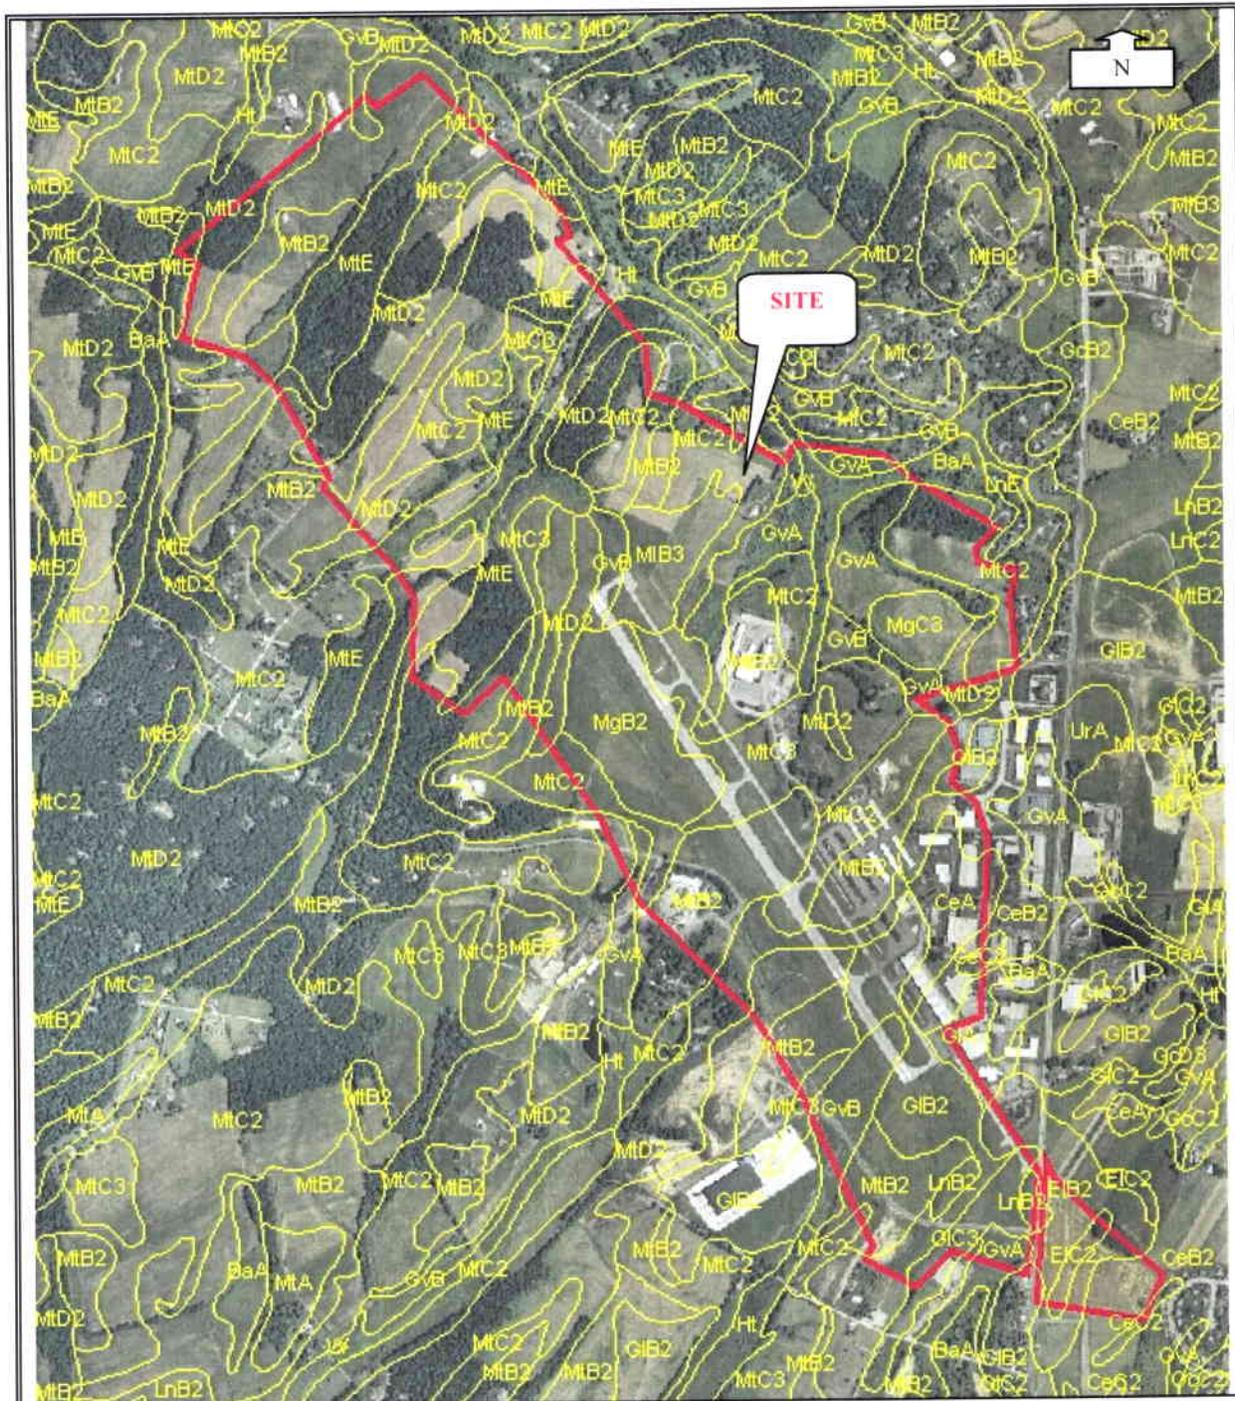
FIGURE 2
Soils Map
Carroll County Regional Airport Site
Town of Westminster,
Carroll County, MD

The Soil Survey of Carroll County, Maryland (<http://soildatamart.nrcs.usda.gov>) indicates Baile silt loam, 0-3 % slopes (BaA), Chester silt loam, 0-15% slopes (CeA and CeC2), Glenelg loam, 3-15% slopes (GIB2 and GlC3), Glenville silt loam, 0-3% slopes (GvA), Hatboro silt loam, 0-3% slopes (Ht), Linganor channery silt loam, 3-8% slopes (LnB2), Manor gravelly loam, 3-8% slopes (MgB2), and Mt. Airy channery loam, 3-45% slopes (MtB2, MtC2, MtC3, MtD2 and MtE), as the soil phases mapped on the Carroll County Regional Airport Site (Figure 2). The Baile series consists of very deep, poorly drained soils found in upland depressions and on footslopes. The Chester series consists of very deep, well drained soils found on uplands. The Glenelg series consists of very, deep well drained soils found on uplands. The Glenville series consists of very deep, moderately well to somewhat poorly-drained soils found on uplands. The Linganore series consists of moderately deep, well drained soils found on uplands. The Manor series consists of very deep, well-drained to somewhat excessively-drained soils found on uplands. The Mt. Airy series consist of moderately deep, somewhat excessively drain soils found on uplands. The Soil Survey of Carroll County, Maryland lists Baile, Glenville and Hatboro series as hydric soils.

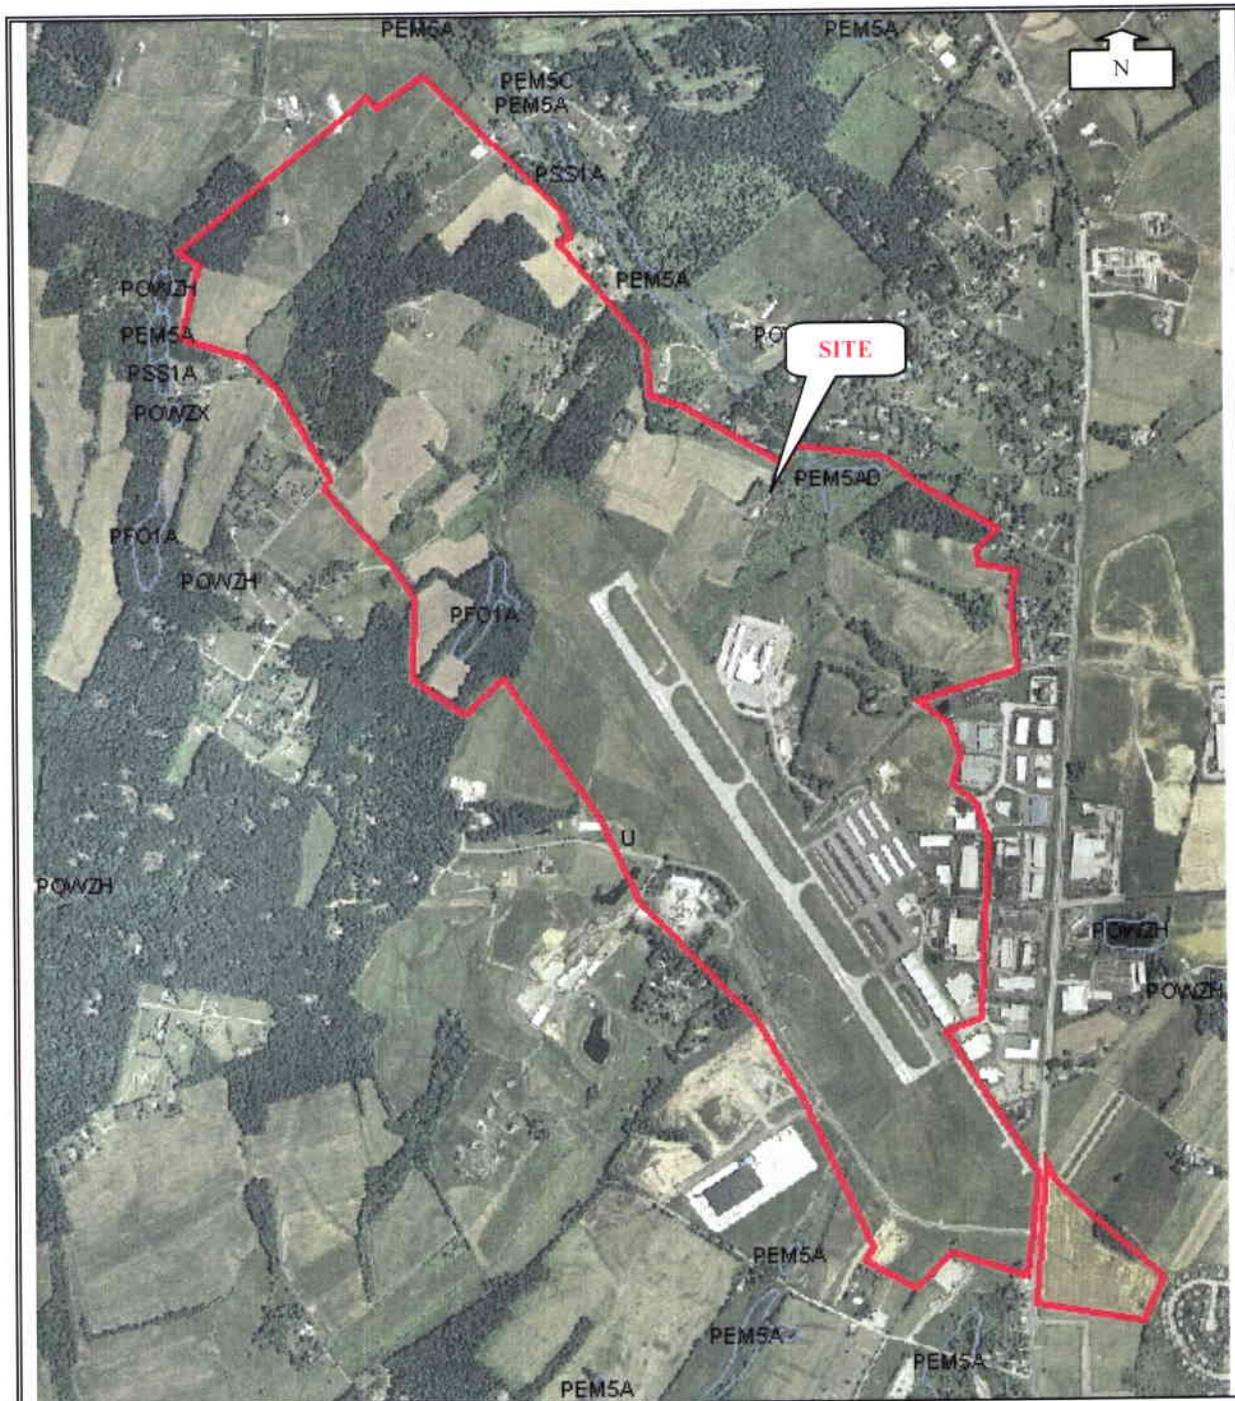
FIGURE 3
National Wetlands Inventory Map
 Carroll County Regional Airport Site
 Town of Westminster,
 Carroll County, MD

Sample Points #A1, A4, D3, D7, E4, and E5 were located within wetlands throughout the Carroll County Regional Airport Site. The dominant vegetative species in the wetlands include *Fraxinus pennsylvanica* (green ash, FACW), *Viburnum recognitum* (southern arrowwood, FACW-), *Acer rubrum* (red maple, FAC), *Juncus effusus* (common rush, FACW+), *Vernonia noveboracensis* (New York ironweed, FACW+), *Solidago* sp. (goldenrod), *Epilobium coloratum* (purpleleaf willowherb, OBL), *Salix nigra* (black willow, FACW+), *Rosa multiflora* (multiflora

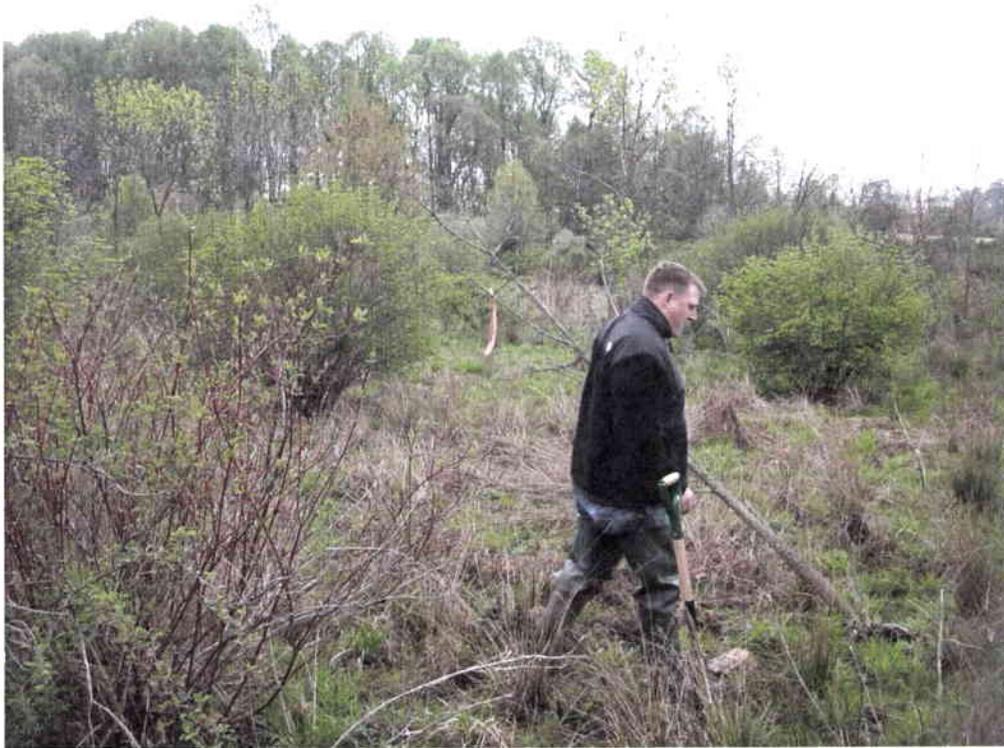
Photo 1 - Facing southeast from Pleasant Valley Road, viewing PEM/PSS portion of Wetland #1 and Sample Point #A1 at the Carroll County Regional Airport Site.

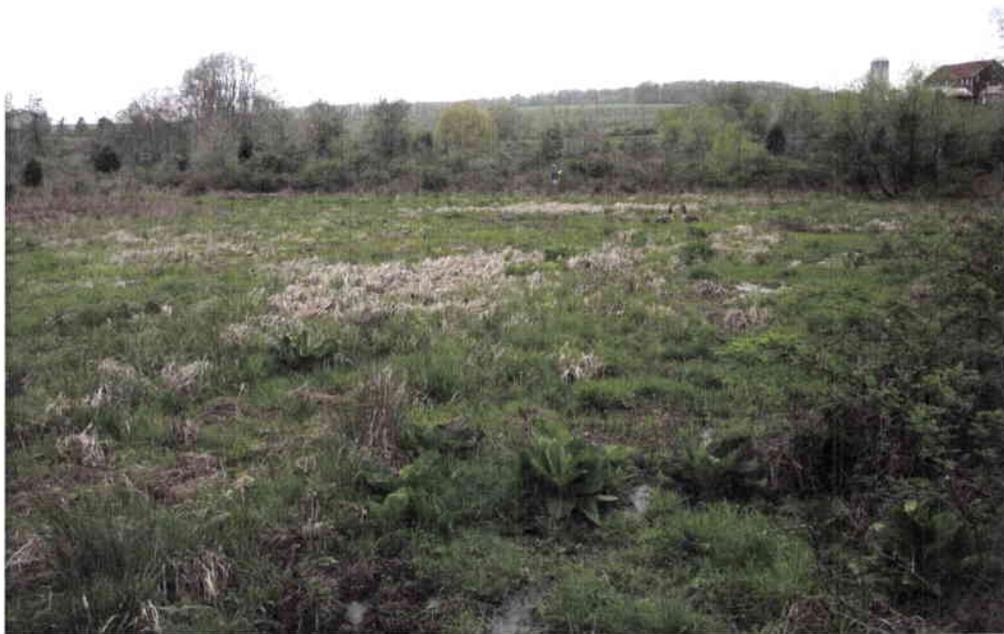
Photo 2 - Facing west, viewing PEM portion of Wetland #1.

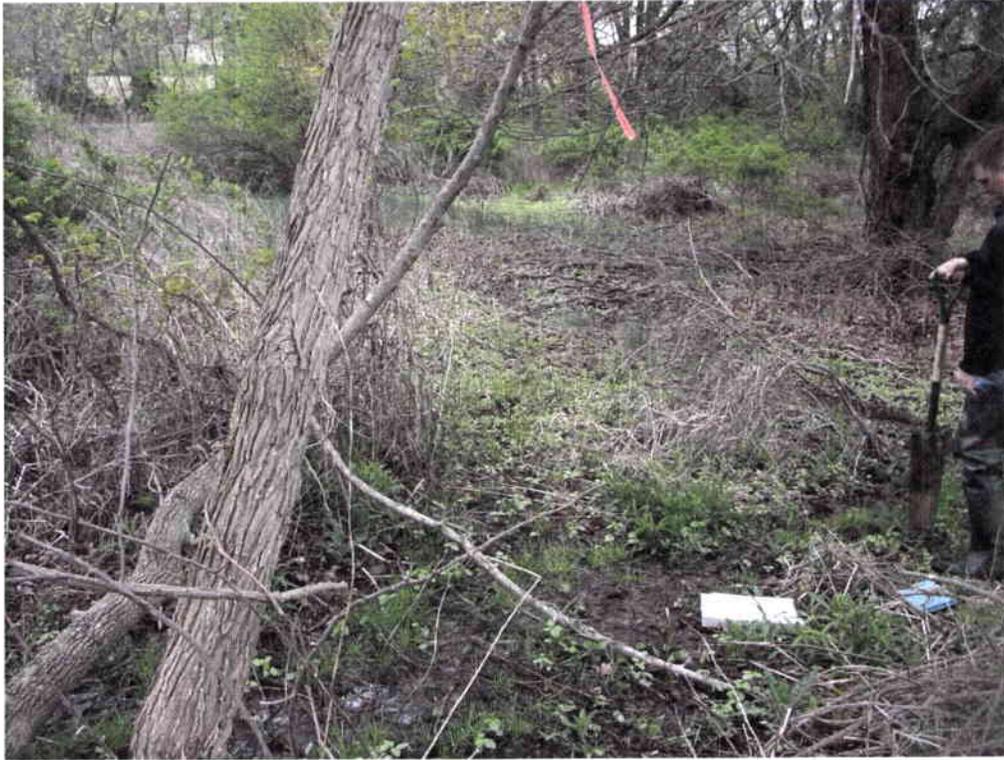
Photo 3 - Facing east from Sample Point A4, viewing PEM/PS/FO portion of Wetland #4 and Sample Point #A4 at the Carroll County Regional Airport Site.

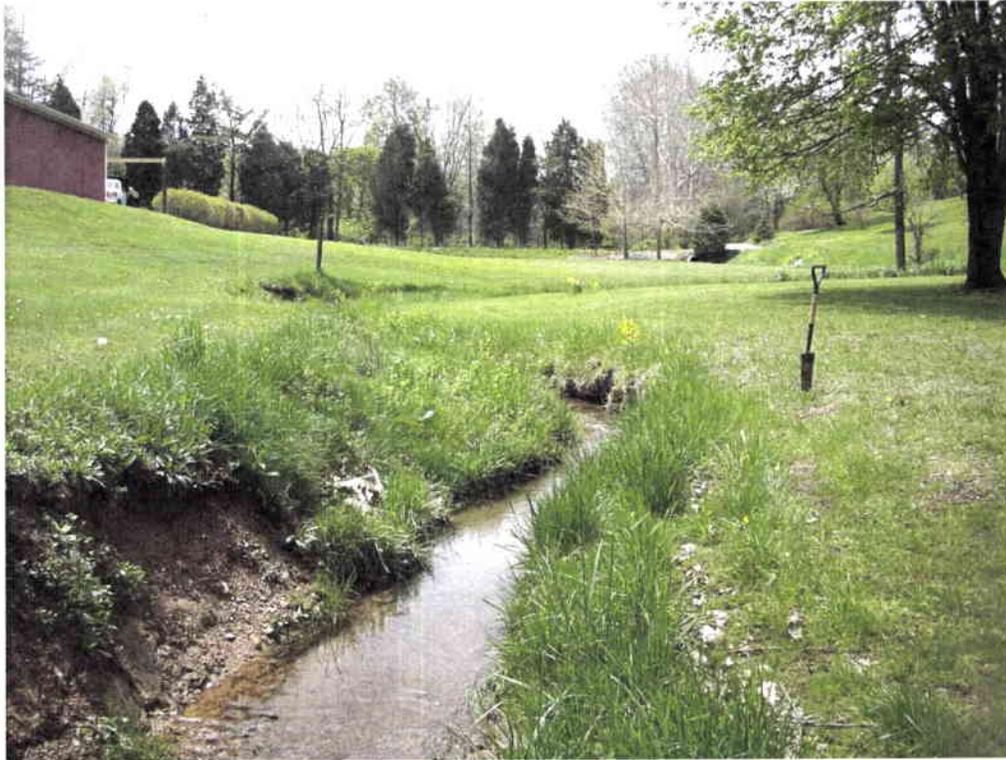
Photo 5 - Facing southwest from Sample Point #C6, viewing Stream #5. This stream is identified as an unnamed tributary to Bear Branch of Big Pipe Creek.

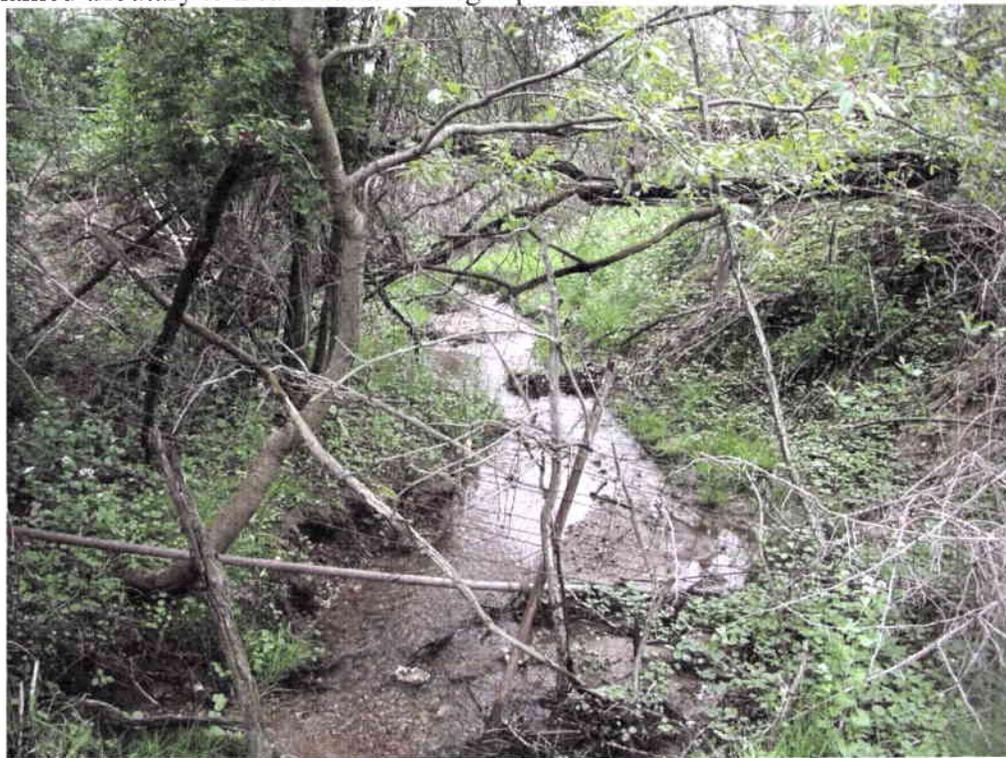
Photo 6 - Facing northwest from north of Wetland #6, viewing Stream #1, an unnamed tributary to Bear Branch of Big Pipe Creek

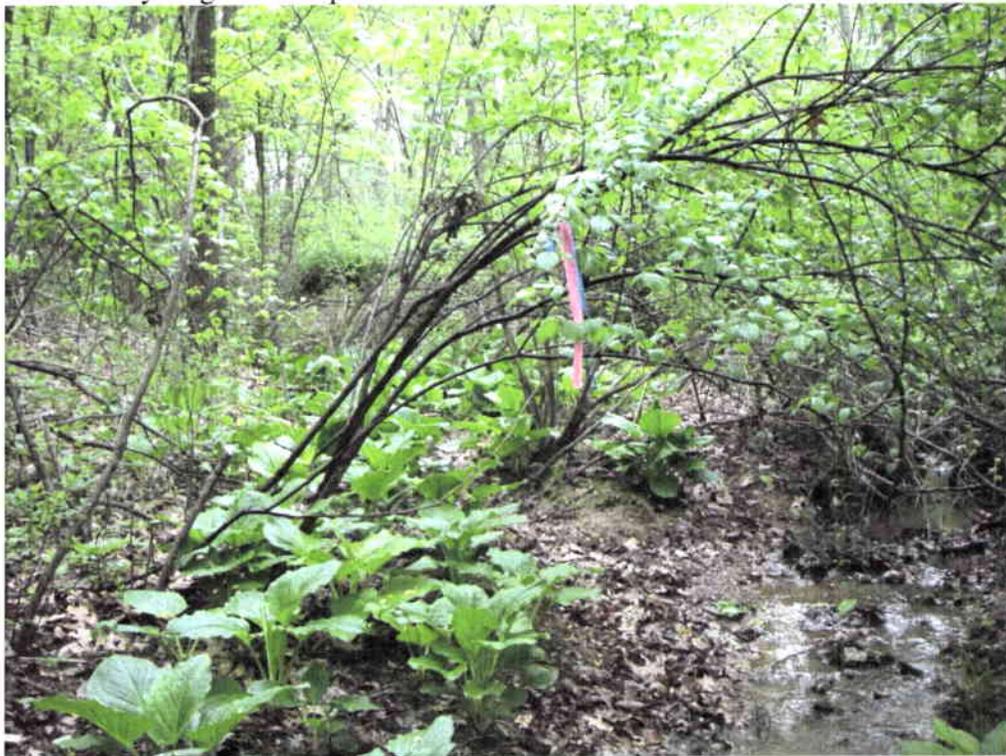
Photo 8 - Facing southwest from the northern end of the site, viewing a portion of fringed PFO Wetland #13 and Stream #8.

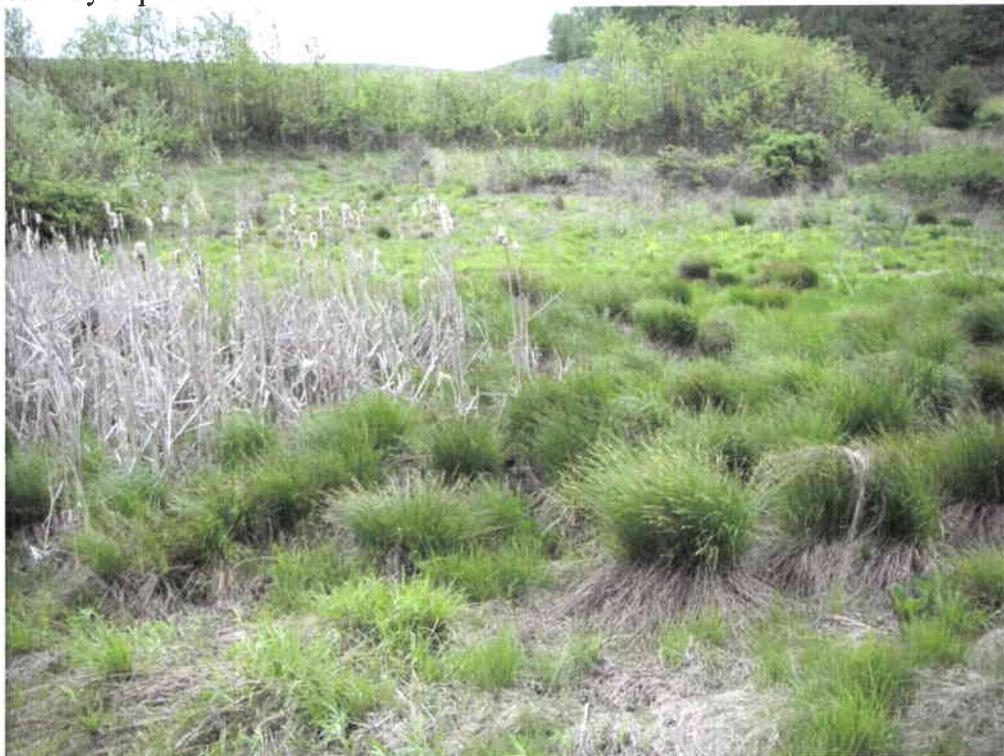
Photo10 - Facing south from the southern side of Pinch Valley Road (Sample Point #D7), viewing PEM portion of Wetland #9.

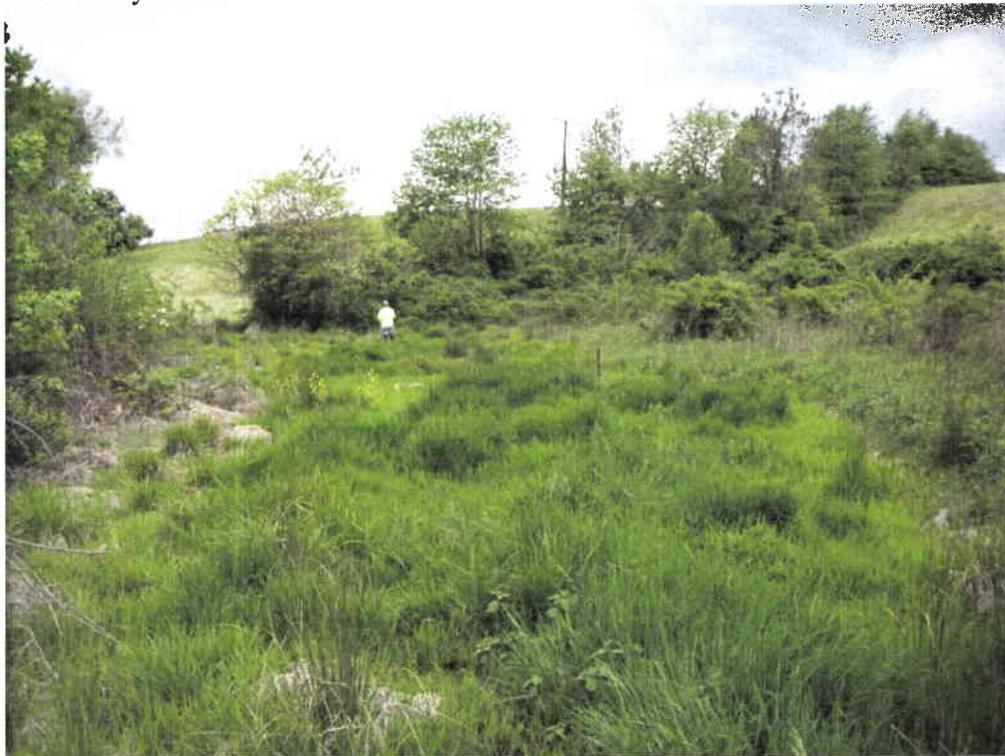
Photo 12 - Facing northwest from the northern side of Pinch Valley Road viewing a PEM portion of Wetland #9.

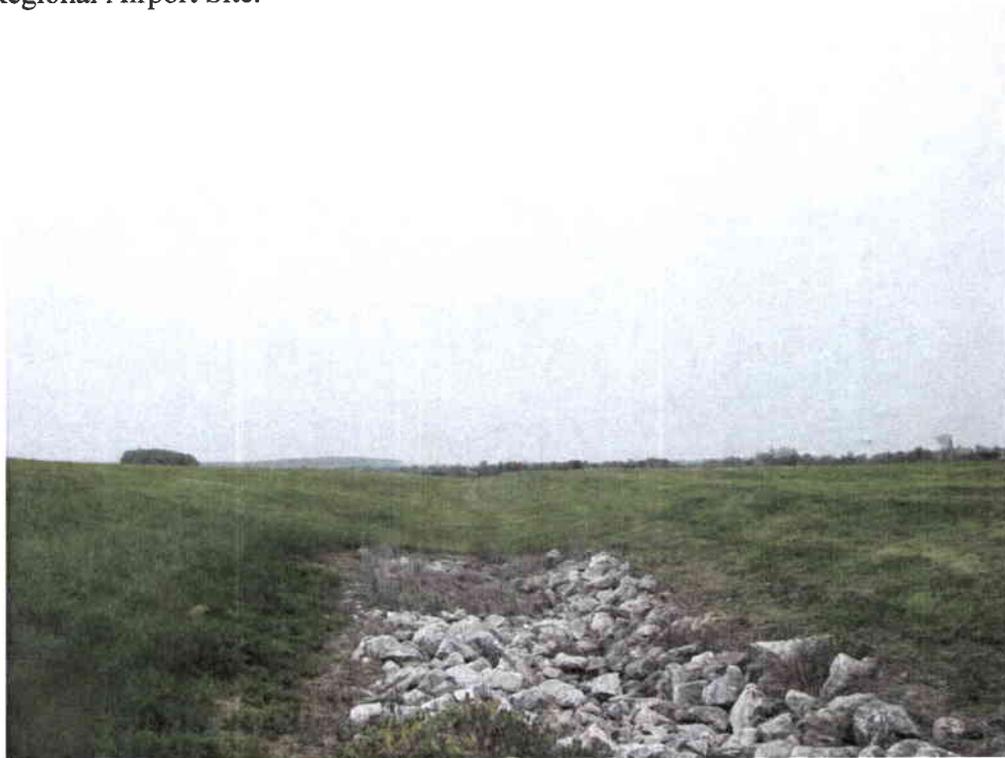
Photo 14 - Facing east from the southern end of the runway, viewing a drainage ditch at the Carroll County Regional Airport.

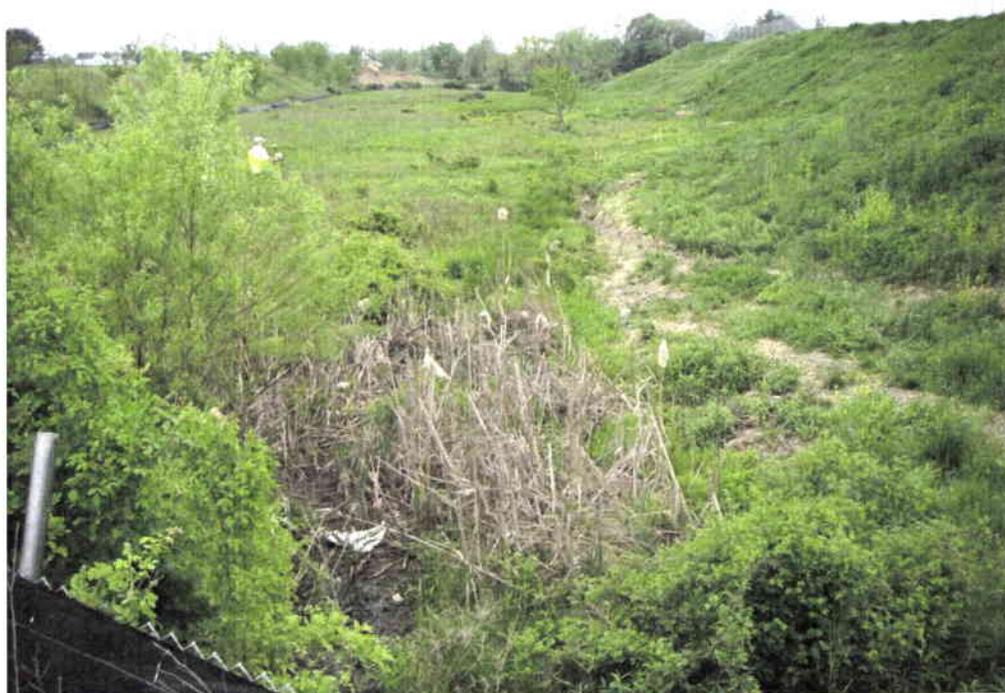
Photo 14 - Facing south from Meadow Branch Road, viewing a PEM wetland (Wetland #14).
