# 2025 Total Maximum Daily Load Stormwater Implementation Plan Carroll County, Maryland

Prepared by Carroll County Government Resource Management Division

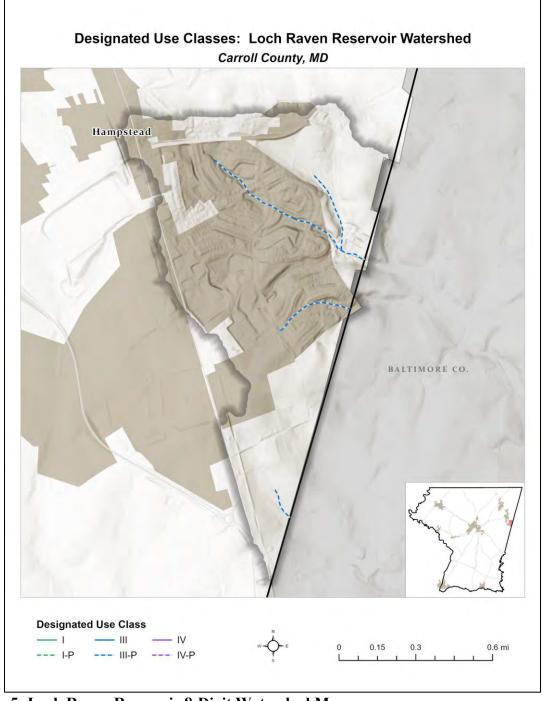
Figure 5: Loch Raven Reservoir 8-Digit Watershed Map

The Carroll County portion of the Loch Raven Reservoir Watershed is located in the northeast corner of the County, and covers a total land area of 592 acres. The watershed is within the Gunpowder River Basin, part of the Piedmont physiographic province of Maryland. **Figure 5** depicts the location of the Loch Raven Reservoir Watershed and its streams, symbolized by use class.

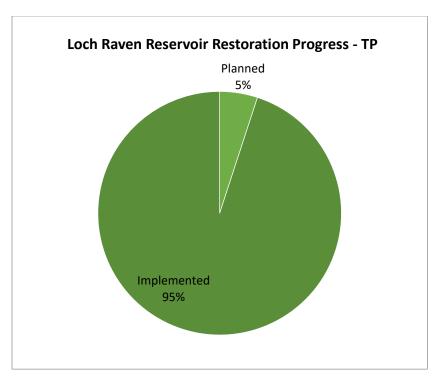
Figure 15: Loch Raven Reservoir Restoration Progress for TP

The current progress of implemented and CIP planned projects for the Loch Raven Reservoir Watershed since the TMDL baseline year is shown below in **Figure 15**.

Modeled Baseline Load (lbs/yr)	% Required Reduction from TMDL	Required Load Reduction based on Modeled Baseline (lbs/yr)	Reduction from Current BMPs (lbs/yr)	Reduction from Restoration Plan Strategies (lbs/yr)	Total % Reduction (Achieved + Planned)
509	15%	76	72.63	253	63.86%

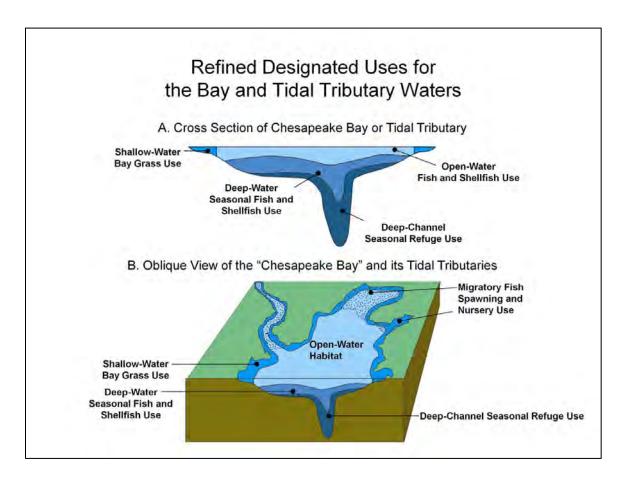
Figure 23: Chesapeake Bay Tidal Water Designated Use Zones (USEPA, 2003b)

habitats, and locations are listed in **Table 27**, and the tidal water designated use zones are shown in **Figure 23**.

The Chesapeake Bay designated use boundaries are based on a combination of natural factors, historical records, physical features, hydrology, and other scientific considerations (USEPA 2003b, 2004, 2010). The tidal water designated use zones for areas within Carroll County include: Use 1, migratory fish and spawning nursery; Use 2, shallow water; and Use 3, open water fish and shellfish. Criteria for the migratory fish spawning and nursery, shallow-water Bay grass, and openwater fish and shellfish designated uses were set at levels to prevent impairment of growth and to protect the reproduction and survival of all organisms living in the open water column habitats (USEPA 2003a).
