**South Branch Patapsco  
Stream Corridor Assessment**

**Winter 2013**

**Carroll County Bureau of Resource Management**

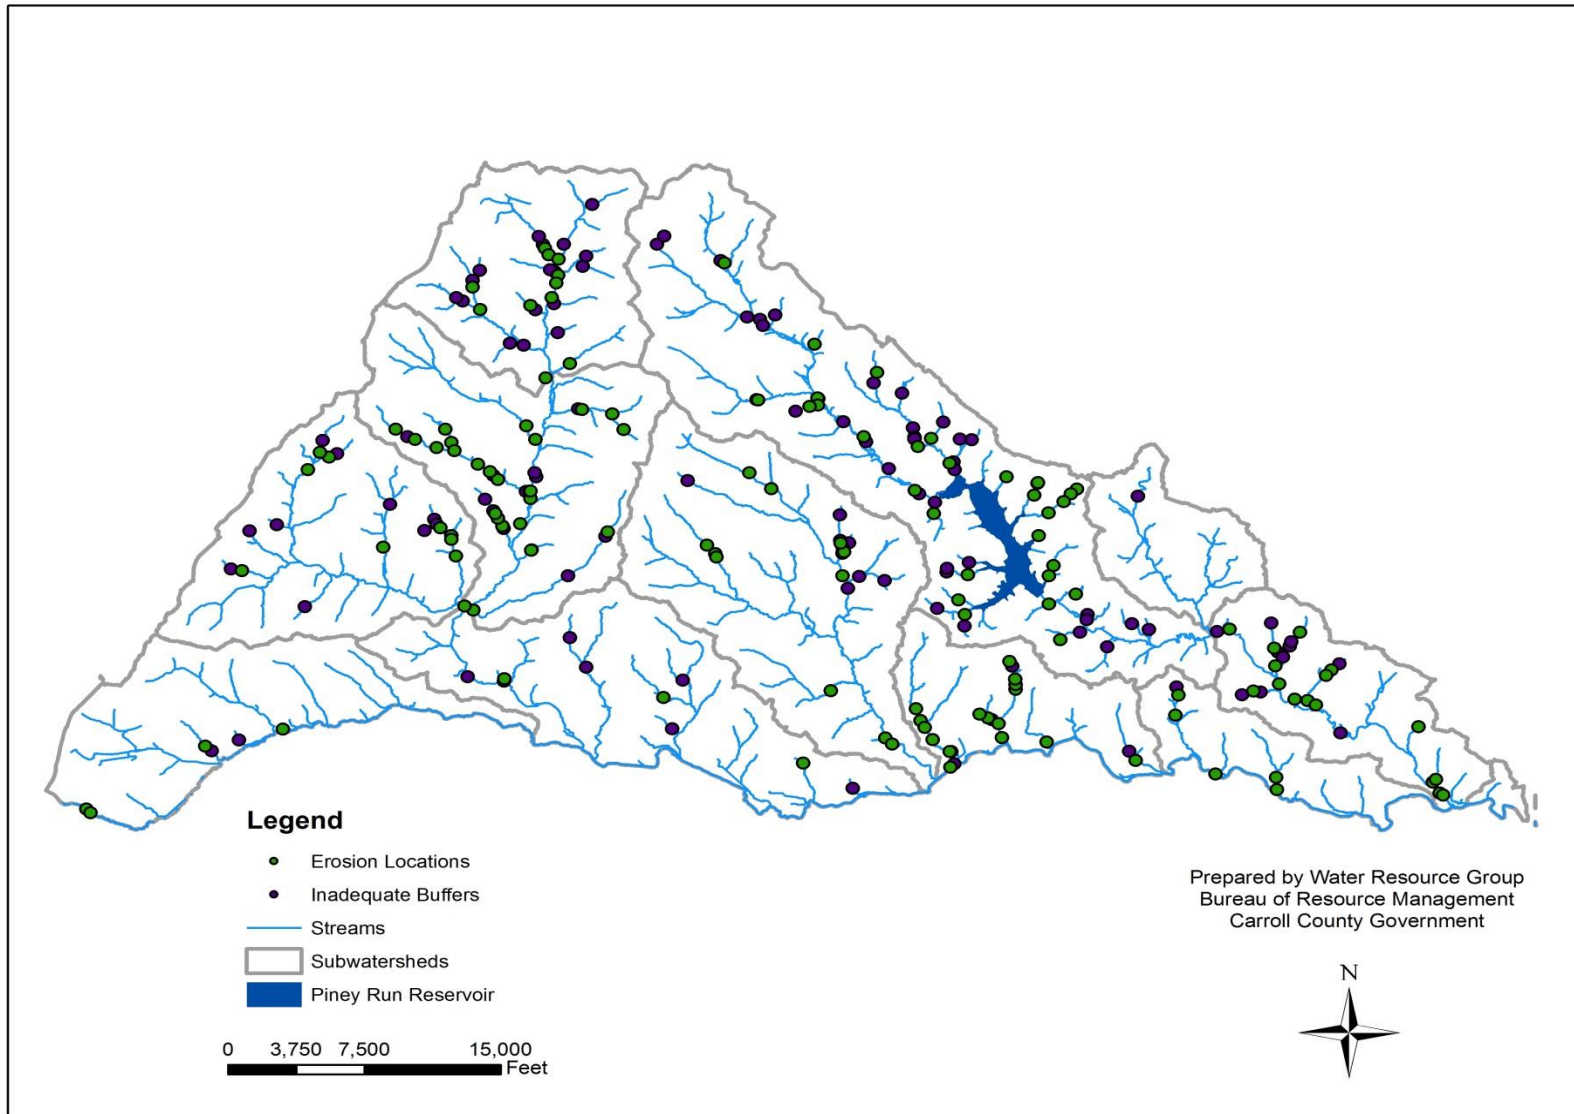
Figure 1-3: Most Commonly Identified Impacts

A total of 312 data points were collected across the watershed. Inadequate buffers and stream bank erosion were the most frequently identified problems. Drainage pipe outfalls and fish blockages were also regularly present throughout the watershed. Table 1-2 lists the data points by severity across the entire watershed. The most commonly identified impacts are shown in Figure 1-3 and Table 1-3 presents a summary of the number of impacts identified in each subwatershed. Criteria for ranking each impairments severity can be found in Appendix B.
