PINEY RUN WATERSHED STUDY

EXISTING SITE CONDITIONS

CARROLL COUNTY BUREAU OF RESOURCE
MANAGEMENT

Maryland Dam #139

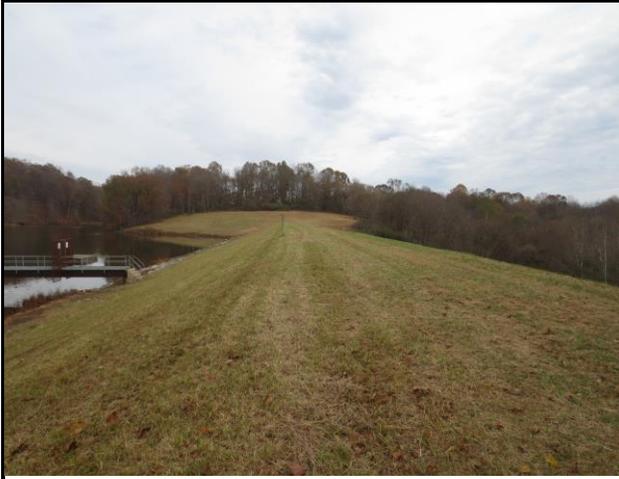
Image 1: Embankment crest, Looking Northeast

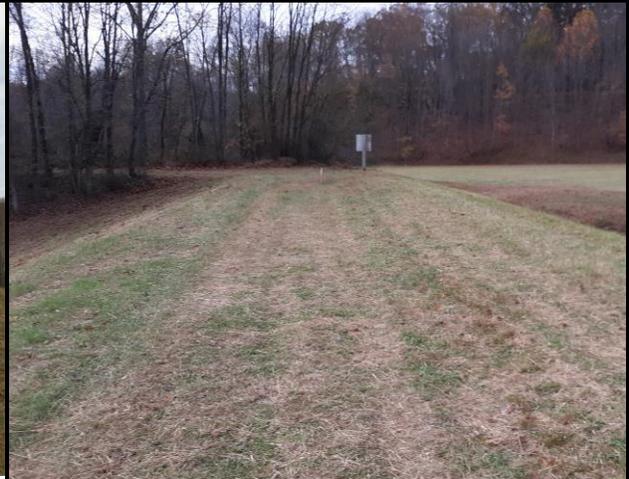
Image 2: Embankment crest, Looking Southwest

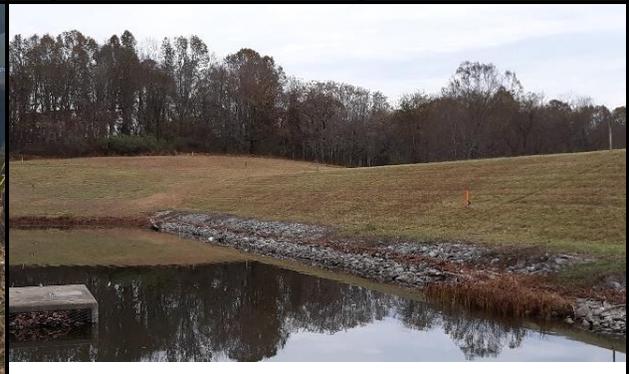
Image 6: Riprap on upstream slope

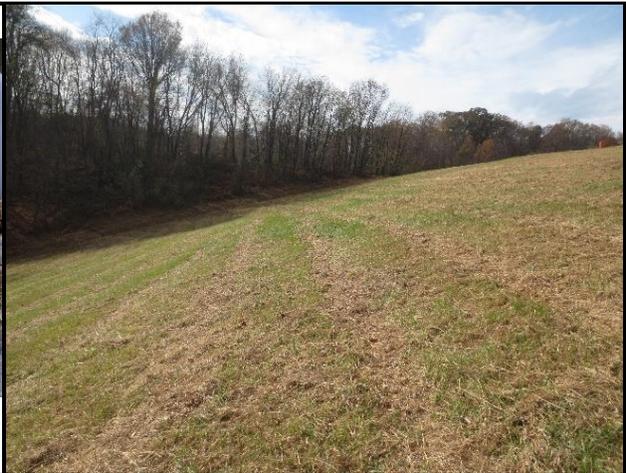
Image 8: Downstream slope from left groin

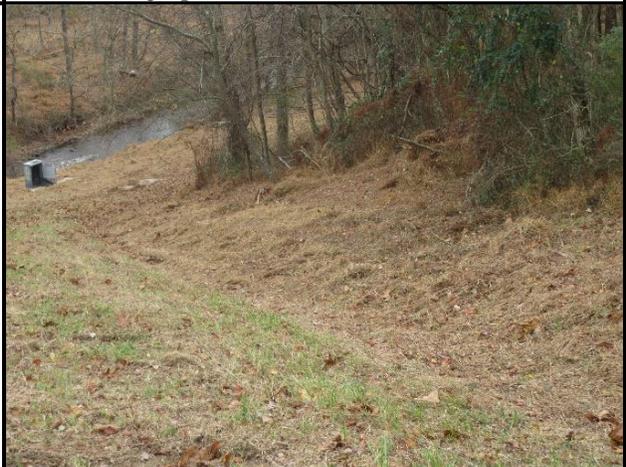
Image 12: Right downstream groin

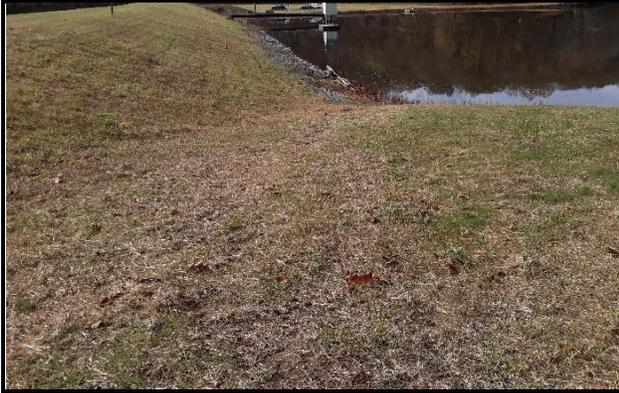
Image 13: Left upstream groin

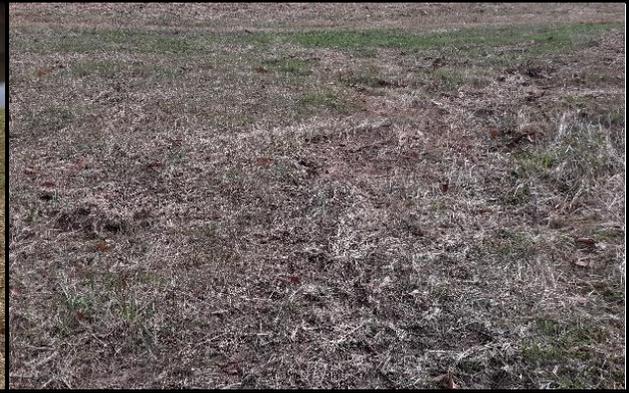
Image 14: Bare spots on left upstream abutment

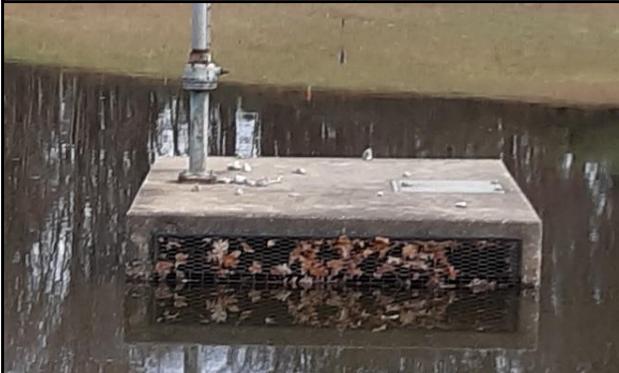
Trash racks are located at the top of the riser along the two intake weirs. The trash racks on the intake are made of horizontal steel bars below elevation 522.5 feet and grated metal openings above elevation 522.5 feet. The side grates were observed to be intact and free of corrosion but, were obstructed by leaf litter. A log was lodged in the horizontal slotted trash rack, extending several feet into and out of the riser, as shown in **Photograph 6**. The anchor bolts connecting the trash rack to the riser appeared to be in overall good condition.

Image 17: Leaves collected on PSW riser trash rack

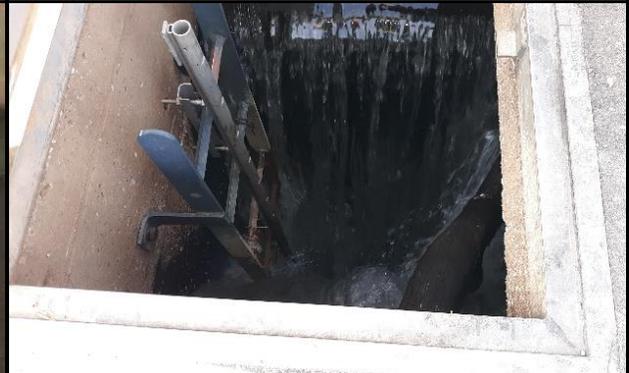
- Depressions on the upstream and downstream slopes;
- Woody debris lodged in the trash rack of the principal spillway riser (see Image 18 in Appendix B);
- Broken / corroded animal grates on the internal drain outlets;
- Damage to two observation wells (#9 and #11) which made readings difficult to obtain and possibly inaccurate.

Image 18: Inside of PSW riser. Note log lodged in inlet

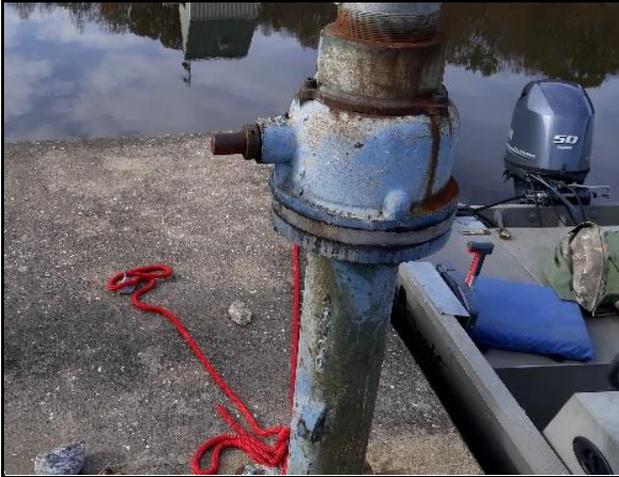
Image 19: Lake drain gate wheel

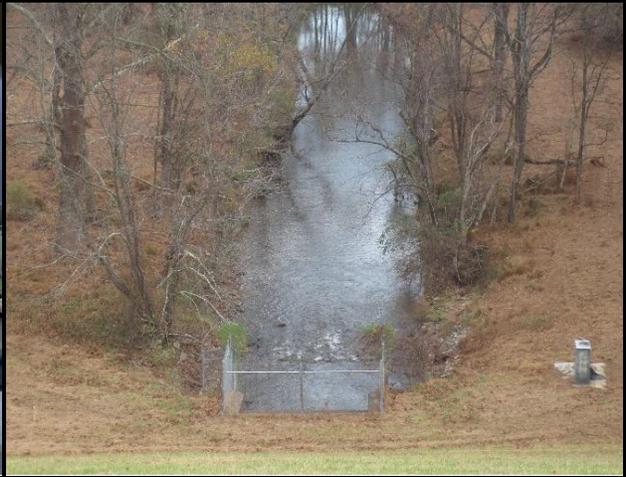
Image 20: PSW outlet channel

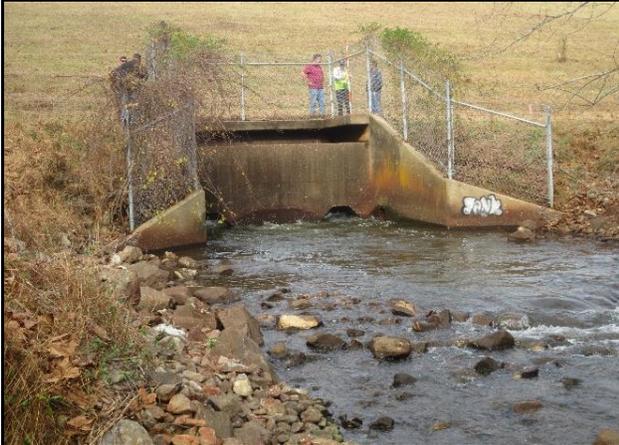
Image 21: PSW outlet impact basin

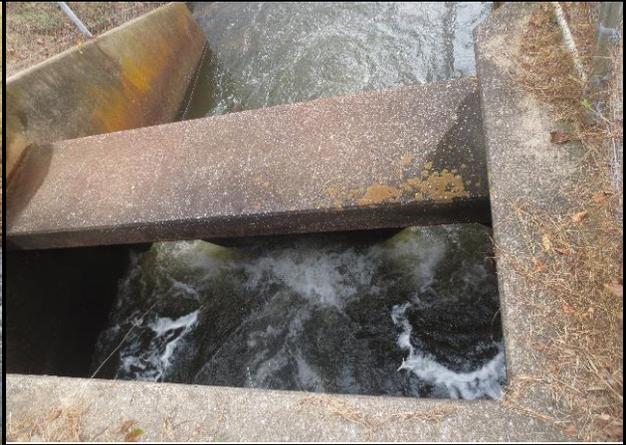
Image 22: Impact basin from above

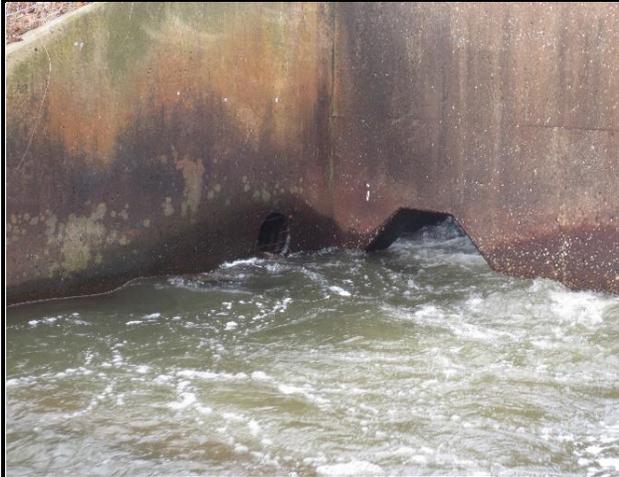
Image 23: Right toe drain outlet at impact basin

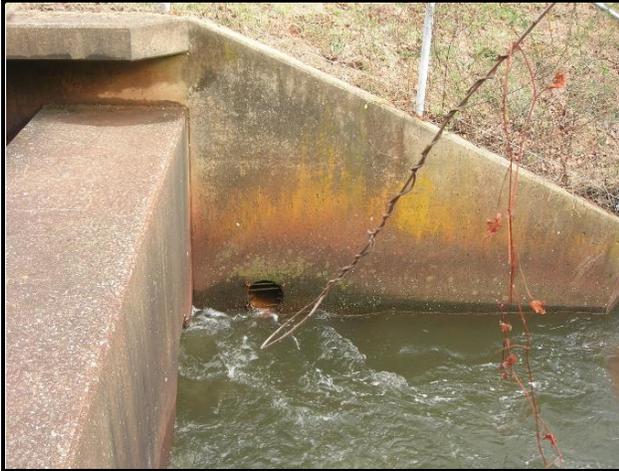
Image 25: Left toe drain outlet at impact basin

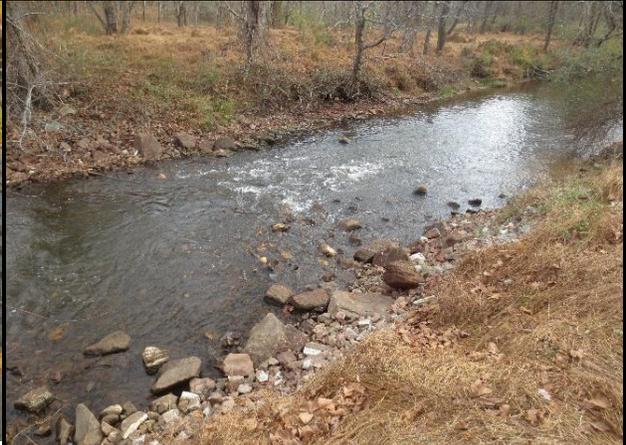
Image 28: PSW outlet channel left slope

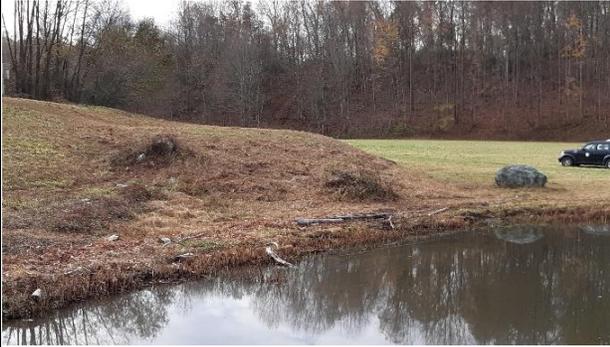
Image 31: Training dike. Note woody debris

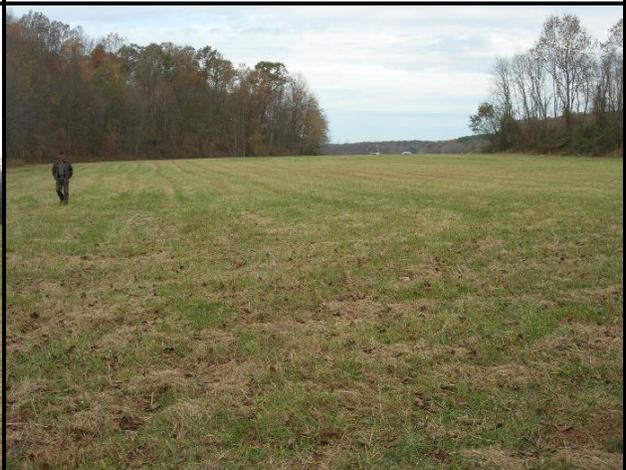
Image 34: ASW vegetated channel facing upstream

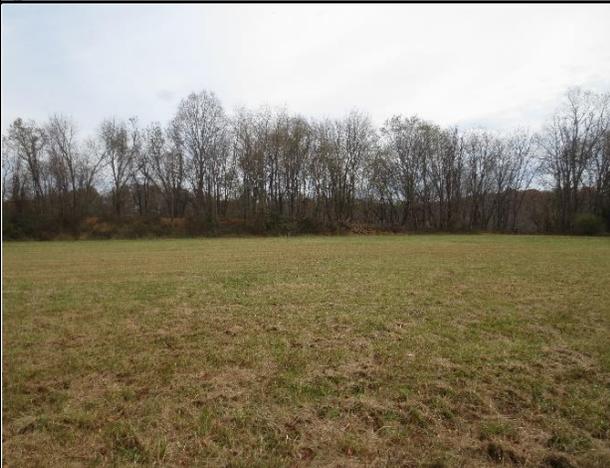
Image 35: ASW vegetated channel facing downstream

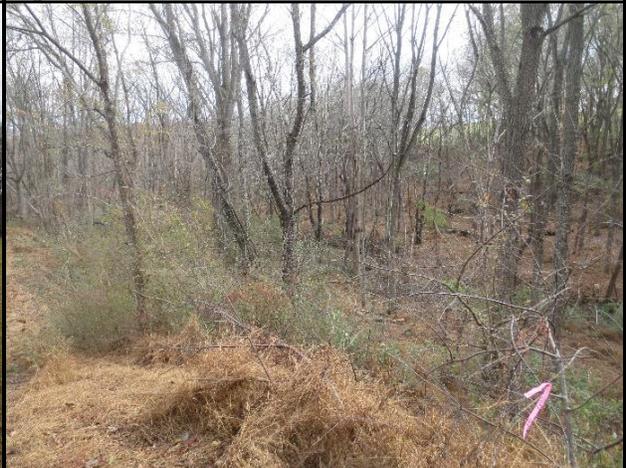
Image 36: ASW outlet into wooded valley

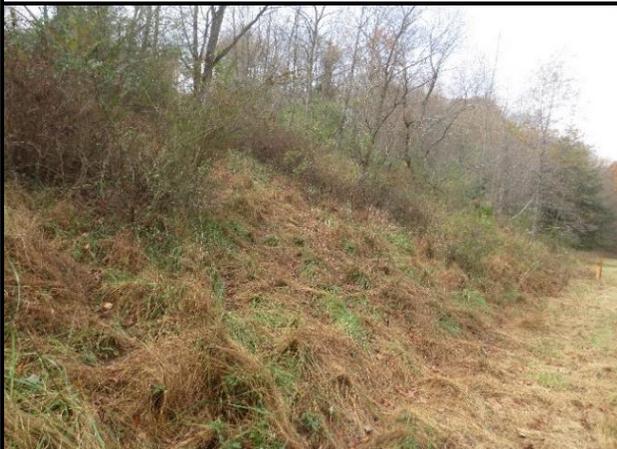
Image 39: ASW outside slope, downstream

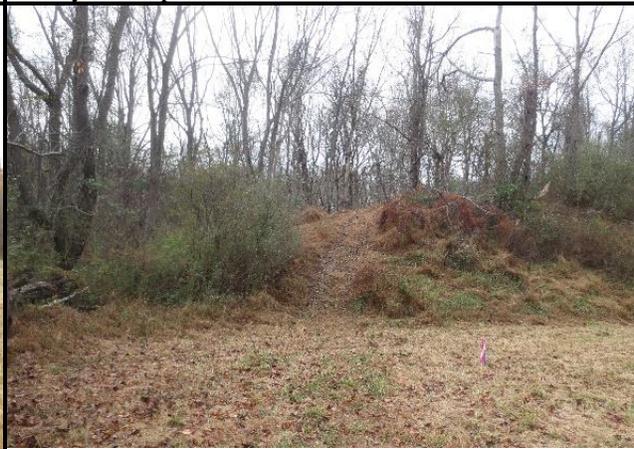
Image 40: ASW outside slope at outlet. Note path which leads to electrical standpipe and fourteenth observation well

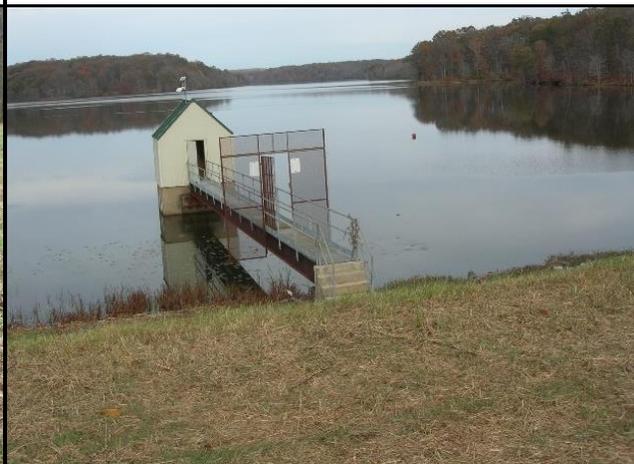
Image 42: Water intake structure

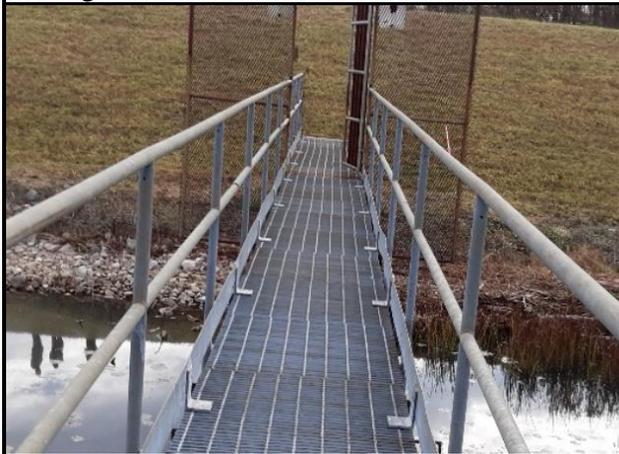
Image 45: Catwalk leading to intake tower

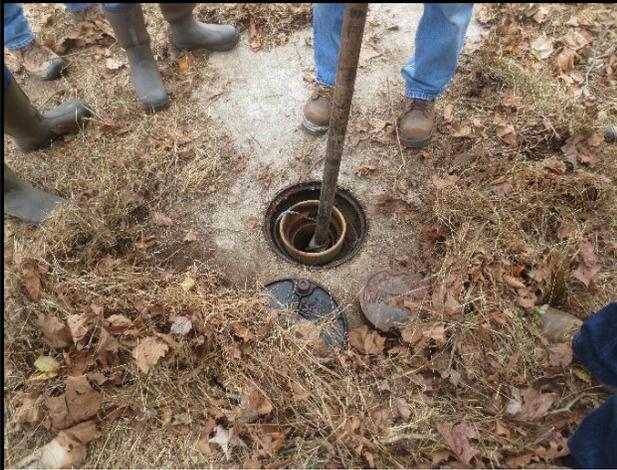
Image 51: Rate control piping butterfly valve operation

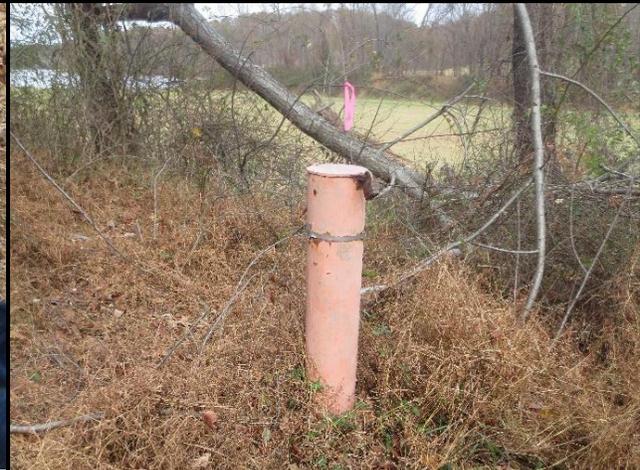
Image 52: Locked observation well, ASW outside slope
